STOP - Important Notice

Clutch Master Cylinder Failure 1993-88 GM "C" and "K" Pickups

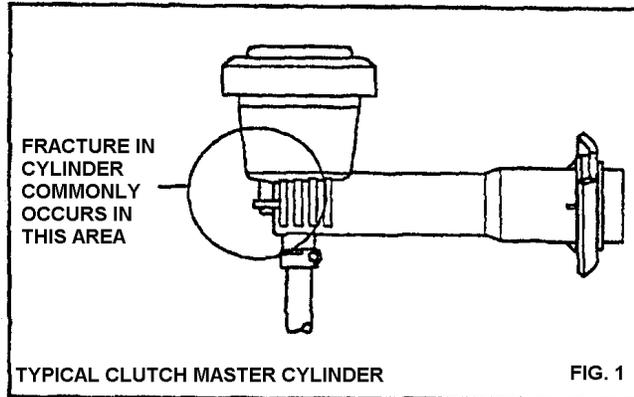
The clutch master cylinder housing can fracture, or seals can be blown out due to excessive hydraulic pressure build up (Fig. 1). Fractures in plastic units can begin as a small crack creating a leak, which can later develop into a visible crack in the clutch master cylinder housing. Also, for those units made of sheet metal, seals will blow out due to the same high pressure build up. This is often mistakenly diagnosed as a defective master cylinder, especially after repeated failures.

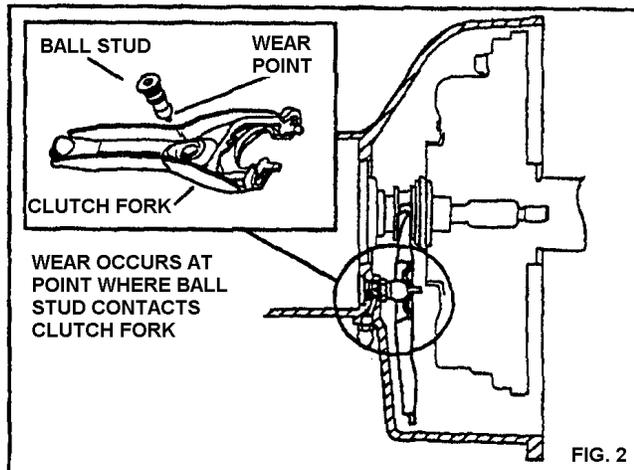
The most common cause of master cylinder fracture has been reported to be a binding clutch fork, or throw out lever (Fig. 2). If the area of contact between the ball stud and the clutch fork is binding, from lack of lubrication, hydraulic pressure in the clutch system can rise substantially. Excessively high pressure can cause the master cylinder to fracture.

If there is a squeaking in the clutch fork or increased pedal resistance the ball stud and clutch fork should be inspected and lubricated, or replaced.
