TROUBLESHOOTING GUIDE FOR MALLORY HEI CONNECTOR

During installation, it is possible that the ears of the HEI connector that plugs into the cap terminal can be damaged. This simple procedure can be used to change the black plastic shell.

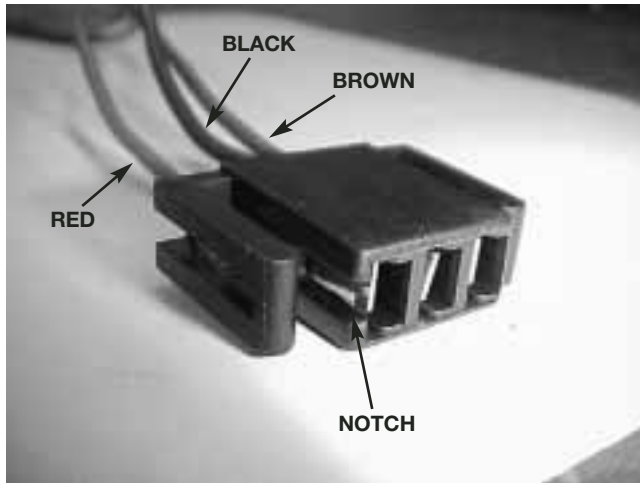
Figure 1

Using the notch in the one side of the connector shell as a reference point (Figure 1), the correct wiring layout is:

- Red Wirein the outside cavity with the notch
- Black Wirein the center cavity
- Brown Wirein the outside cavity opposite the notch

NOTE: The open side of the terminal is towards the notch in the connector shell.
