SK[®] 44-55E

Forward Clutch Failure—2/3 Cutloose
 Hard Throttle 2/3 Slip—4th and 2nd Band Failure
 Coast 3/2 Clunk—Won't Move
 Slipping Codes: 733—734—647—648

Fits: 1995-2010 4R44E, 4R55E, 5R55E

2.3—3.0 and 4.0 V6
 Aerostar-Explorer-Bronco-Ranger
 Mazda B2300—B3000—B4000

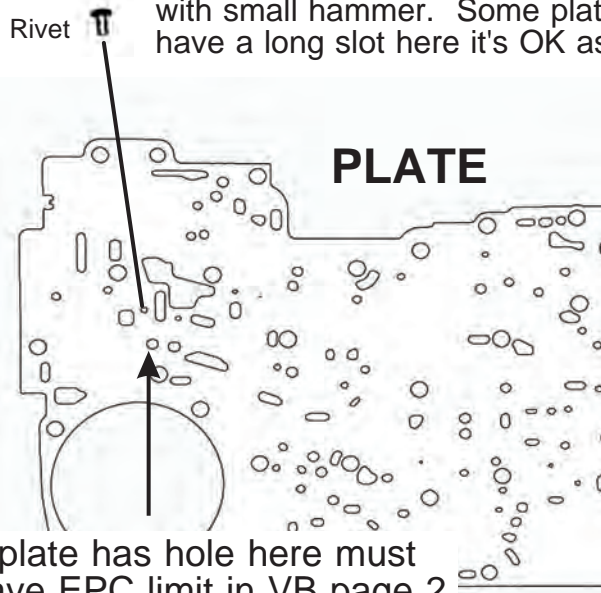
If plate has hole here must have EPC limit in VB page 2

A. Insert small rivet furnished up thru this hole. Hit it smartly a couple times with small hammer. Some plates will have a long slot here it's OK as is.

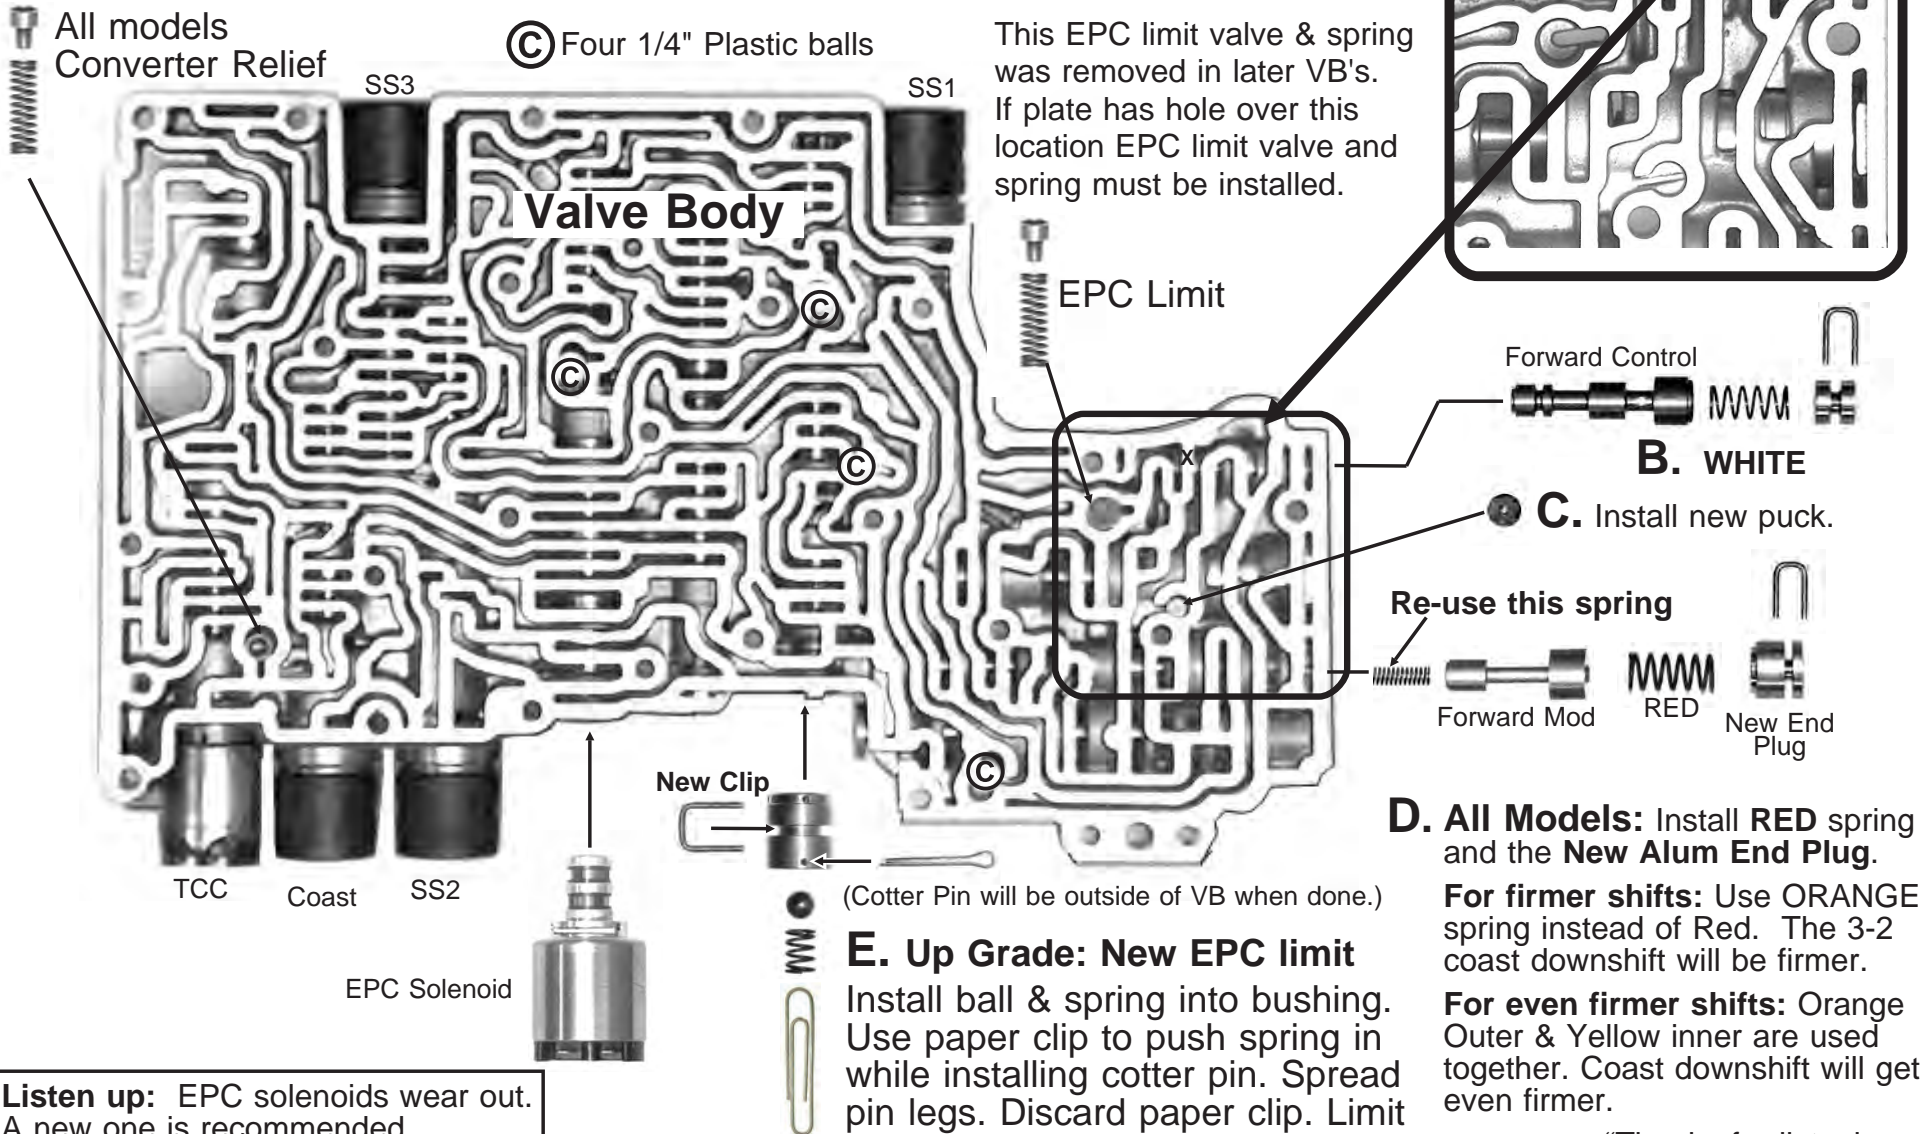
Original calibration: 1. Clutch and band shift pressure is regulated as low as 40 psi even when line pressure is much higher.
 2. This often causes burned forward clutch and bands.
 3. If EPC solenoid sticks vehicle will not drive forward or reverse.
 This kit changes forward circuit so that vehicle can at least be driven somewhere for service. **SHIFT FIRMNESS** is upgraded to avoid soft shifts and band failure. Also lockup is slightly firmer.

A. YOU MUST cross drill thru partition, under the X, with the .063 (1/16") drill furnished.

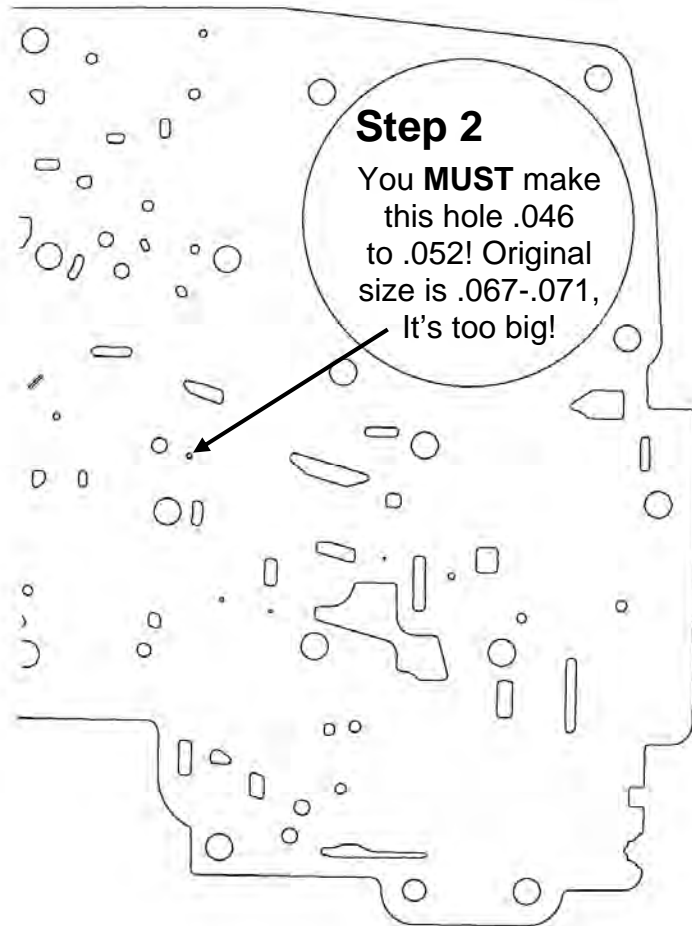
No Reverse or Delay Bang Reverse Correction.

Plate hole size reduction. Works on bonded plates too!

Use (2) approx .314 steel balls (700R4 TV exhaust balls will work) to downsize plates. Take 1/4" nut set it on a hard surface and set (1) .314 Ball on it. Lay plate on ball and nut and set other .314 ball on top. Hit top ball with light hammer until hole is .052 but no less than .046. Engagement into reverse will feel firm like A4LD. Smaller hole = less firm.

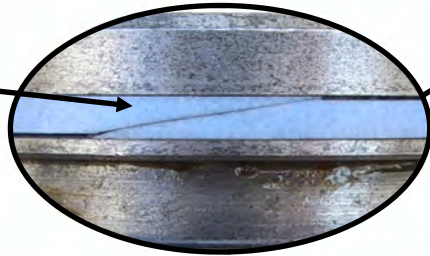
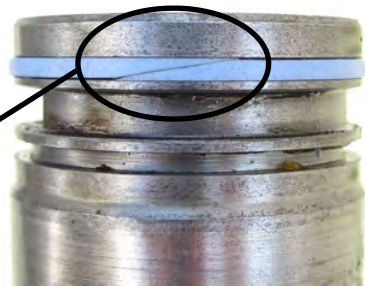
The ring shown was pushed firmly and is locked in the groove

Ends of rings should have small gap or just touch **GENTLY**. **Don't push** the ends together **firmly** or they will **bind** in the groove and will **not seal**.
