# **SK®AODE Shift Kit®** 1991-2013 also fits 4R70W&E & 4R75W&E

Correct/Reduce/Prevent Neutrals on Start Off--Converter Slip 2nd Roller Failure--4th Band Failure 2nd Clutch Burn Up--Kickdown Runaway

#### **Upgrade Explanation**

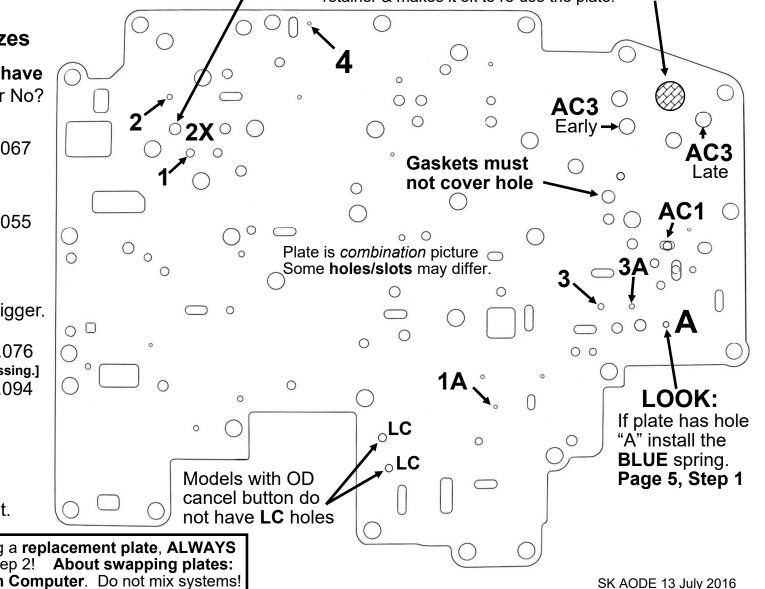
Listen up! Models without a bolt-down plate here, can develop a small crack in the separator plate in shaded area below. Our new spacer fits pointed end of 3rd accumulator retainer & makes it ok to re-use the plate.

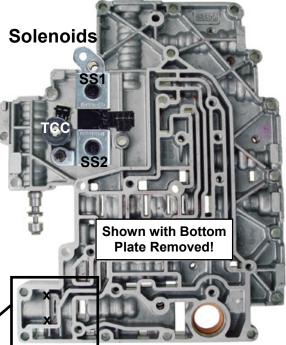
Corrects uncontrolled line pressure due to electrical malfunction, stuck EPC valve, or cross leaks. Reduces the accidental neutral condition [Run-Away] and brutal 2nd clutch re-apply that breaks 2nd roller or mid shaft.

Step 1 Remove Thick Bottom Plate. Drill two .125" [1/8"] holes thru this partition from right to left under "X's". Do not allow the side of the drill to contact any partitions!
