SK® CD4E-Jr Shift Kit® Series 7D

Converter Slip and Code 628

Drum Blow-out due to run-away line pressure.
Bushing wear due to accidental Lube cut-off.

Ford CD4E
Mazda LA4A-EL

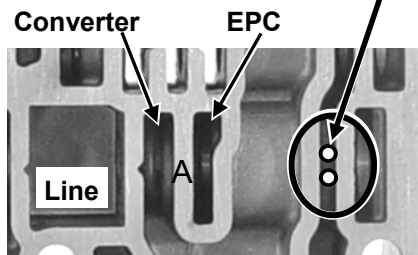
The bore at "A" erodes over size. Converter and EPC then mix which causes high line pressure and converter slip with blinking OD light-Code 628. No worries! You're **fixing the problem** with this kit!

Drill two .060 to .094 holes through the floor of this passage just enough to enter into the PR valve bore, **STOP! Don't drill out the back side of the VB!** De-burr holes & clean out chips. **Do not reassemble PR yet.**

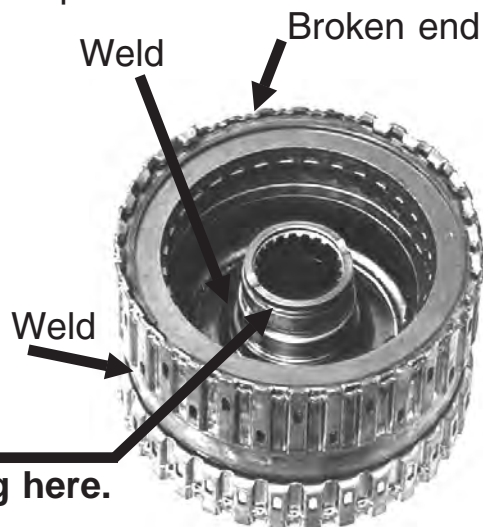
Forward Drum

A common failure is forward drum. The end blows off due to runAway line pressure. The driving complaint is a rough 1-2 shift when HOT. A new valve body may correct it for a while. The permanent FIX, for runAway line is the TransGo SK® CD4E-Jr Kit.

ALSO: The welds in this drum often crack with high miles in normal use. ***It's a good idea to install a new drum.*** Don't forget to add the lube ring, new drums come without the lube ring.

Warning: Install ring here.

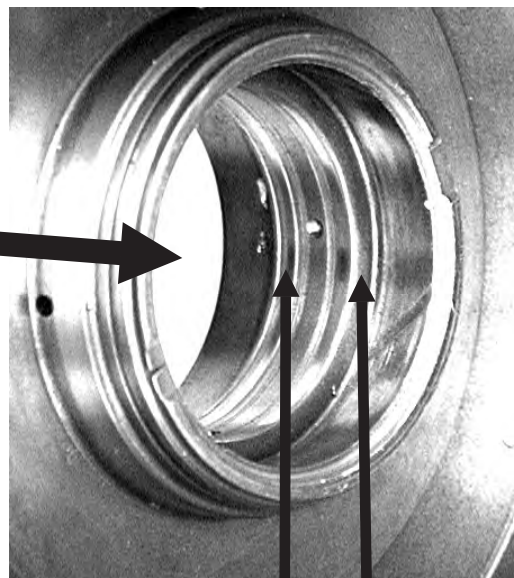
Bushing Wear

It may look like the rings ate into the drum. The truth is; Loose bushings allows the TOP of the ring lands to eat into the drum bore—not the rings. **LOOK and LISTEN:** if the two places where the ring rides are still smooth and at least 1/16" wide, you can re-use the drum by installing new bushings.

Must be smooth and at least 1/16" wide where the rings actually seal.

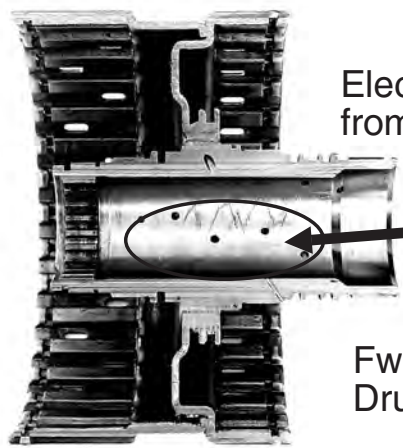
1994 to 97 4cyl Probes and Mazda 626's have a serious ground strap problem that will eat this trans up in a few days—Unless you prevent it. It may look like a lack of lube, but the cause is the engine is starting through the bushing and the gears instead of through the ground strap. The parts shown are out of trans that came back three times.

Electrical arc flash
from drum to shaft.

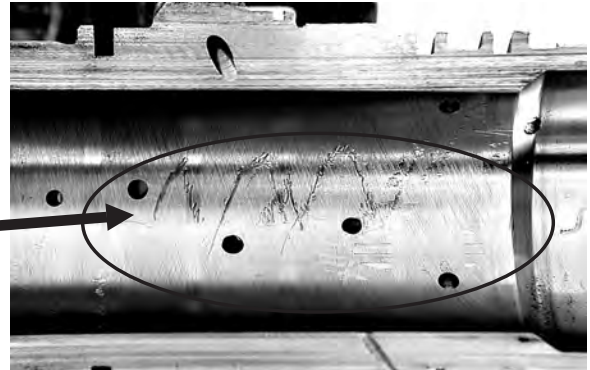
Fwd/Direct Drum.
Drum cut in half.

Melted bushing

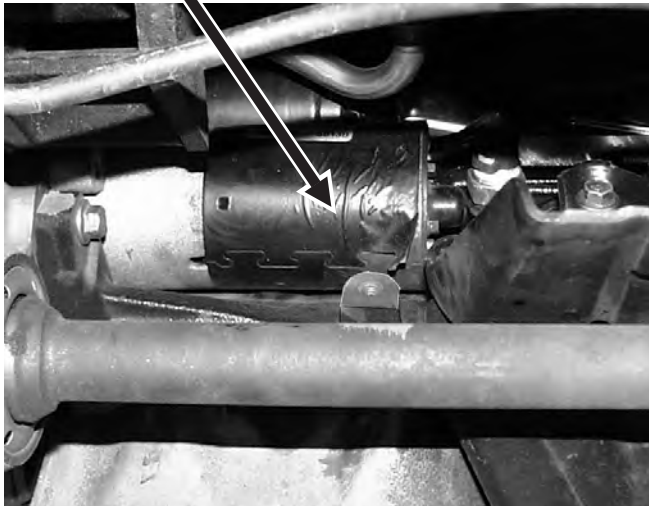
Engine Ground Strap Pad

The car factory put locktite here which can insulate the strap.

File the pad and both sides of the ground strap.

Remove the ground strap that goes from battery to the fender. Clean the paint and the strap and reconnect it.

How to check for solid ground: Attach a volt meter from the negative terminal of battery over to the trans. It must read .09V or less, even while starting the engine.
