SK[®] 722.6-A

Corrects/Prevents/Reduces

Insufficient pressure rise, 2-3 flare, TCC slip or shudder, soft shifts, shudder on hard throttle acceleration from a stop.

Fits 1996-up 722.6 equipped Chrysler, Dodge, Jeep, Sprinter and Mercedes Vehicles.

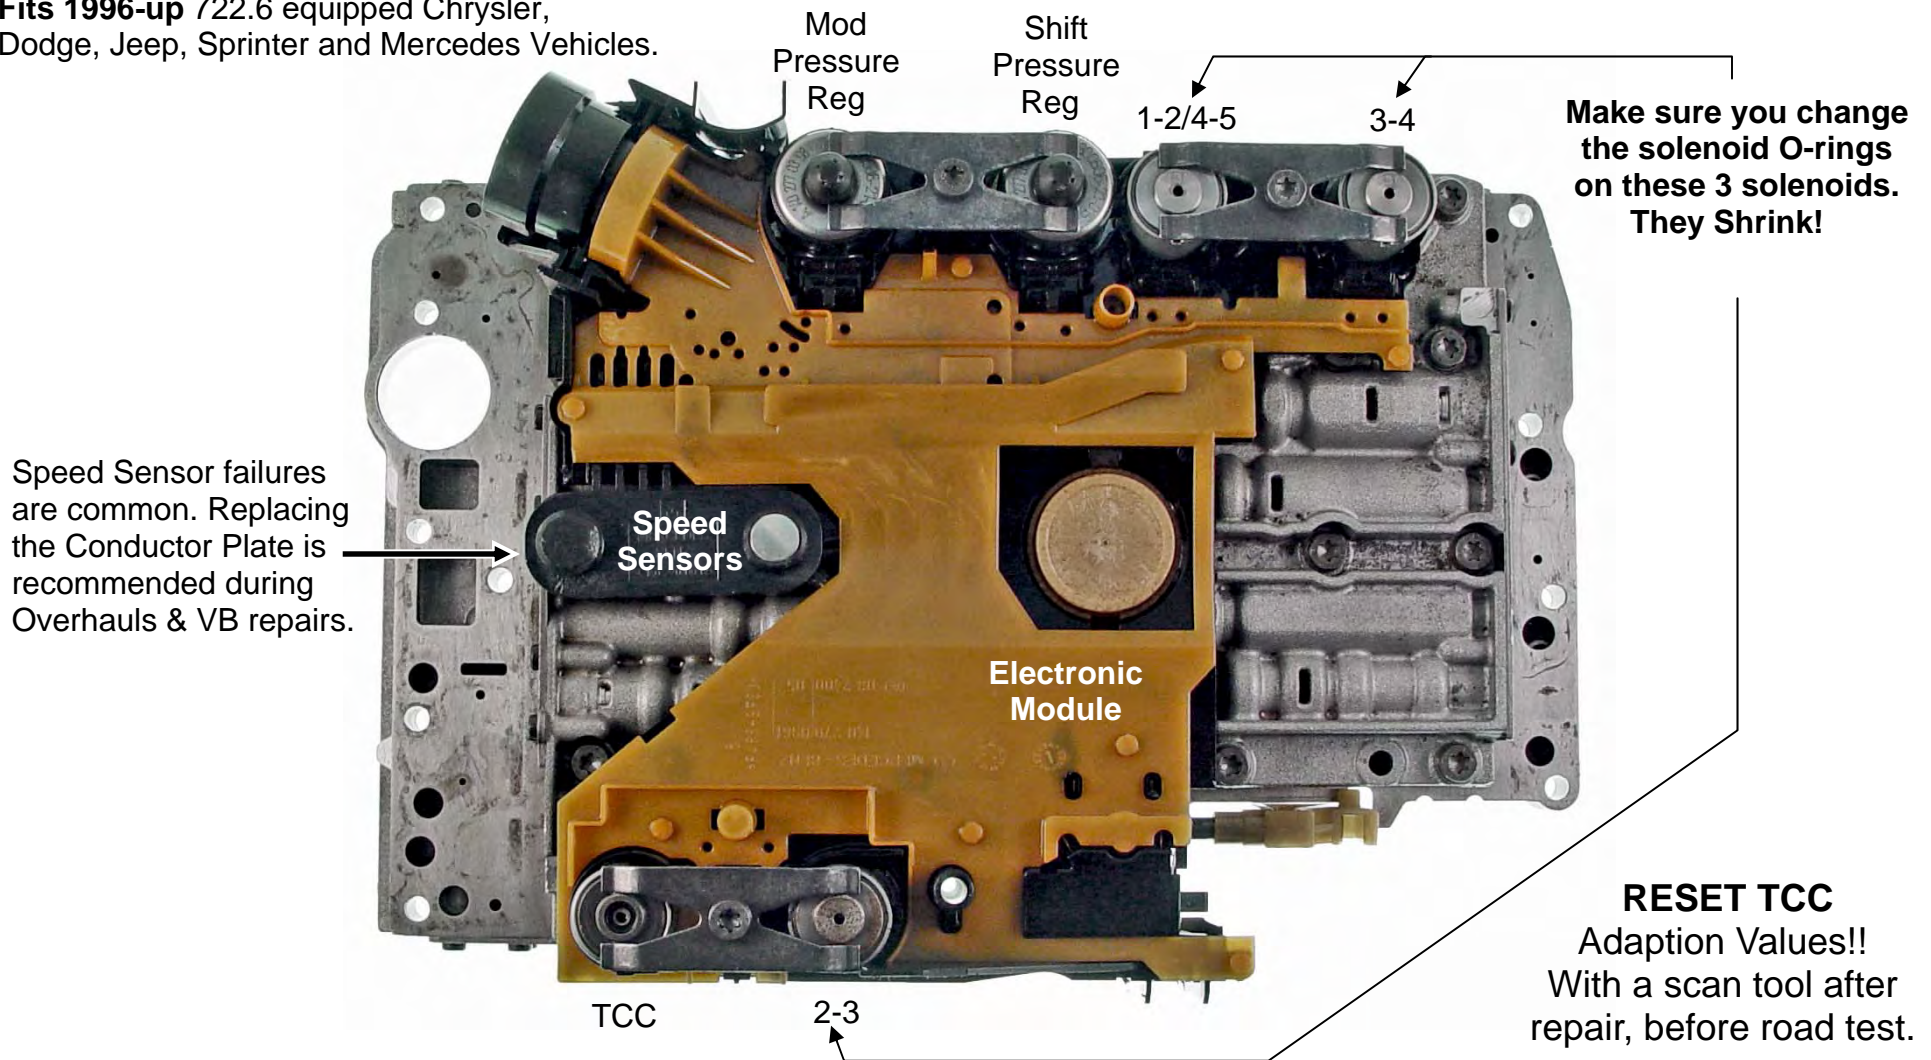
Speed Sensor failures are common. Replacing the Conductor Plate is recommended during Overhauls & VB repairs.

Make sure you change the solenoid O-rings on these 3 solenoids. They Shrink!

RESET TCC Adaption Values!!
With a scan tool after repair, before road test.

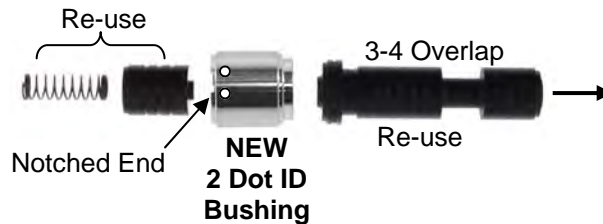
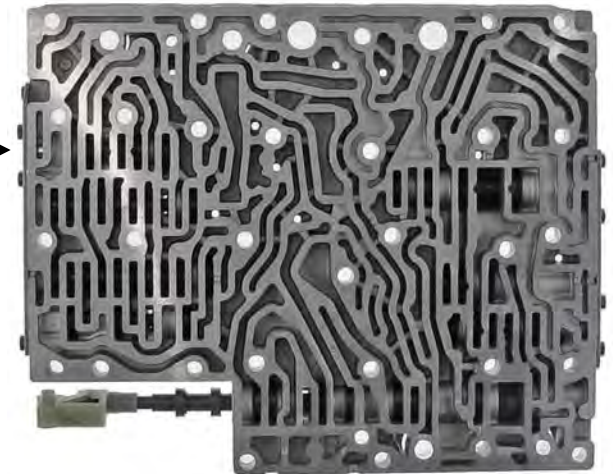
Step 1

The 3 Bushings are different. Don't mix them up!

Replace **original 3-4 Overlap Bushing** with new **2 ID Dot Aluminum Bushing** provided. Re-use original valves and spring.

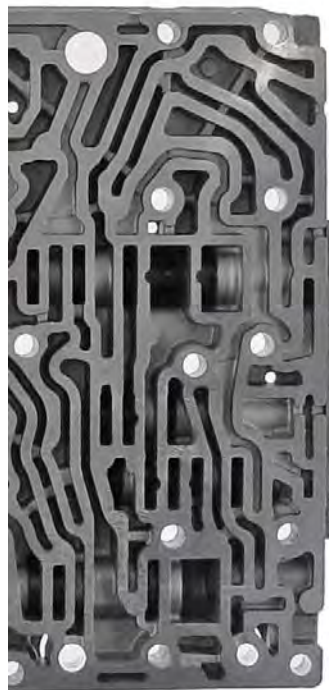
Step 2

Heads Up! Our **New PR Valve** fits the **most common** PR valve size. Meaning, there are other sizes, as well as aftermarket repairs that may have bored the valve body to use an oversized valve. **Always** measure your original valve.

Remove end plate & original PR Valve. Measure **each land diameter**. If original valve diameters are within a thou or 2 of our valve, Perfect! Use **New PR Valve** & re-use the original spring. **If your valve is different**, carefully check valve & bore for wear before re-using the original parts.

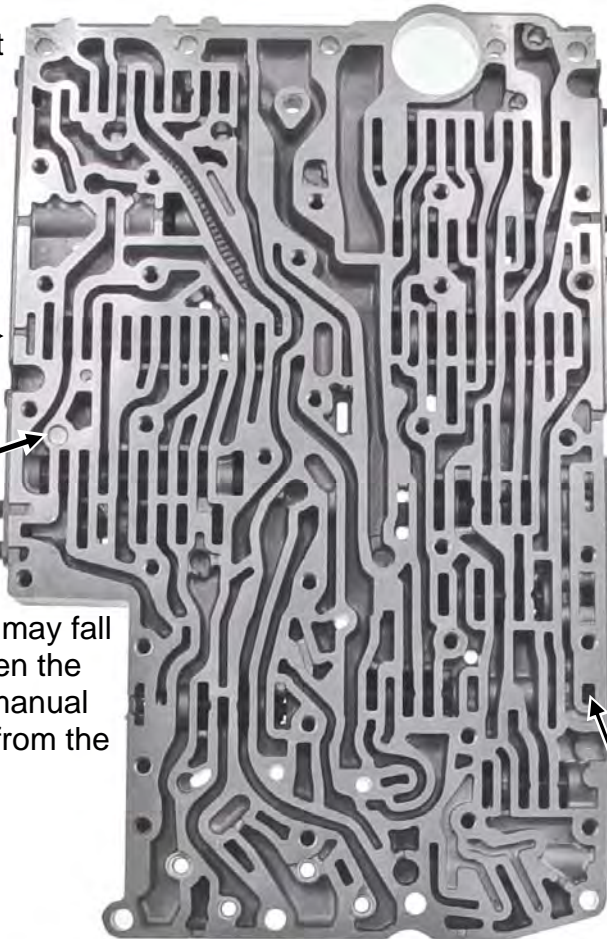
Step 1

The 2-3 Shift Pressure Valve Spring often is broken. For your convenience we have provided a **NEW RED** replacement spring. Always look for broken springs when working on these Valve Bodies.

VB Alignment Pin may fall out of position when the detent spring for manual valve is removed from the bottom of VB.

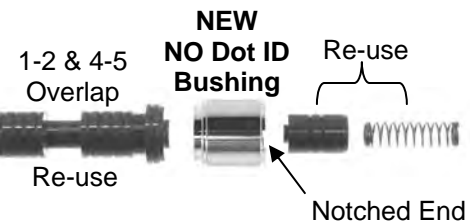
Step 2

The 3 Bushings are different. Don't mix them up!

Replace **original** 1-2,4-5 Overlap Bushing with new **NO ID Dot Aluminum Bushing** provided. Re-use original valves and spring.
