# 6R80-VBR-WT (With Tools)

VB Repair Kit – Solenoid & Lube Regulator

Fits: FORD 6R60, 75 & 80 (2006-20)

Also fits: ZF6HP19, 26 & 32 Gen 1 (2003-up)

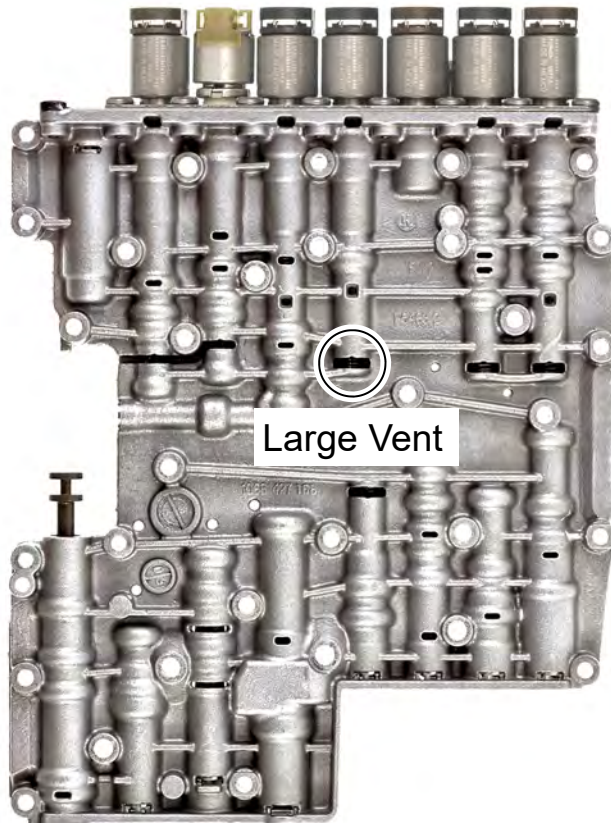
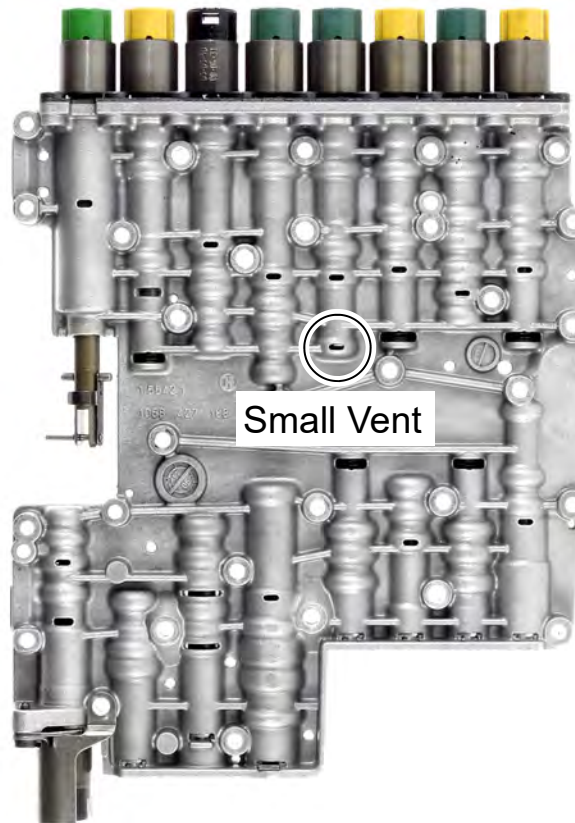
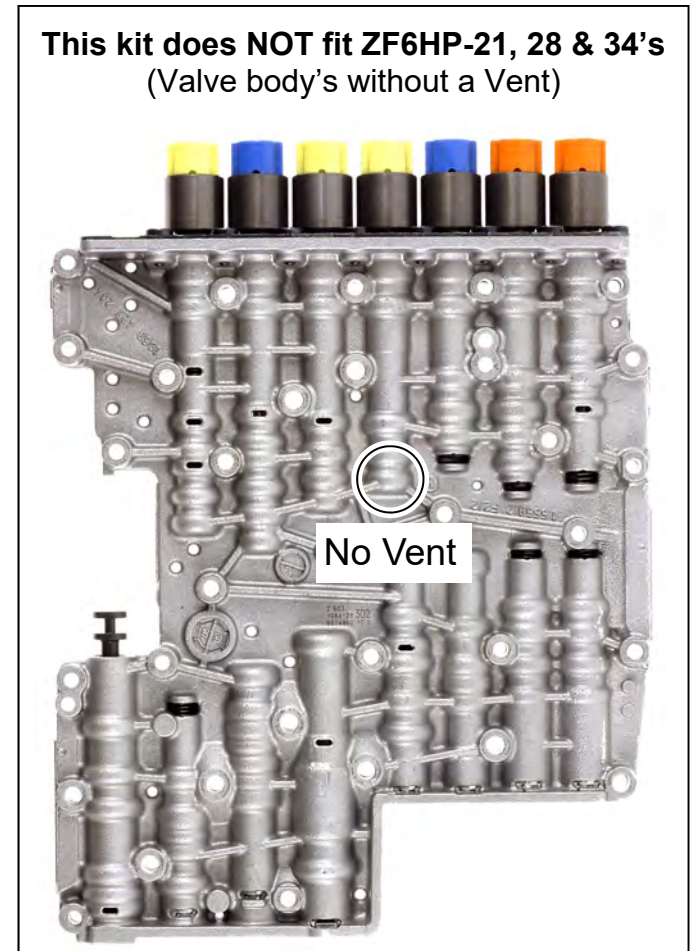
**This Kit Only Fits Vented VB's**

**Large or Small**

Ford 6R60 thru 80 Series

ZF6HP-19, 26 & 32 Gen 1 Series

**This kit does NOT fit ZF6HP-21, 28 & 34's**  
(Valve body's without a Vent)

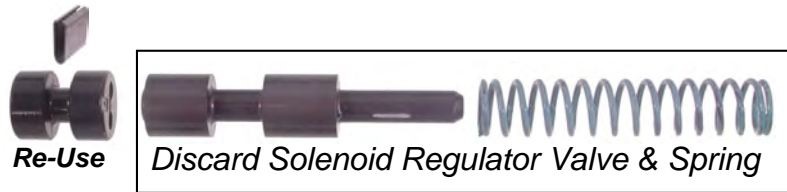
**VB Type ID**  
**Look for Vent Here!**  
Must have a Vent, Large or Small.  
**This kit only fits Vented VB's!**

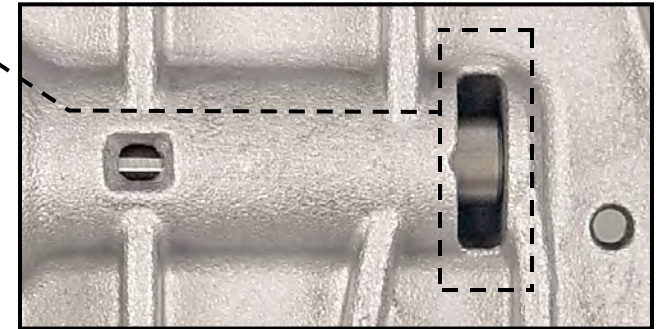
**Reaming Tip:** The less you push, the slower you go, the better the finish!  
Reamer will stop when **it contacts** the Solenoid Reg. Spacer.

The Spacer Stops the Reamer!  
Never Ream **Solenoid Reg. bore** without using spacer or severe damage will occur!

**Step 2.** Flooding bore with WD-40 while reaming works best. Slide shank end through largest hole of Solenoid Reg. Reamer Guide. Insert **Solenoid Reg Reaming Spacer** into the bottom of the empty Solenoid Reg. bore **NOW**.

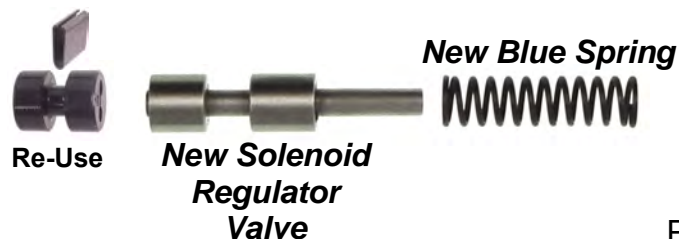
**Step 4.** Check New Solenoid Regulator Valve in bore for free movement. Then clean & lube **New Solenoid Reg Valve** & install as shown with new **Blue** spring. Then re-install original end plug and retainer.

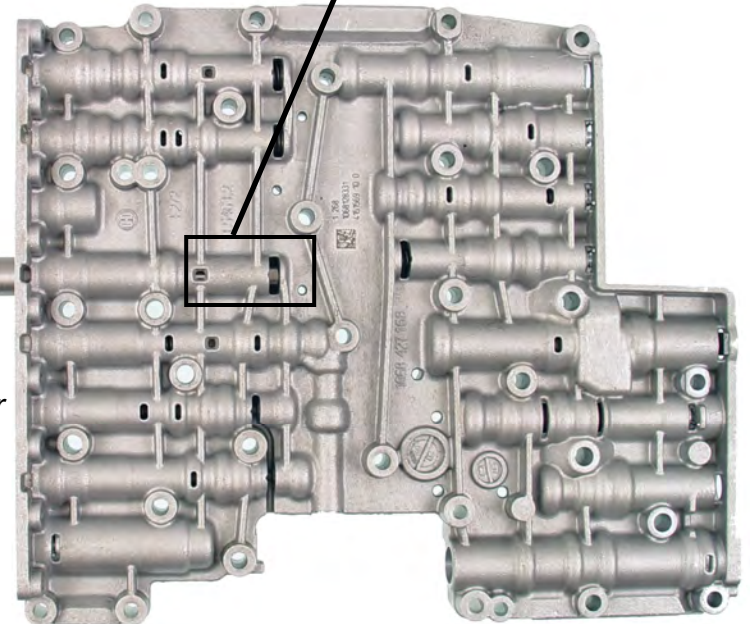
**Step 3.** Insert guide bushing and reamer into bore until Reamer **Guide** bottoms out. Use locking pliers **just snug** on the guide to keep it from spinning. Turn reamer at slow speed with drill until reamer contacts the **Solenoid Reg Reaming Spacer**. Remove Guide, Reamer and the Reaming Spacer & save them. Rinse & Clean out chips.

Hold Reamer Guide Here with Locking Pliers **Just Snug!**

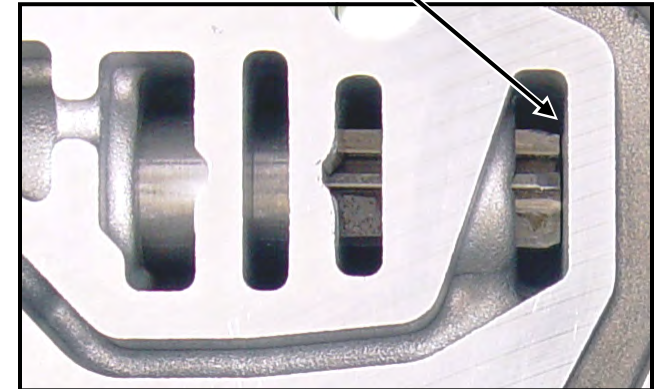
**Step 3.** Insert guide bushing and reamer into bore until Reamer Guide bottoms out. Use locking pliers **just snug** on the guide to keep it from spinning. Turn reamer at slow speed with drill. You're finished when the **tip of the reamer contacts the inner wall** as shown. Turn valve body over, rinse and blow out chips. Do final cleaning on entire VB.

Reamer tip contacting inner wall.

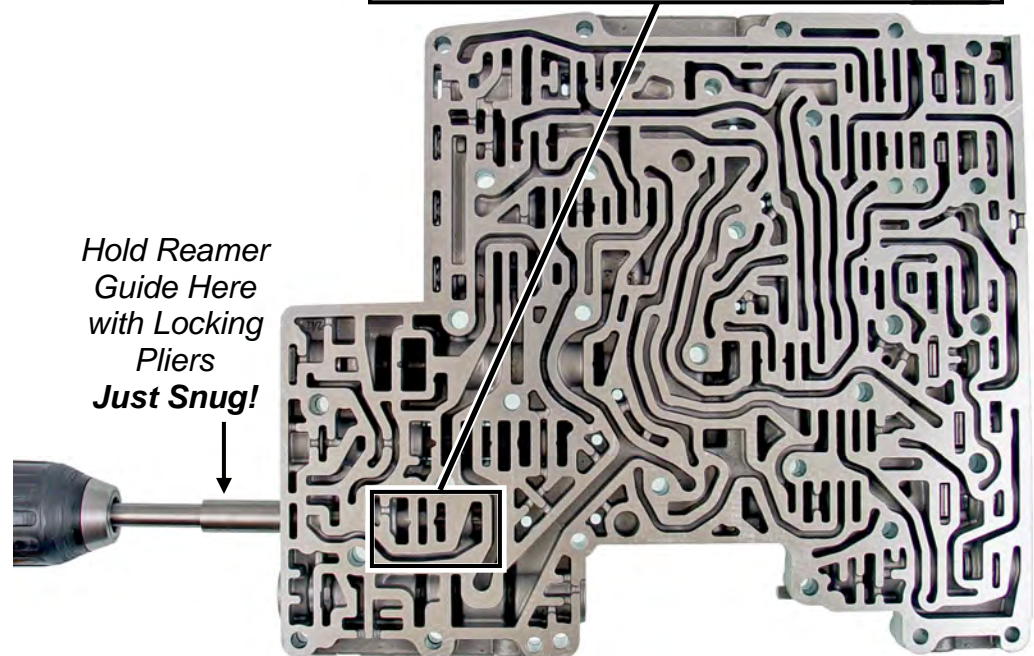
Hold Reamer Guide Here with Locking Pliers Just Snug!

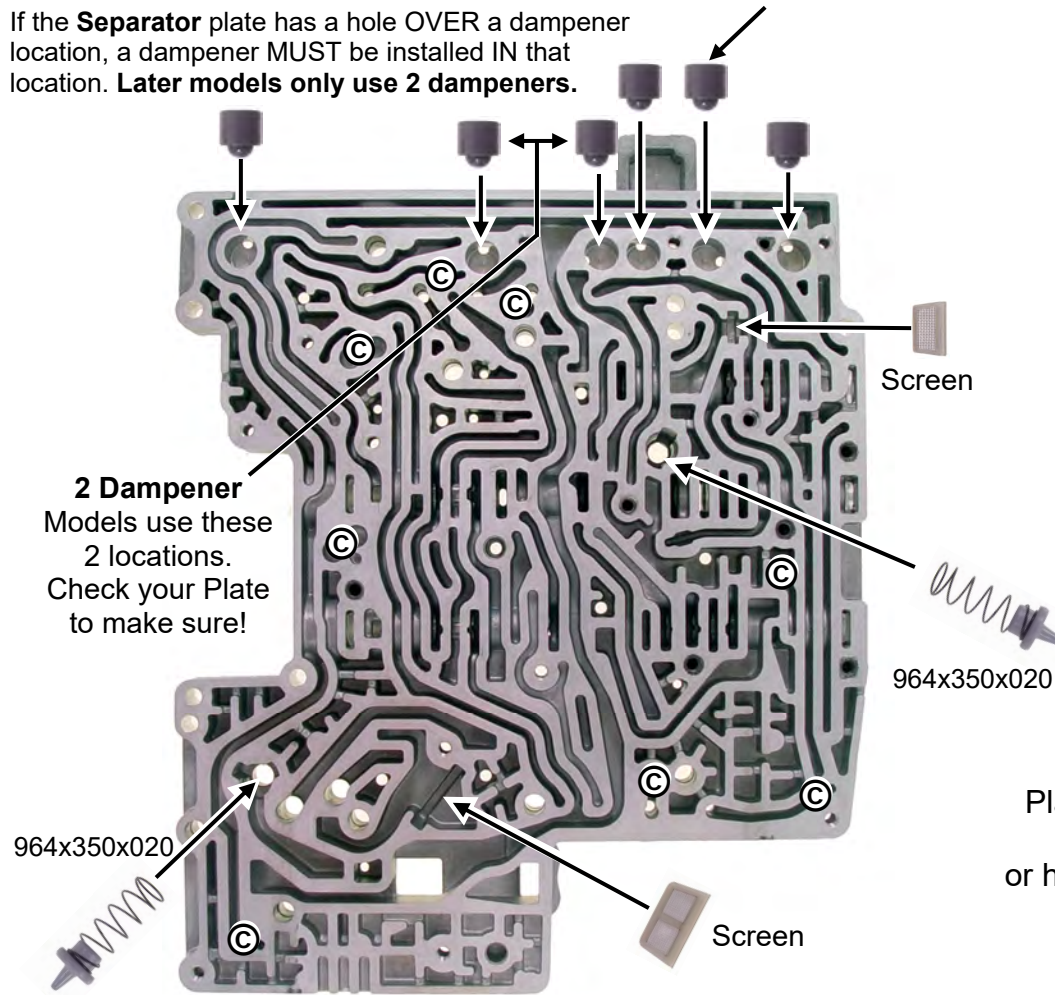
If the Separator plate has a hole OVER a dampener location, a dampener MUST be installed IN that location. Later models only use 2 dampeners.

**2 Dampener Models** use these 2 locations. Check your Plate to make sure!

**This Model Used:**

⊙ = 8 Check Balls

■ = 6 Dampeners

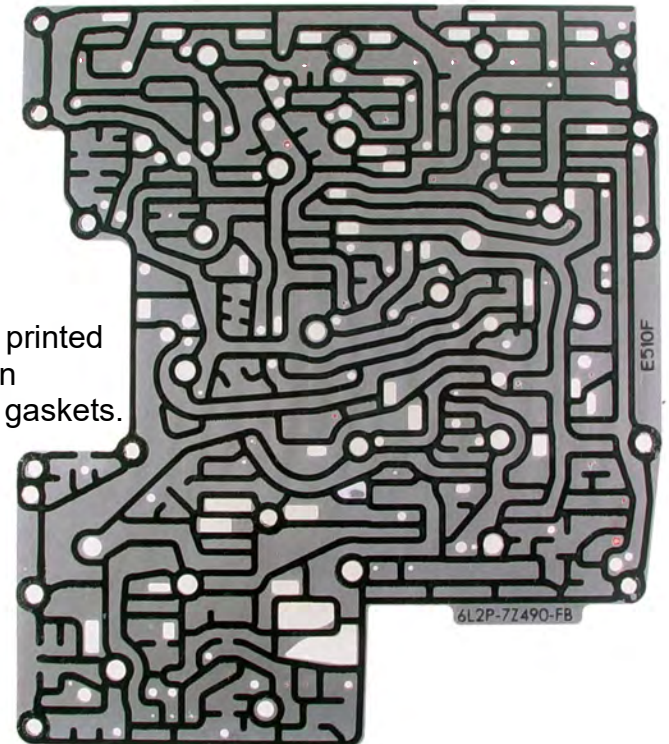
**Watch for damaged plate printing!** Splitting the VB halves usually pulls the printing off somewhere on the plate. Plates are available from your supplier.

Plates may be printed as shown or have bonded gaskets.

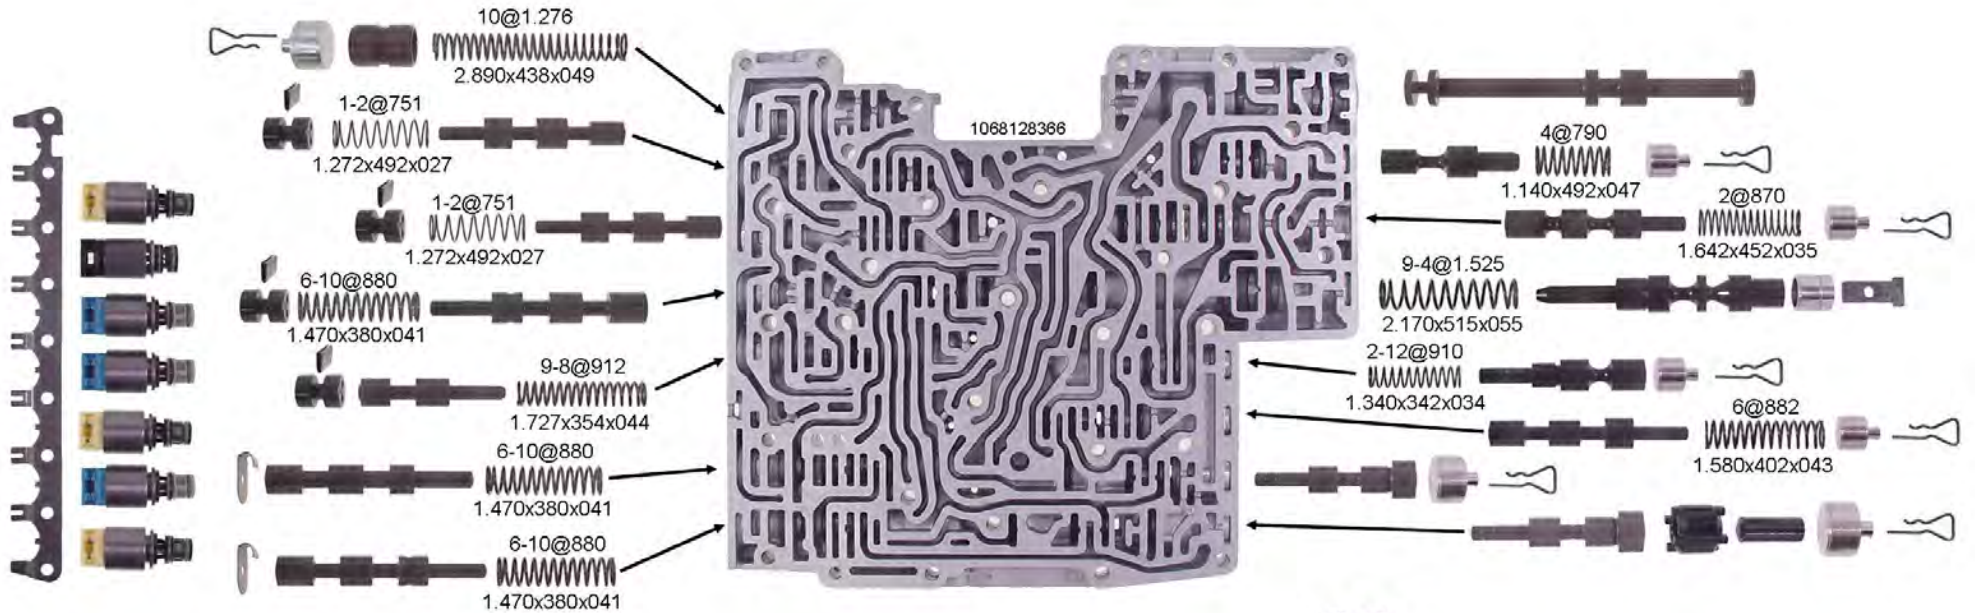
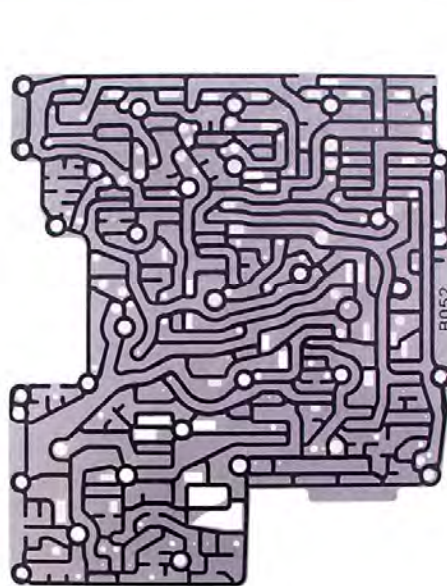
## Typical M-Shift Valve Body Layout

Mark locations of ALL small parts and re-install as you found them. They are model specific.

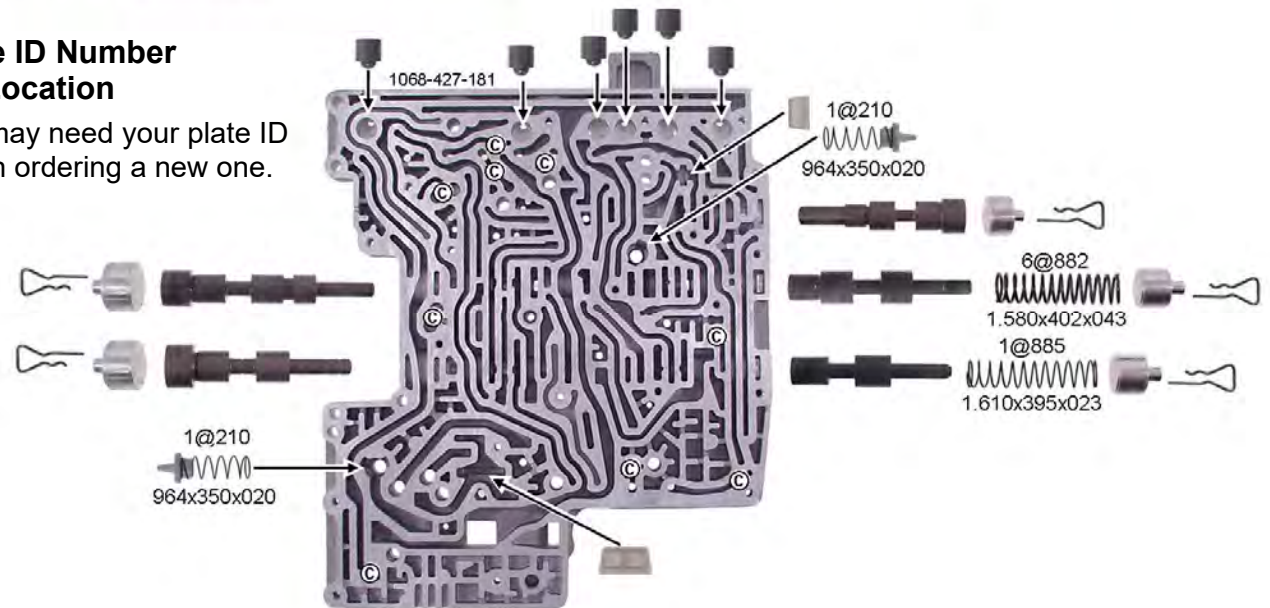
### Plate ID Number Location

Distributors may need your plate ID number when ordering a new one.

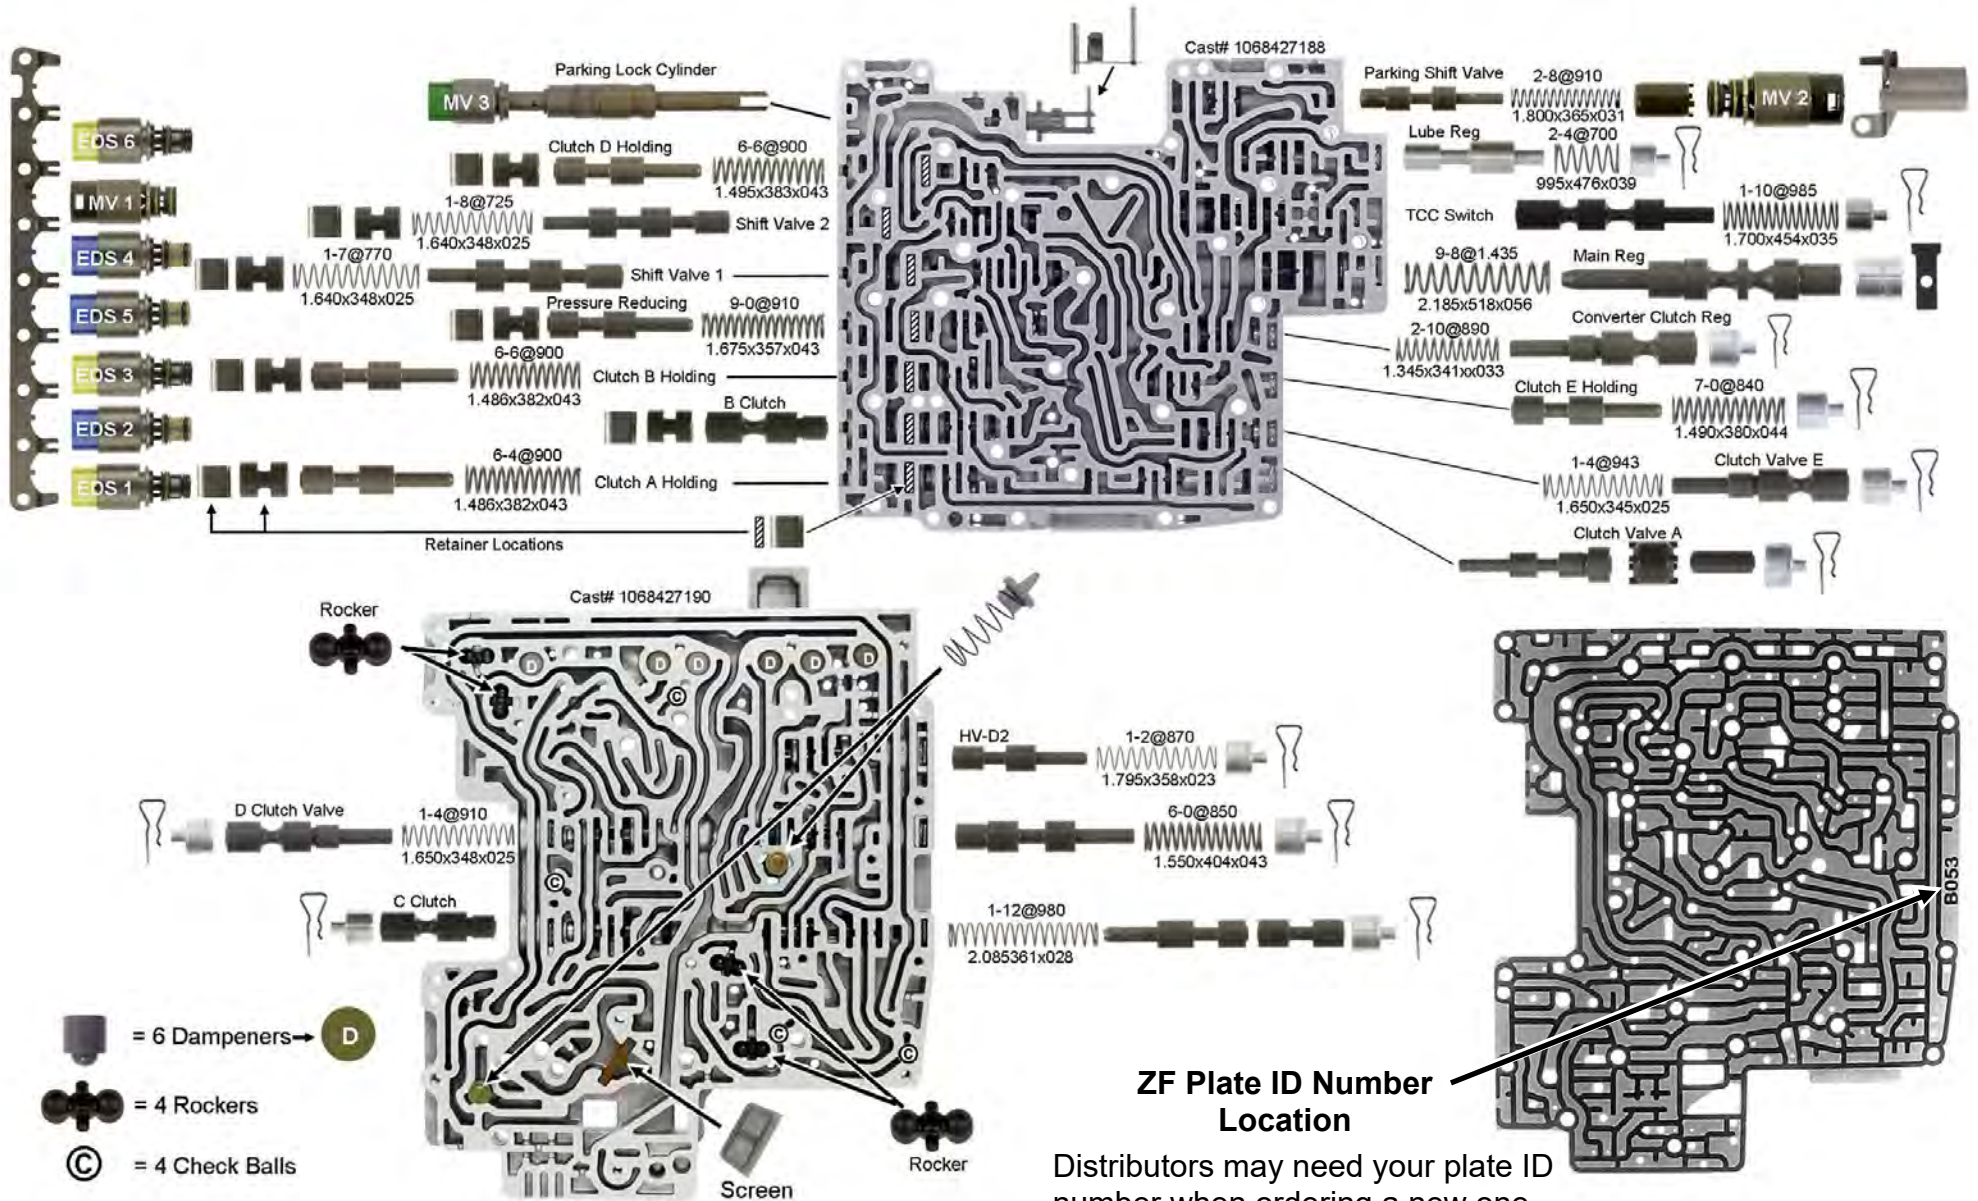
## Typical E-Shift Valve Body Layout

Mark locations of ALL small parts and re-install as you found them. They are model specific.

Distributors may need your plate ID number when ordering a new one.

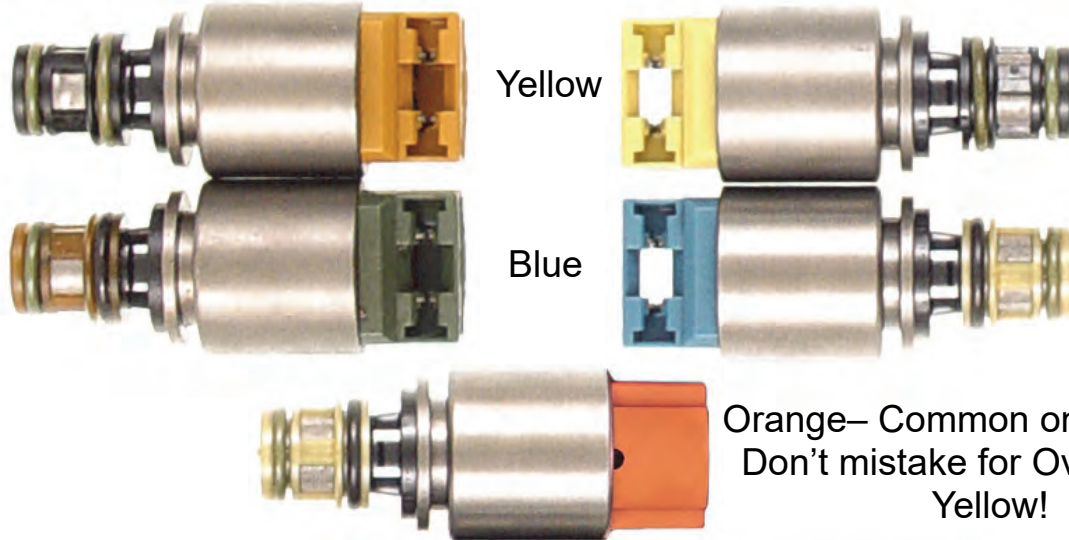
These two sets of solenoids are supposed to be the same colors. The left set has **overheated** and should **not** be used. **Overheating** is what **caused** the **color change**. Even though the bottom left solenoid connector might “Look” Green, it was originally **Blue**. The top left may appear cream or burnt orange in color but it too was over-heated, the original color was actually **Yellow**. If your Solenoids turned color **REPLACE THEM!** Do not ask them to go another 100k, **they won't!**

**Overheated**

**Normal**

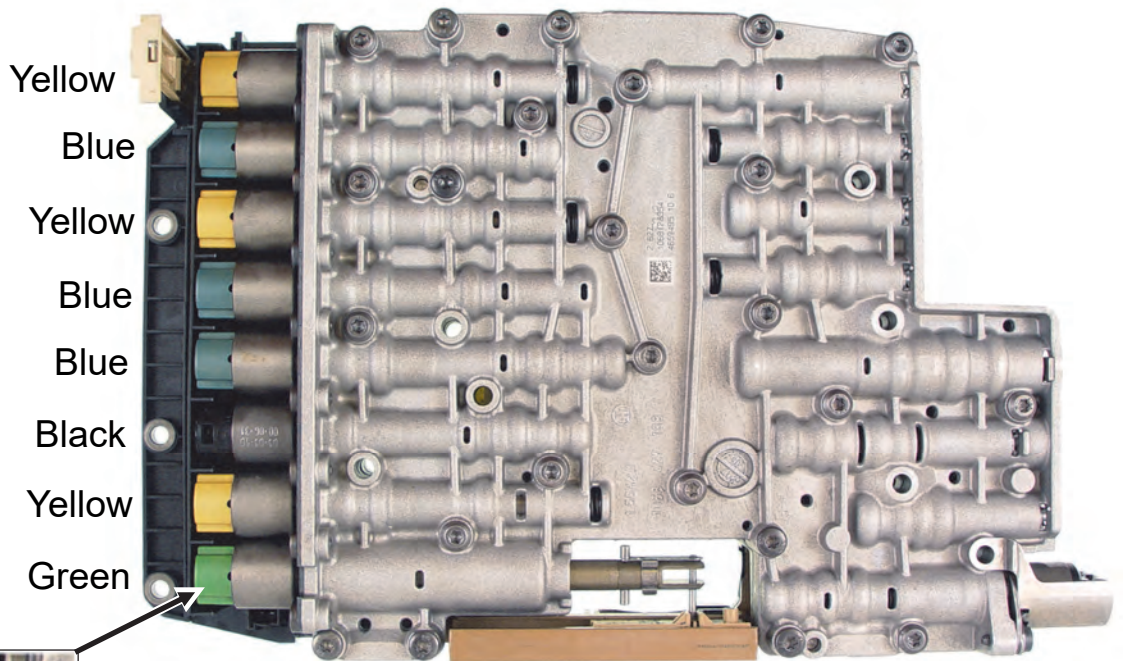
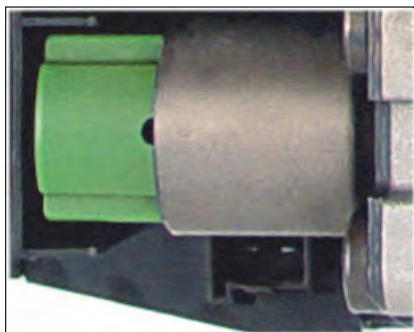
The actual quantity of blue or yellow solenoids depends on the manufacturer.

Green MV3 Solenoid is used in models without a shift cable. (BMW Typically)

**Only this Solenoid is Green!**

MV2 & MV3 are only on models without a shift cable.

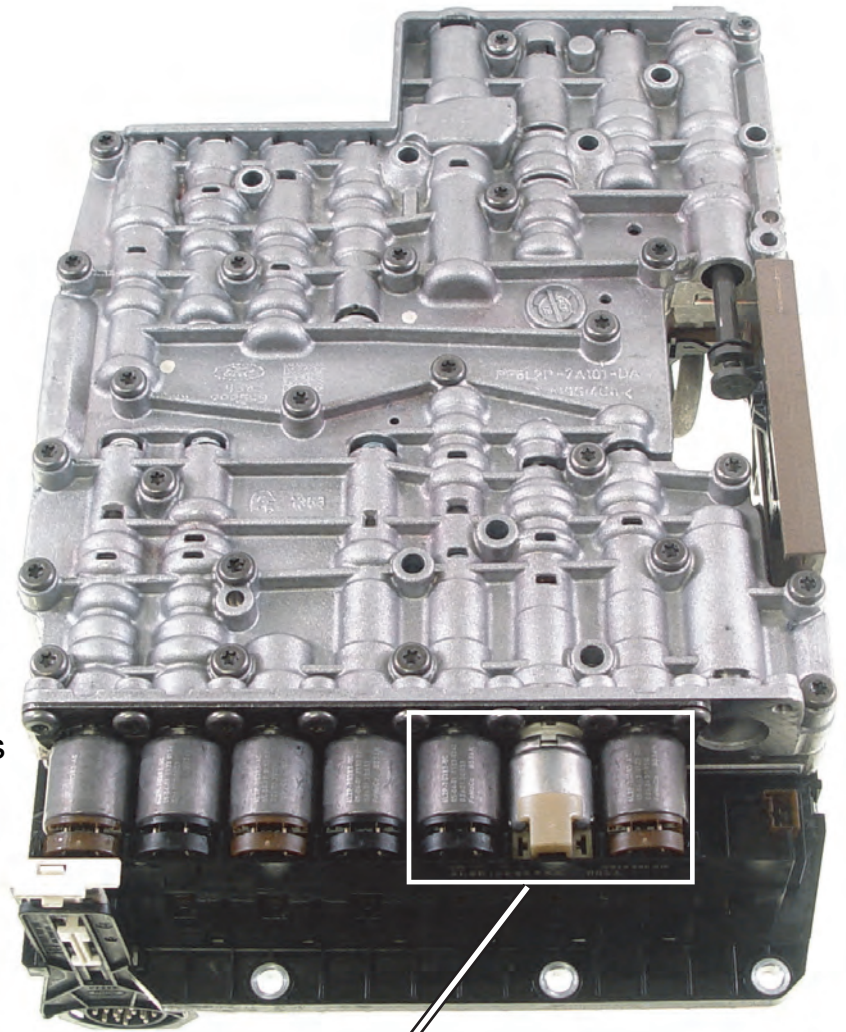
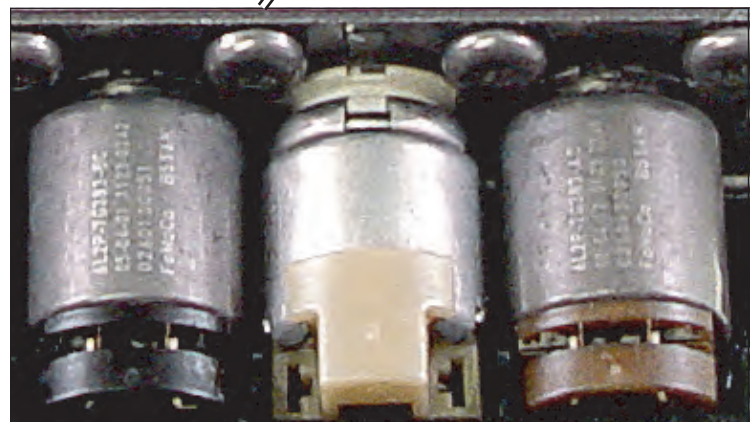
Ford uses a combination of Black, Brown and Cream colored Solenoids. While the discoloration is harder to see on black and brown solenoids when they overheat, you can see enough difference when comparing the browns. Let that be your guide when deciding to put a set of solenoids on.

Late model Fords without TCM in the trans are known for speed sensor failures. A TSB was issued for the concern. Replace the Lead Frame Connector.
