SK® 6T70-G2 Fits 2013-2017

Corrects/Prevents/Reduces

Pressure Regulator and Actuator Feed System Malfunctions that lead to broken parts.
Adds over boost protection, improves TCC stability.

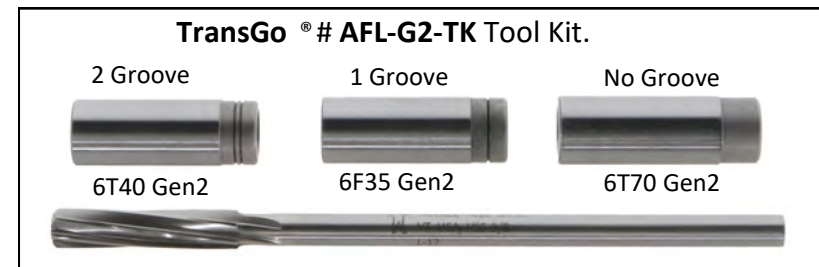
Note: This product requires TransGo® # **AFL-G2-TK** Tool kit to repair the Actuator Feed Limit Valve.

AFL-G2-TK Tool kit, works on 3 **different** transmissions
Fits All **Gen 2 Vb's** 6F35's, 6T40's and 6T70's.

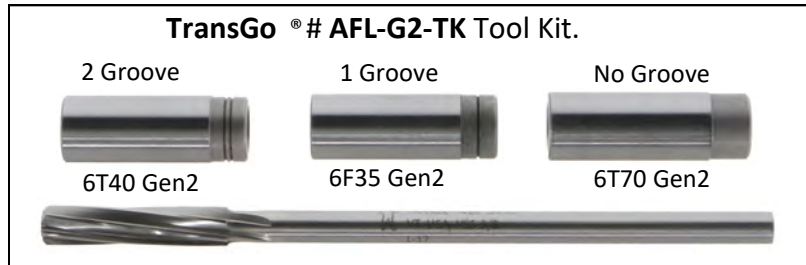
Due to the new vent location in a Gen 2 Rear body and the amount of bore wear seen, the AFL leak can not be fixed with a “drop-In” solution for the Gen 2 Actuator Feed Limit Valve. To repair the AFL Valve bore a tool kit is also required: TransGo # **AFL-G2-TK** Tool kit

Tool Kit fits 3 **different** transmissions, just use the correct reamer guide.
Fits All **Gen 2 Vb's** 6F35's, 6T40's and 6T70's.
