# SK® AW55-50

## Reduces/Corrects/Prevents

Delay/Bang drive engagement, 4-3 and 3-2 coast clunk, 2-3 and 3-4 cut-loose, kick-down run-aways, TCC Slip, Coast 3-2 part throttle bang, double-bump 3-4 and 2nd Sprag failure.

01-07 Volvo,  
04-07 Nissan RE5F22A  
02-07 Saab & AF33-5  
03-04 Saturn  
05-06 Chevrolet Equinox  
06-08 Pontiac Torrent

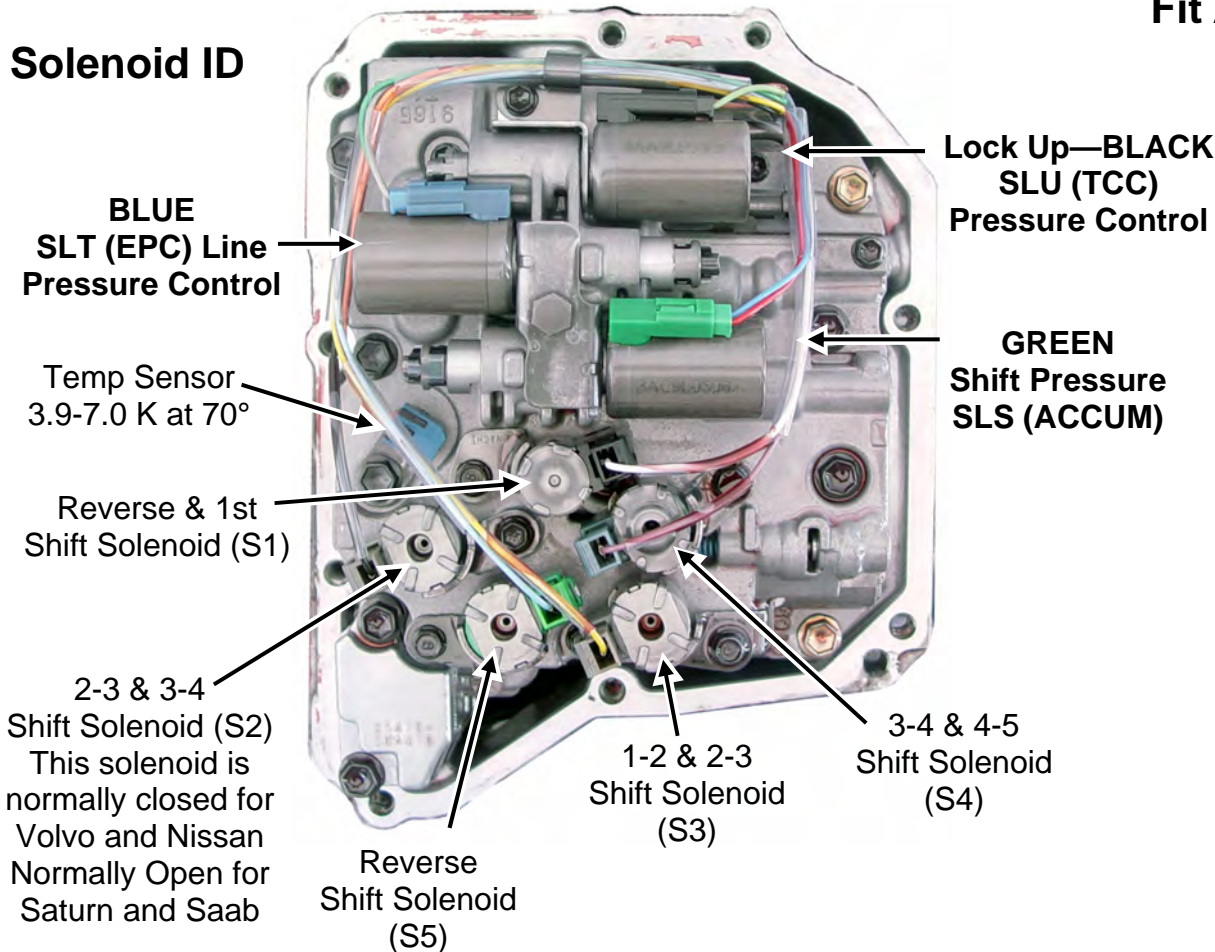
### Solenoid ID

**First Thing Check Resistance!**  
SLU,SLS and SLT 5-7 Ohms @ 70°F  
SS1 through SS5 11-16 Ohms @ 70°F

Locate the EPC, TCC and Accum Solenoids. Before repairing them, perform Ohm check by probing the connectors. They must be 5-7 Ohms between the pins. From either pin to solenoid body must be open. Don't repair solenoids until you know electrically they are OK. **Any solenoid out of range must be replaced.**

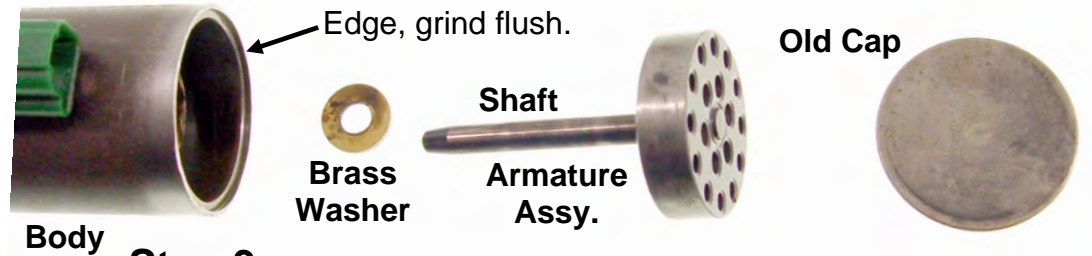
**Step 2** On the angle shown, using the **SIDE** of the grinding wheel, grind off the crimped end.

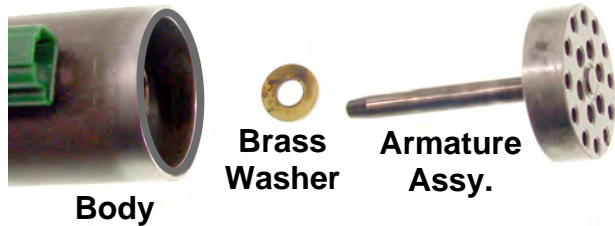
**Step 8** Install brass washer onto pin and insert armature assy. into solenoid.

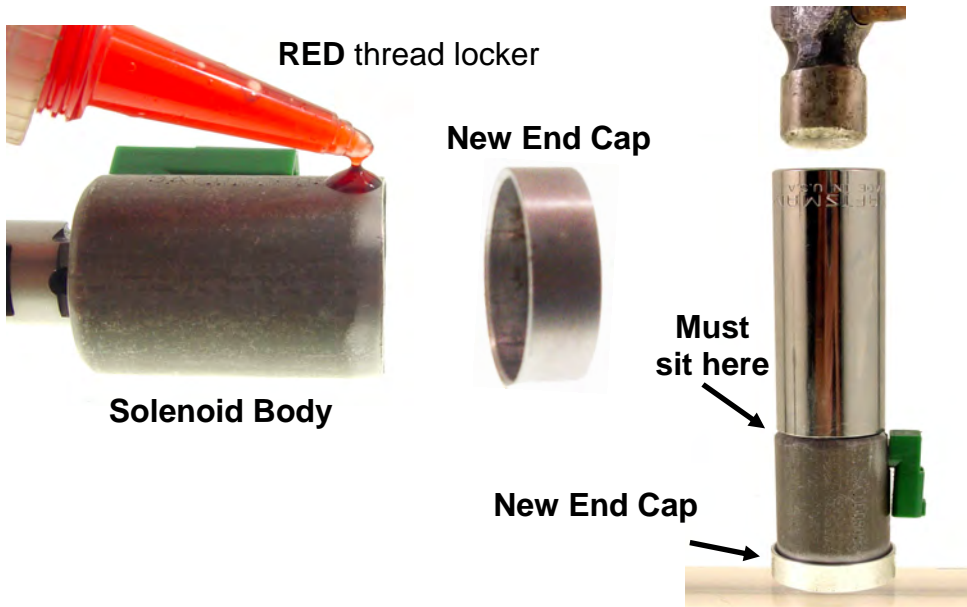
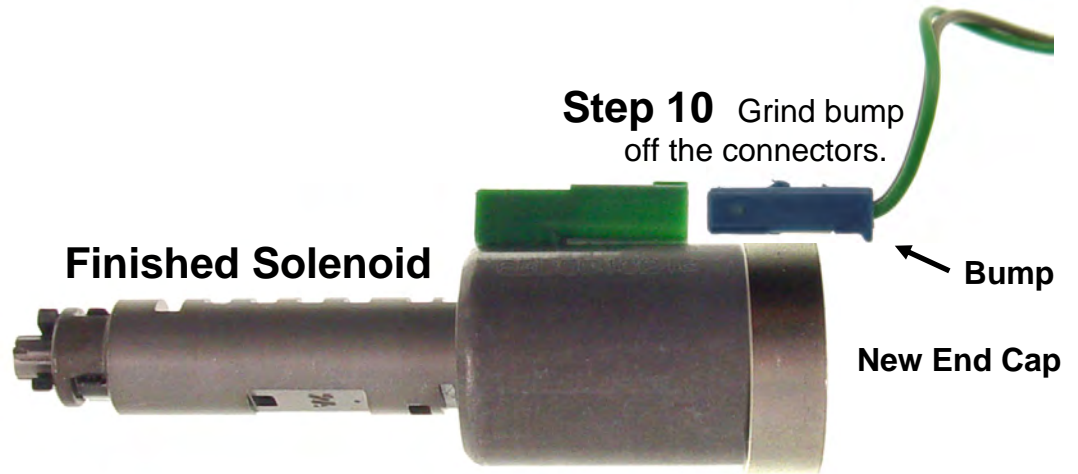
**Step 9** Use brake clean to clean the end of the solenoid. Place very small amount of RED thread locker on the outside. Stay a little away from the end. Be careful—Do not get any into solenoid or in the new end cap. Start end cap onto solenoid. Place the whole assembly, cap down, onto a hard flat surface. Place 1/2" drive 3/4" deep socket over solenoid snout insuring that the socket is sitting on the snout end of the solenoid body as shown. Lightly tap the socket with a light hammer until the solenoid is seated into the cap.

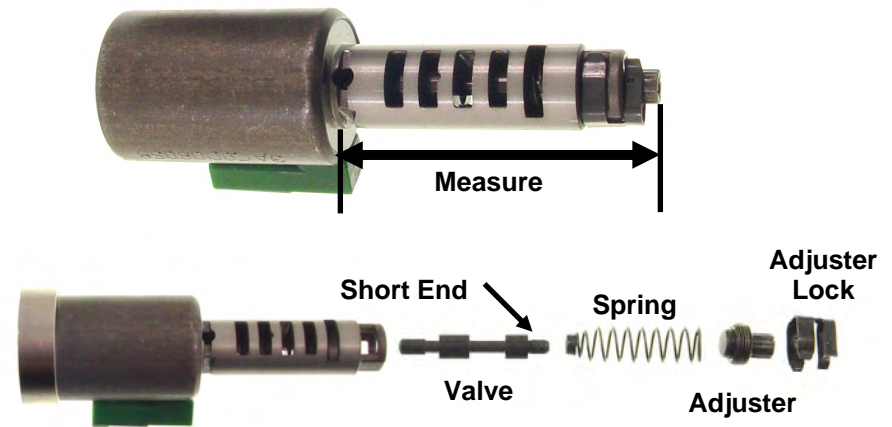
## Stuck Valve Correction

If a solenoid valve is sticking it may be necessary to disassemble and clean it. To maintain the adjustment, measure the distance from the body to the end of the adjustment screw, and put it back the same.

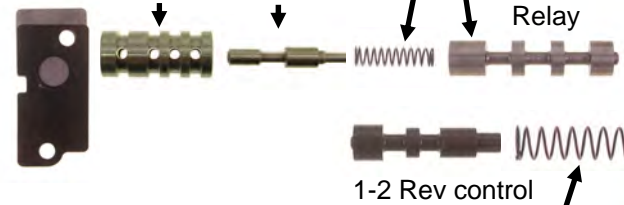
## Step 3

Install NEW LRC Sleeve & Valve

Some models have this spring that matches the car's computer program. If swapping VB's, add or remove this spring to match your original VB!

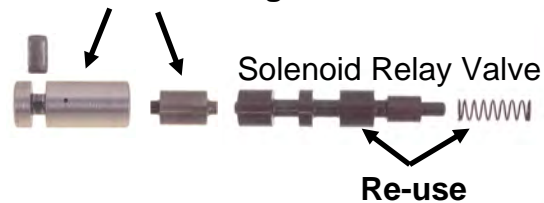
## Step 1

Install NEW Solenoid Relay Sleeve & Plunger Valve

3-2 Part-Throttle Bang?  
2nd Sprag failure?  
Fixed!

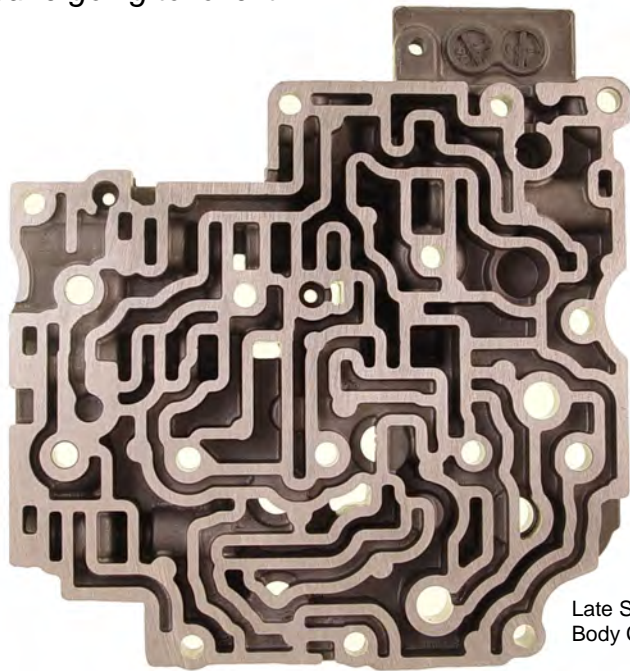
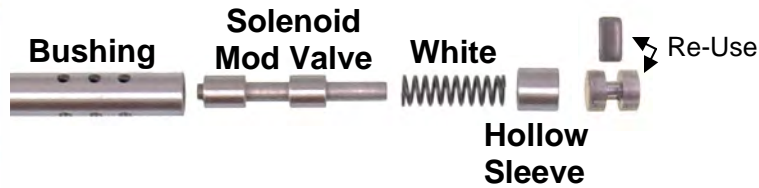
## Step 1

**Good News!** Installing the NEW Solenoid Modulator Valve system eliminates the need for expensive reaming/boring tool purchases on this valvebody!  
The “**drop-in fix**” for the worn Sol Mod bore!  
You’re going to love it!

Install **NEW Solenoid Mod Bushing, Valve, White Spring & Sleeve.**  
Re-use end plug and retainer.

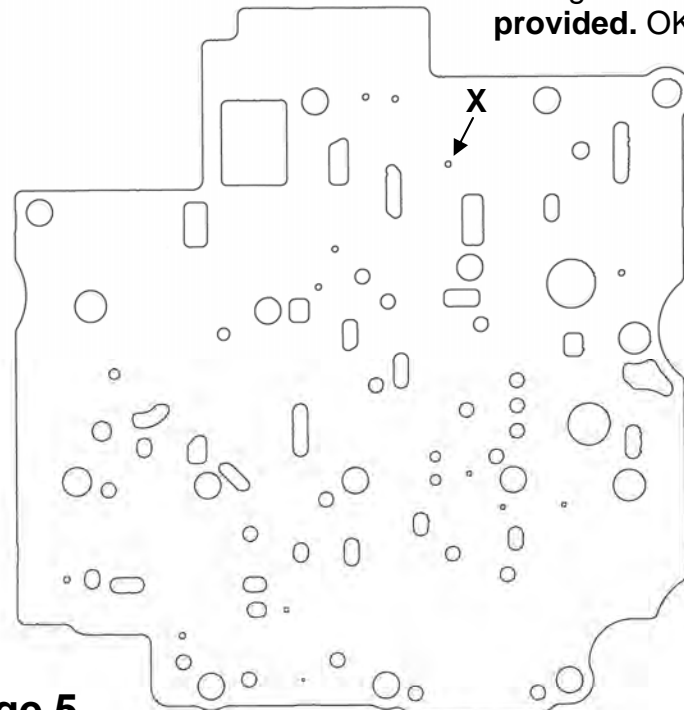
## Step 2

Enlarge “X” hole with .055 drill provided. OK if already larger.

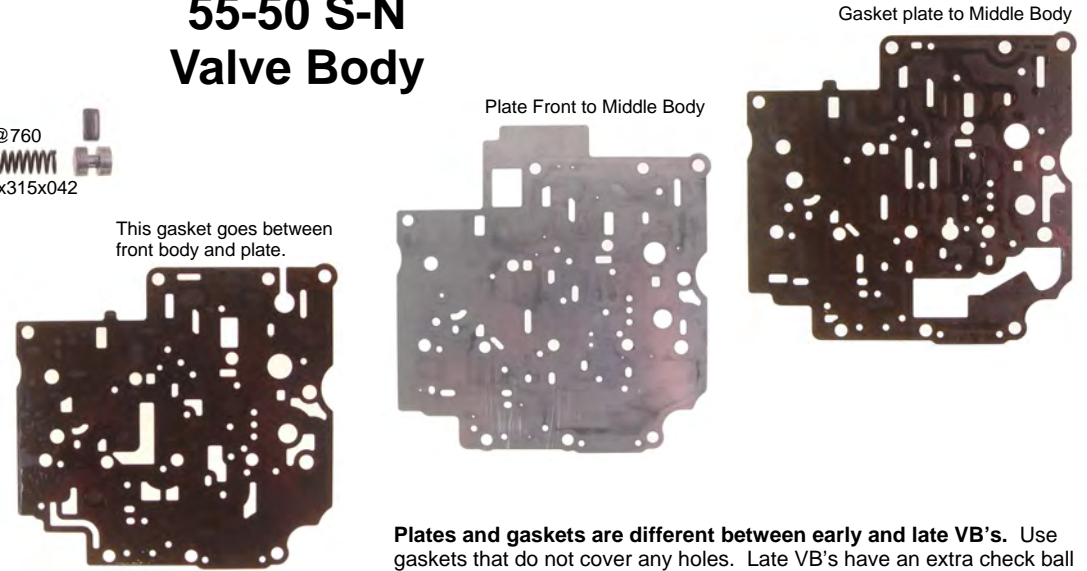
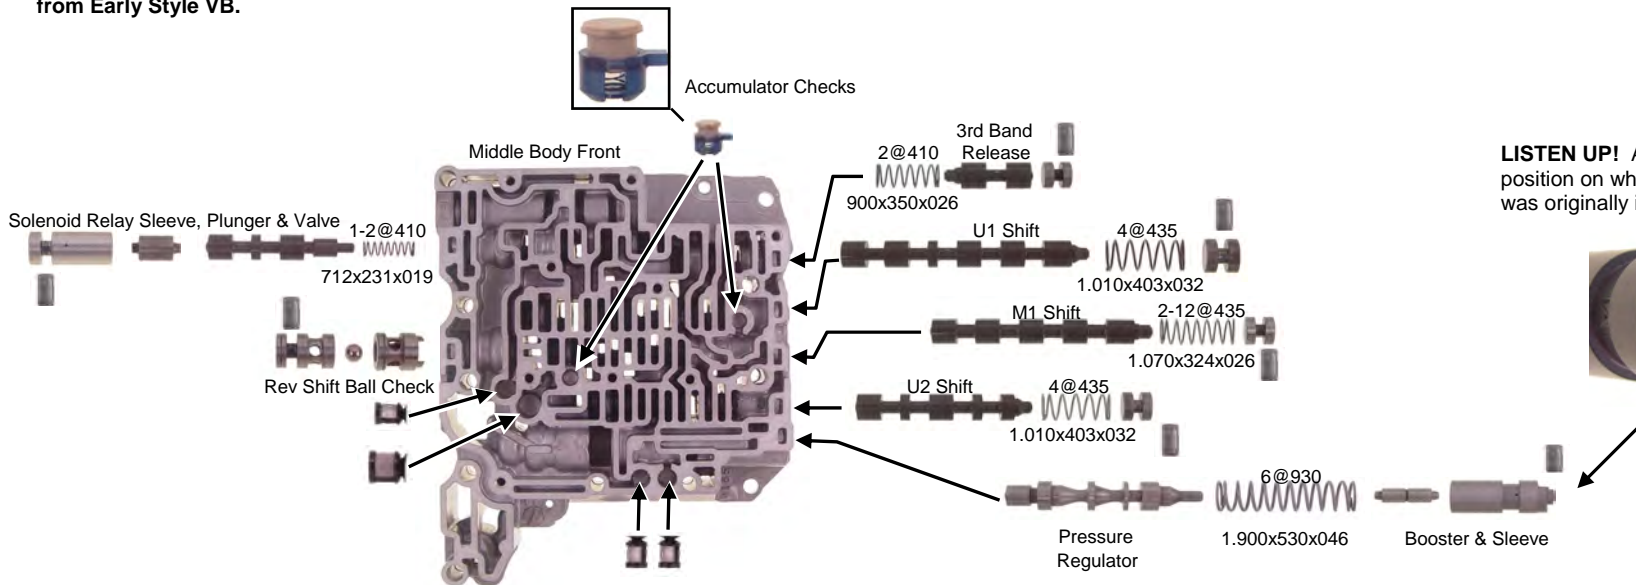
## 55-50 S-N Valve Body

Late Style Front Body Casting shown for Reference only! All other parts shown are from Early Style VB.

Plates and gaskets are different between early and late VB's. Use gaskets that do not cover any holes. Late VB's have an extra check ball in the Front body that does not exist on early VB's. See Left for Front Body Check ball locations. **DO NOT MIX** late and early VB parts!

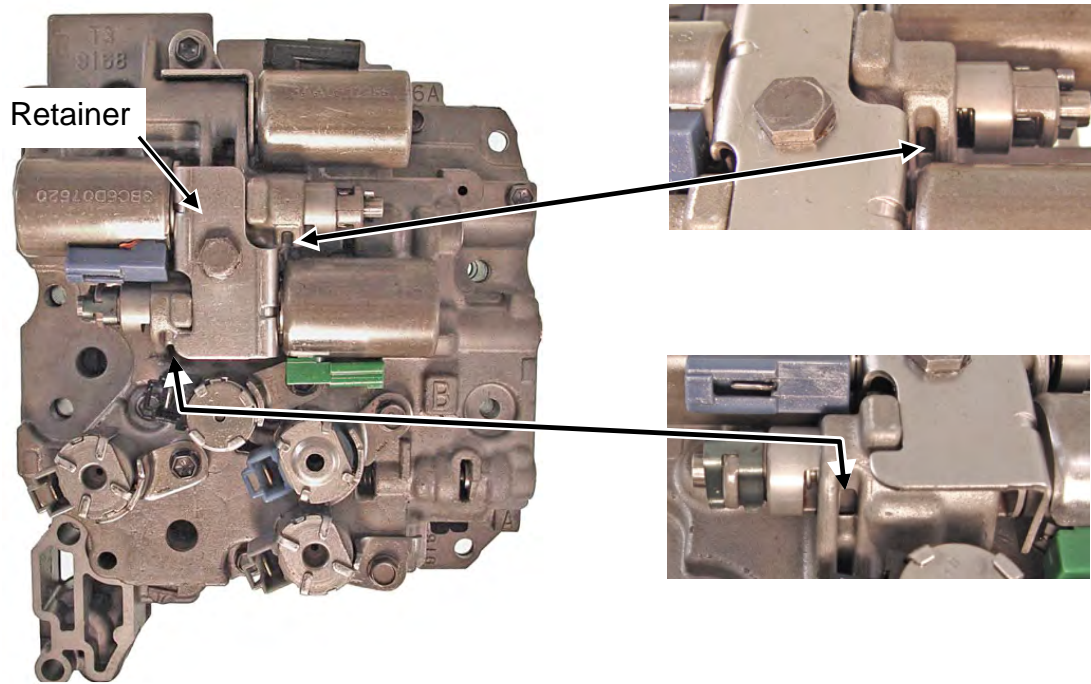
# ATTENTION!! VB & Solenoid exhaust Ports must line up!

**VB exhaust Port MUST line up with the Solenoid exhaust Port . Then install the Solenoid Retainer.**

**Incorrect Retainer, Solenoids or mis-positioned Retainer will block exhaust Ports and cause rough shifts, high line & Sol codes.**

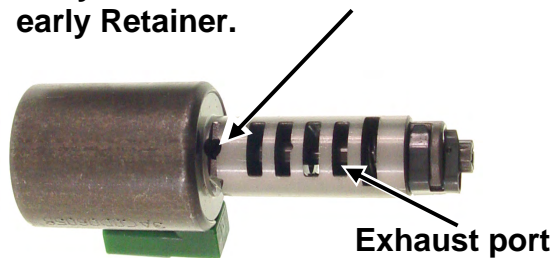
**Early Solenoids have round hole here and use early Retainer.**
