# AW-ACCUM

Fits: All  
U140/U240/U241  
U150/U151/U250  
A750/A760/A761/A960 & AB60

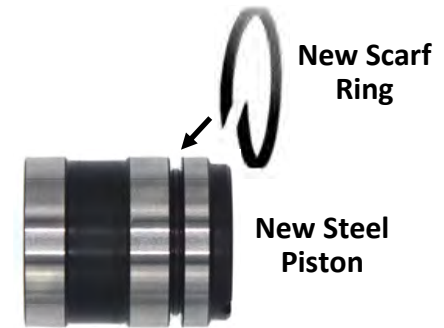
TransGo's solution utilizes made-in USA hardened steel accumulator pistons fitted with scarf cut sealing rings to provide a positive seal in worn bores, even in a less than perfect bore that would normally damage any rubber seals.

The original Toyota accumulator pistons have no seals and rely solely on the close tolerances of the mating components (when new) to control system leaks. However, over time and use, the soft aluminum accumulator pistons and bores wear, creating leaks resulting in shift feel complaints and burnt frictions.

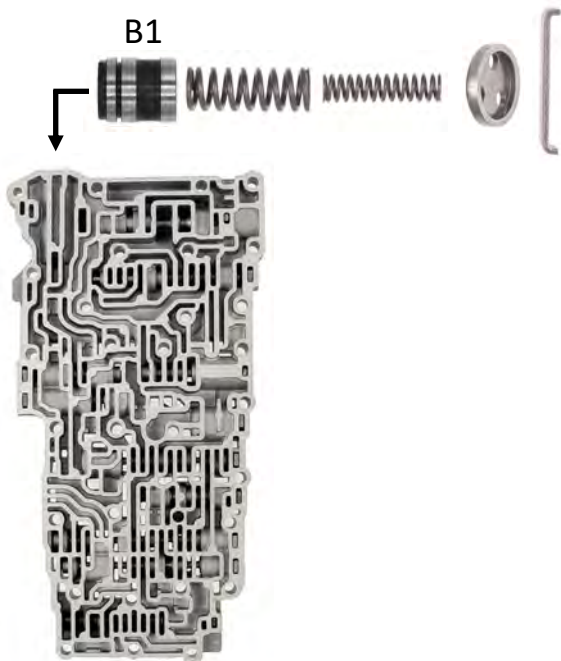
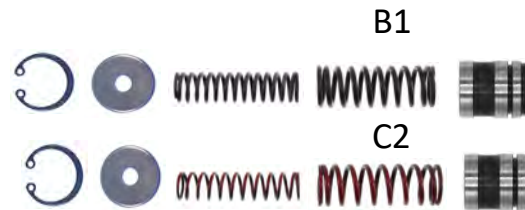
## A750/A760/A761/A960 & AB60

**Step 1.** Remove original accumulator piston & springs. Keep the spring or springs together for each piston to prevent mixing them up.

**Step 2 .** Clean New Piston. Place a small amount of assembly gel into the groove and install the **New Scarf Ring** provided. Make sure gel is holding ring flush or below flush before installing to prevent ring damage. Re-use your original springs.
