SK® CD4E-Jr Shift Kit® Series 7D

Converter Slip and Code 628

Drum Blow-out due to run-away line pressure.
Bushing wear due to accidental Lube cut-off.

Ford CD4E
Mazda LA4A-EL

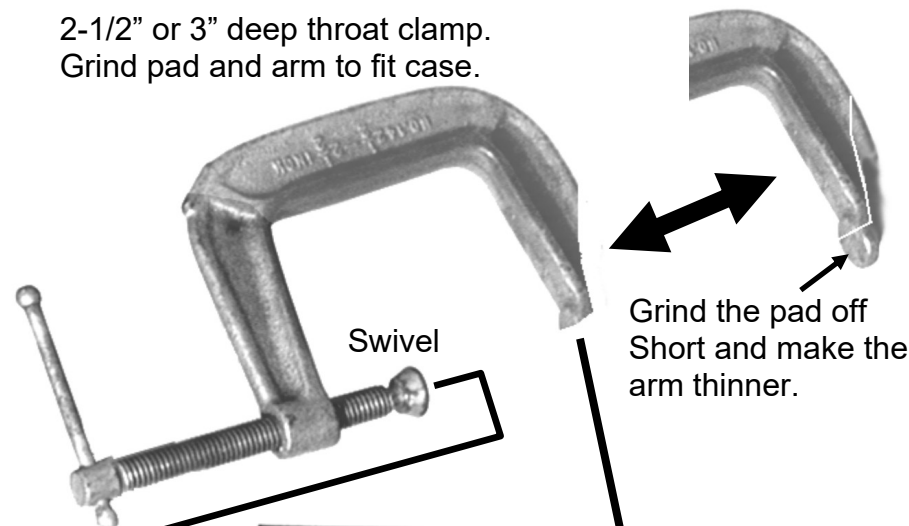
2-1/2" or 3" deep throat clamp.
Grind pad and arm to fit case.

Listen: Be careful. Go buy a Stone Age "C" clamp. It makes servo job really easy.

Step 1 Disassembly: Insert the clamp arm just beyond the steel bracket bolt. Do not put the clamp into an oil circuit. Squeeze cover in with clamp and remove snap ring.

Step 2 Assembly: Squeeze cover in with clamp. Then install the Adjustment Washer and snap ring.

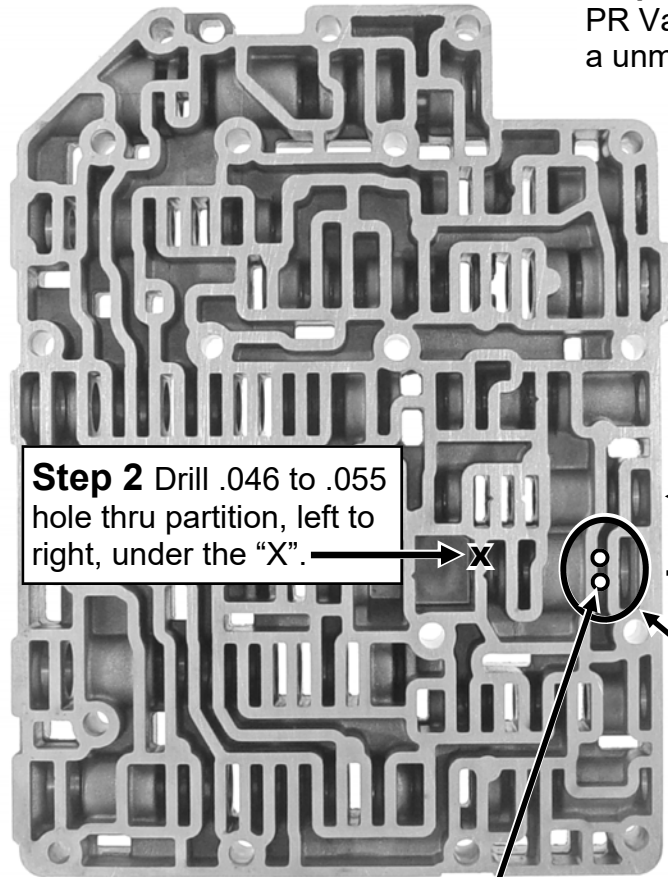
Remove all parts in the PR Valve bore. Measure land "A" on your PR valve. If Land "A" measures approx .472, proceed to **Step 2**. If not, the valve body has been bored for an oversized PR Valve. **STOP!** You will need to change the main body with a unmodified, main body and main plate (if plate was drilled).

Step 2 Drill .046 to .055 hole thru partition, left to right, under the "X".

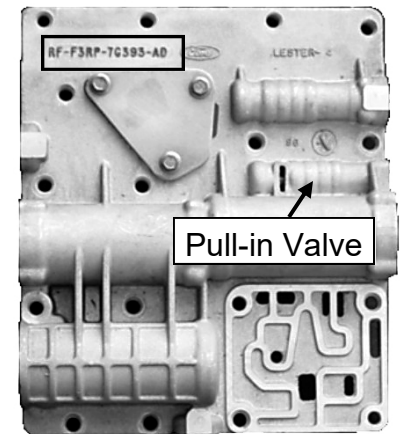
VB ID by Casting Number

High Gear Starts in Man 1
Installing wrong VB can result in High gear start in M1 that may feel like a bind-up. Solenoid firing order in M1 is different for "F6" & "F3" valve bodies & must match the computer strategy.

93-96 Casting # starts with "RF-F3" and has a "Pull-in Control Valve".

97up Casting # starts with "RF-F6" and does **NOT** use a "Pull-in Control Valve".

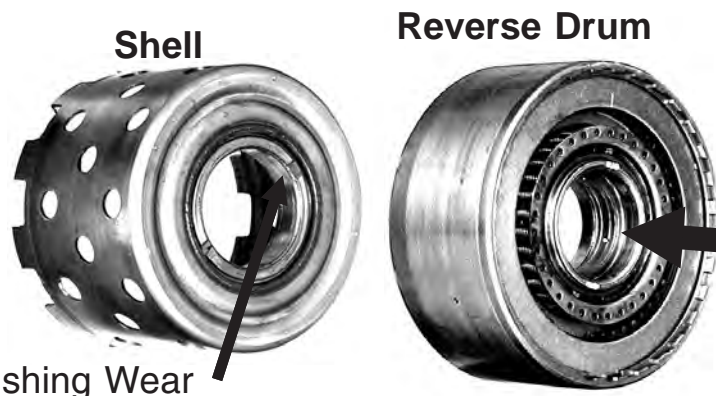
Bushing Wear

It may look like the rings ate into the drum. The truth is; Loose bushings allows the TOP of the ring lands to eat into the drum bore—not the rings. **LOOK and LISTEN:** if the two places where the ring rides are still smooth and at least 1/16" wide, you can re-use the drum by installing new bushings.

Bushings: The drum bushings are usually in bad condition from lack of lube or bad connection at the ground strap. This kit will restore lube flow and cooling, but its up to you to file clean the block and the ground strap. Because the bushings are not blue, from overheat, you may be tempted to reuse them—Don't. Loose bushings allow 2-4 band to push the gear train off-center and the rings will then deform and leak.

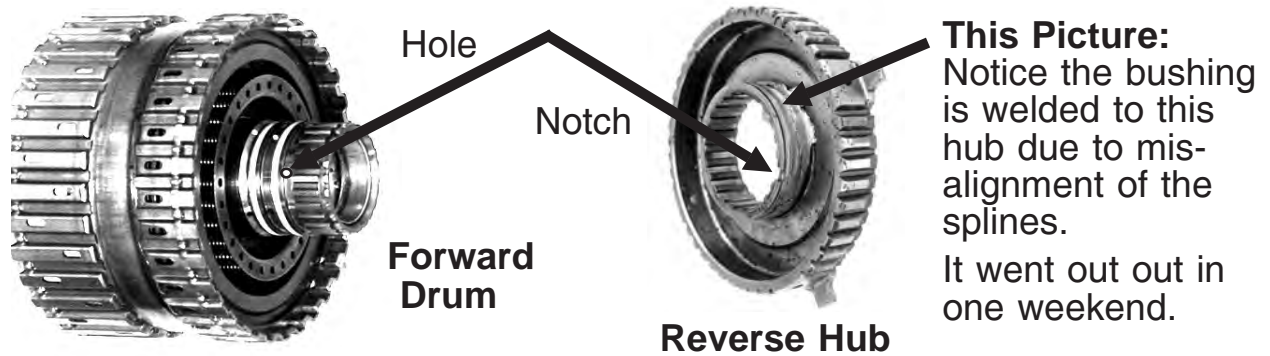
Listen Up: To prevent lube cut-off problem careful assembly is required. Notches in Reverse Hub must align with Lube holes at forward splines.

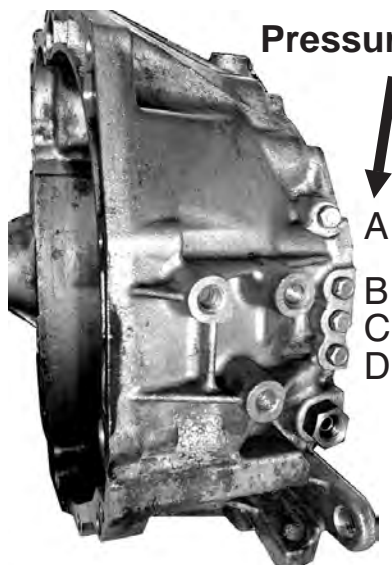
Pressure Ports: A= Differential lube B= Front Lube
C= Converter Mid D= Converter Rear.

Check 628/PO741 Code like this: Gauge port "C". Drive till hot. At 200F Port "C" should be **at least** 70 psi with light throttle in 4th. Restart to clear code. Drive 65 to 75 mph, in lockup, and watch tach while adding throttle. If rpm comes up without an increase in car speed, the converter is slipping.
