# Set # 4-3132

INST: #17110  
9/SEP/01 BRH

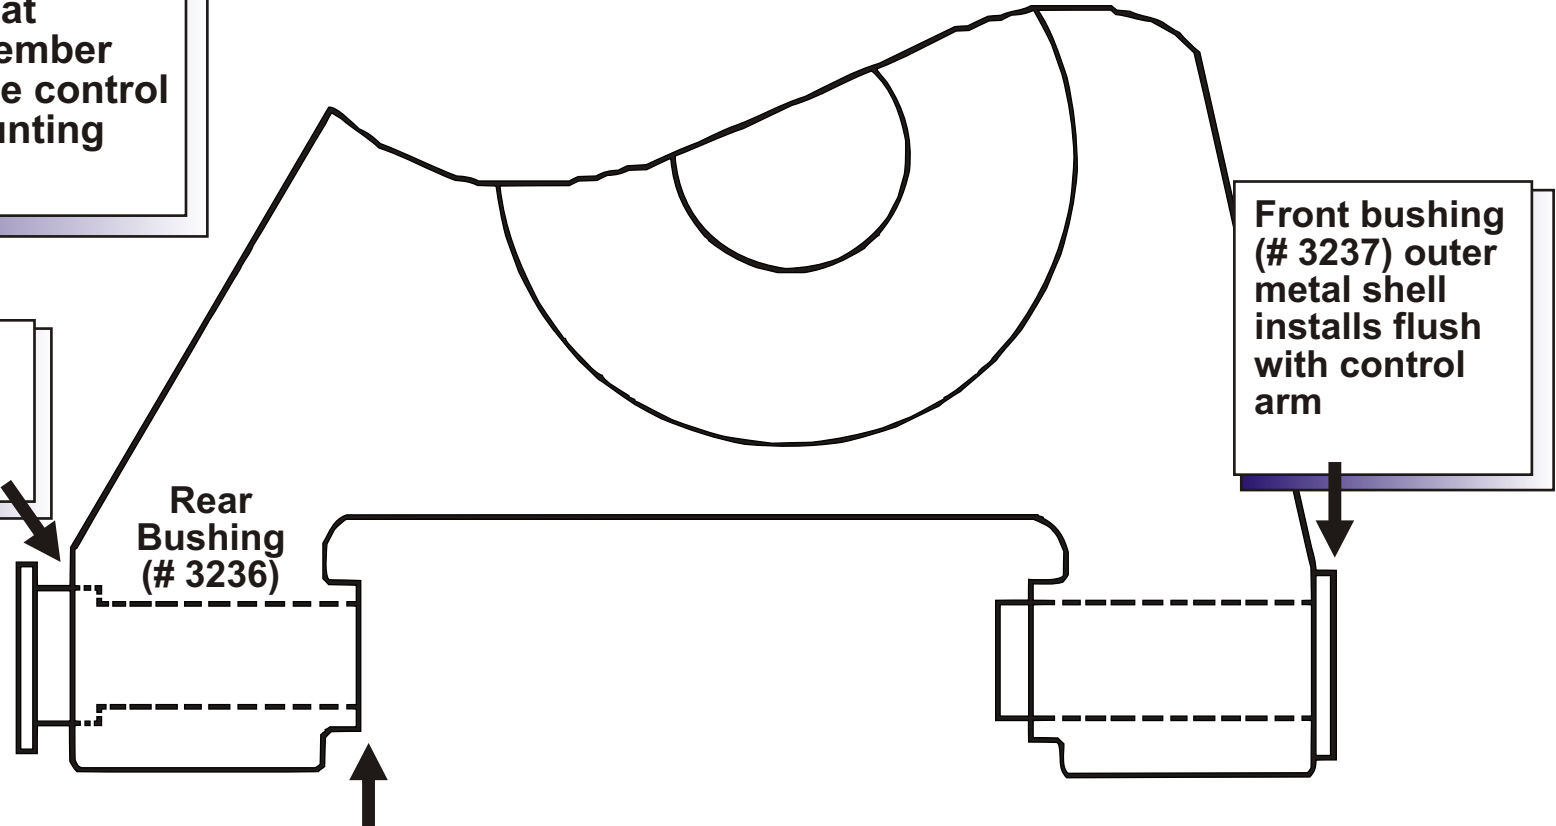
Flange of outer metal shell does not fit flush with control arm face

Rear Bushing (# 3236)

Front bushing (# 3237) outer metal shell installs flush with control arm

The end of outer metal shell should be flush with the end of the control arm eye. Be careful not to collapse control arm when pressing bushing into place.

The bushing at the rear mounting position does not fit into the eye with the flange surface against the face of the control arm.

(see diagram)
