INSTRUCTION SHEET FOR SET #8.3120 TOYOTA MATRIX/COROLLA

BILL OF MATERIAL

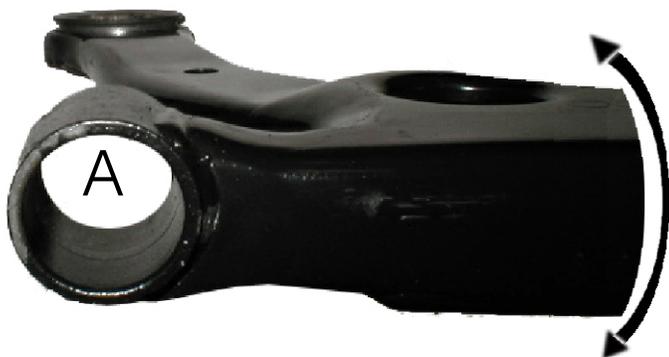
Diagram V

- The center bushing #3304 must be installed with the engraved arrow pointing towards front of car, or the horizontal position **Point A**. If you looked thru the horizontal eye, **Point A**, the cross-section of the vertical bushing assembly would look like **Diagram V**.

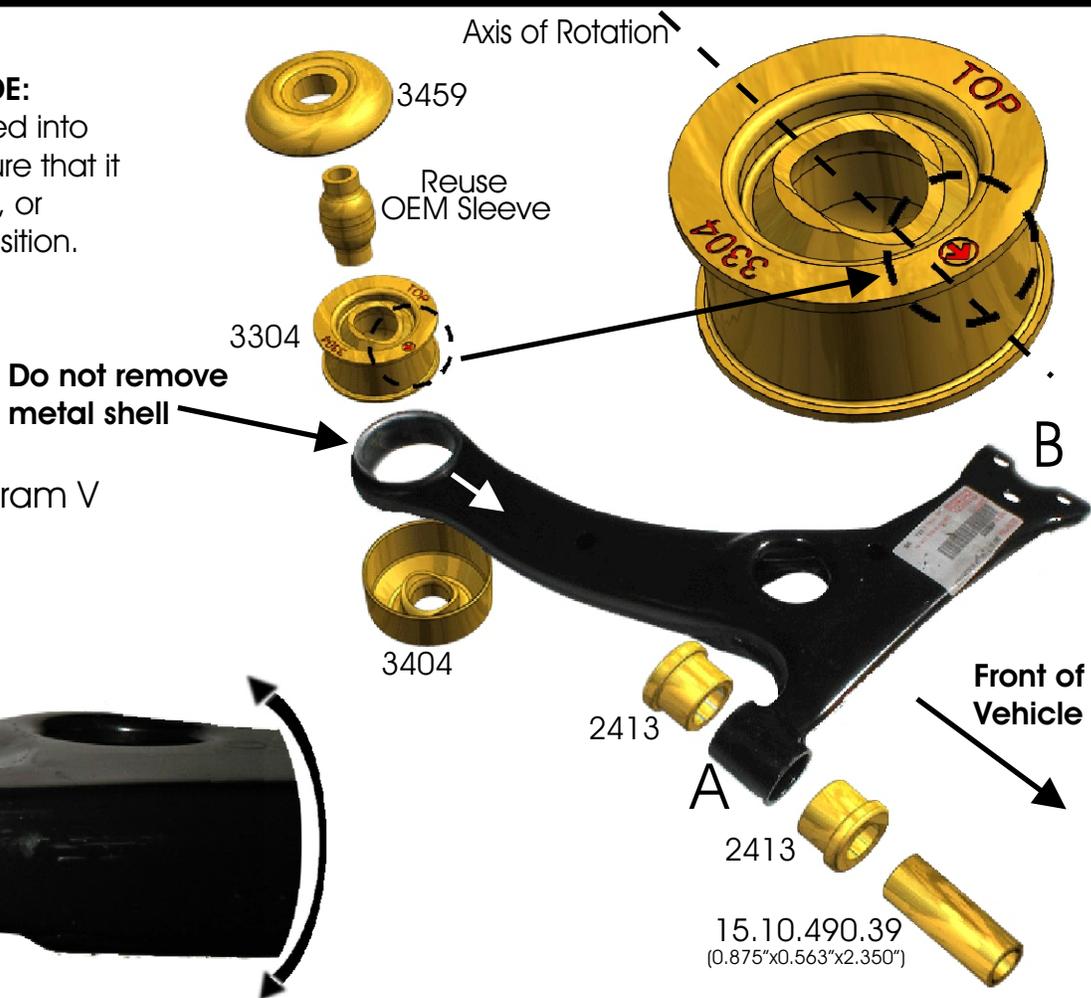
Remove the OEM rubber bushings, using heat to break down their glue bond. **DO NOT remove the metal shell** pressed in at the vertical position. Also don't throw away the inner metal sleeve, it is reused. Now de-burr any rough edges and clean out any leftover debris at the vertical and horizontal positions of the arm.

VERTICAL BUSHINGS MUST BE INSTALLED CORRECTLY!!!!!!!
