1958 CHEVROLET IMPALA

1958 PONTIAC BONNEVILLE, CHIEFTAIN

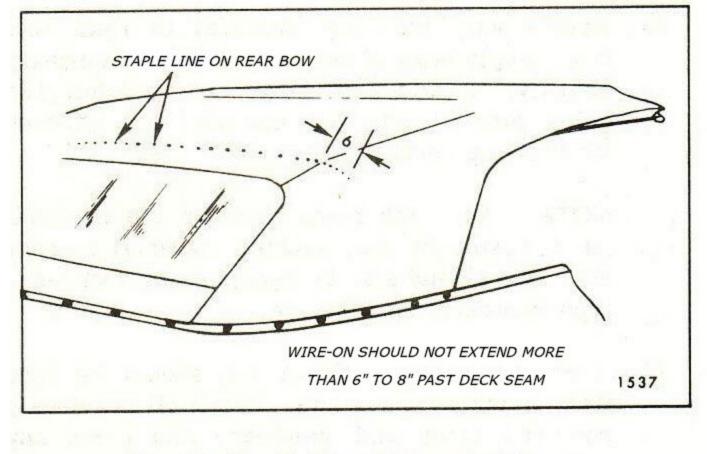
Fig. 13-42 - Tacking Outboard of Seams

WHEN INSTALLING THE FINISHING TRIM (WIRE-ON) IT SHOULD NOT EXTEND MORE THAN 6" TO 8" PAST THE DECK SEAM. TOO FAR OVER THE CURVATURE OF THE BOW MIGHT CAUSE THE METAL WIRE-ON TIP TO CUT THROUGH THE MATERIAL AFTER REPEATED FOLDING DOWN

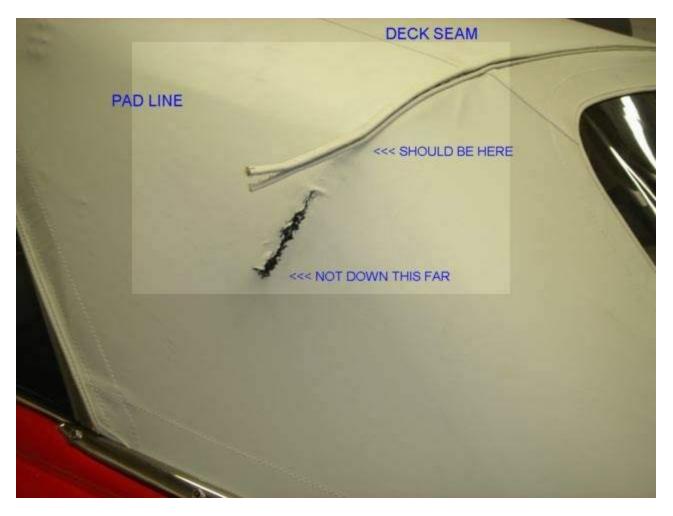
<u>DIAGRAM FOR THE PLACEMENT OF THE WIREON TRIM.</u> EACH CAR HAS A DIFFERENT WIDTH VALANCE. WHEN THE DECK IS PROPERLY PULLED SIDE TO SIDE, STAPLE ON THE DECK SEAM DEAD CENTER OF

THE BOW (X)

ONLY A FEW STAPLES ARE REQUIRED FROM SIDE TO SIDE TO KEEP THE BOUND EDGE LEVEL ACROSS TO HOLD THE DECK IN POSITION.

MORE STAPLES CAN BE ADDED AFTER THE FRONT EDGE IS FASTENED, AND BEFORE THE WIRE-ON TRIM IS INSTALLED

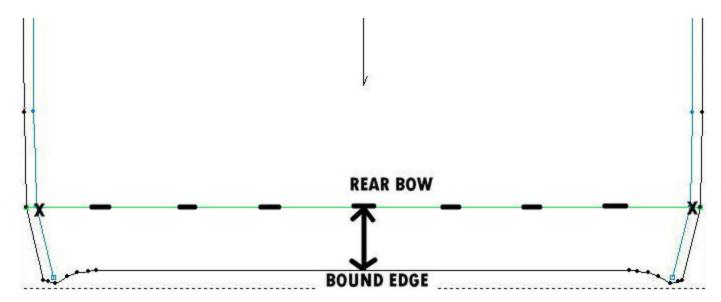
STAPLE ON BOTH DECK SEAMS (X) TO HOLD THE DECK IN POSITION. PULL THE DECK BACK TO AN EQUAL DISTANCE SIDE TO SIDE AND SET WITH ONLY A FEW STAPLES. ADJUST THE FRONT EDGE TO PROPER TENSION, THEN SET THE FRONT EDGE COMPLETELY. NOW FINISH THE REAR BOW WITH MORE STAPLES AND INSTALL THE WIREON TRIM AND END CAPS.
