Camber / Caster Shim Part# 1032H / 1035H

Part # 1032H

Part # 1035H

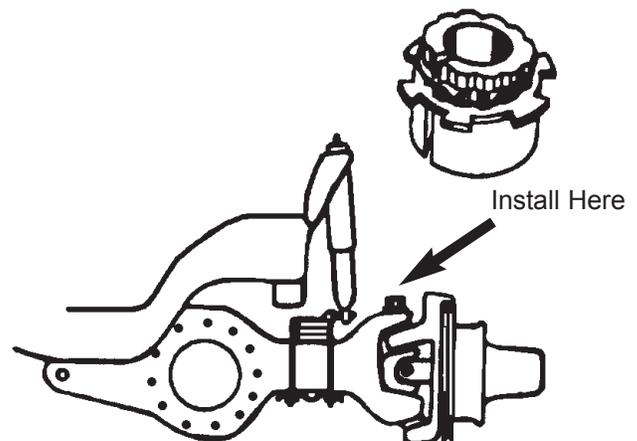
Part # 1032H and 1035H bushings have a detachable lock ring that allows a full 360 degrees of bushing rotation. This allows the bushings to correct either positive or negative camber or caster as well as any joint camber / caster correction.

2. **Using a 1 1/8" box wrench**, rotate the bushing until desired alignment is achieved. Position the lock ring into place using the closest notch possible. Install the snap ring.
