THE COMPLAINTS

SYSTEMS CORRECTION AND CALIBRATION KIT

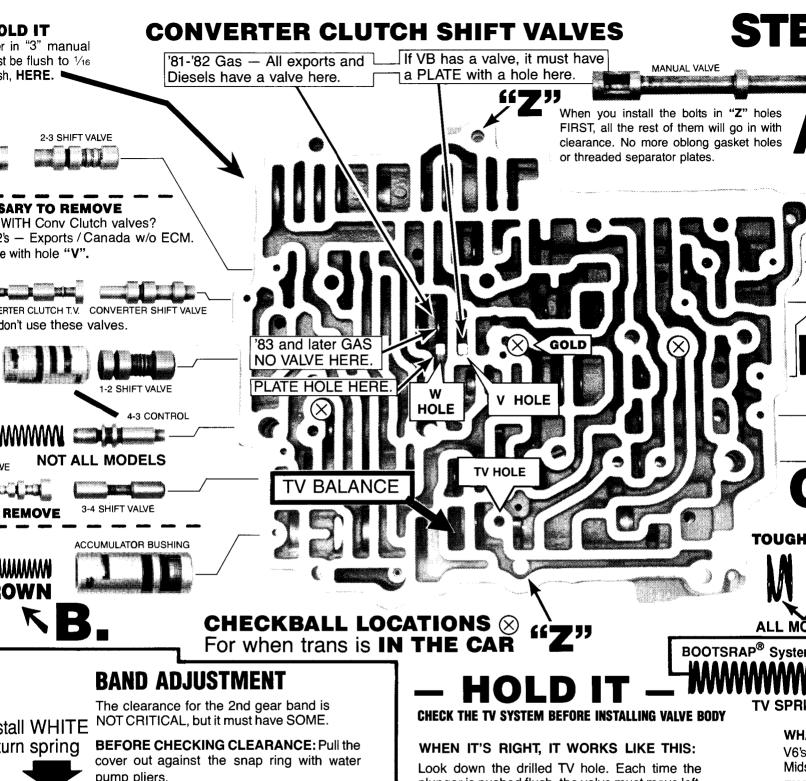
WITH PAN OFF: Reach up past the valve body with screwdriver. Move the band FRONT to REAR. Must move freely FRONT to REAR 1/8" or more.

If it's tight, remove one or two GOLD spacers.

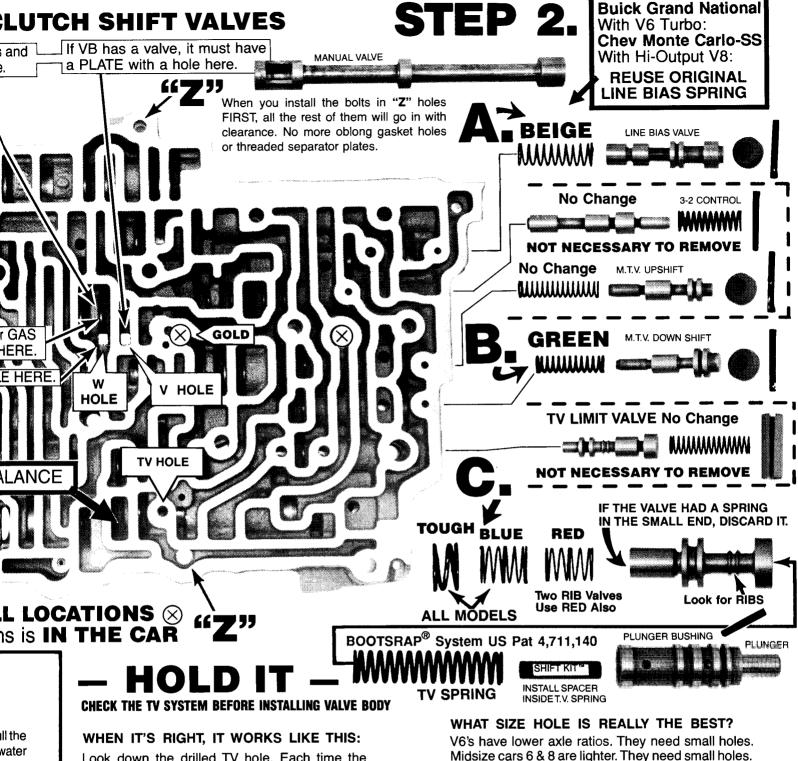
Look down the drilled TV hole. Each time the plunger is pushed flush, the valve must move leftward and open the hole 1/3 or more. As the plunger is released slowly, the valve must move rightward and close the hole. Try it about a dozen times. It should work EVERYTIME. That's it.

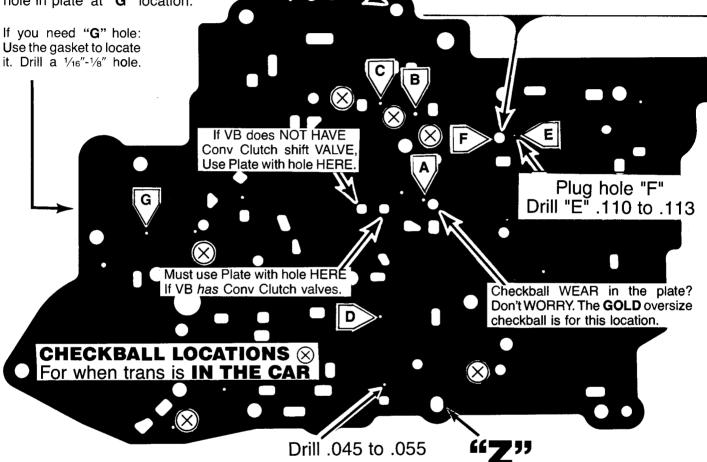
Flip the plate over and hold down against the bench or floor without the gaskets. Hit the slug several times with light hammer to flare it slightly.

Use alum **SLUG** furnished: Install into hole "F."

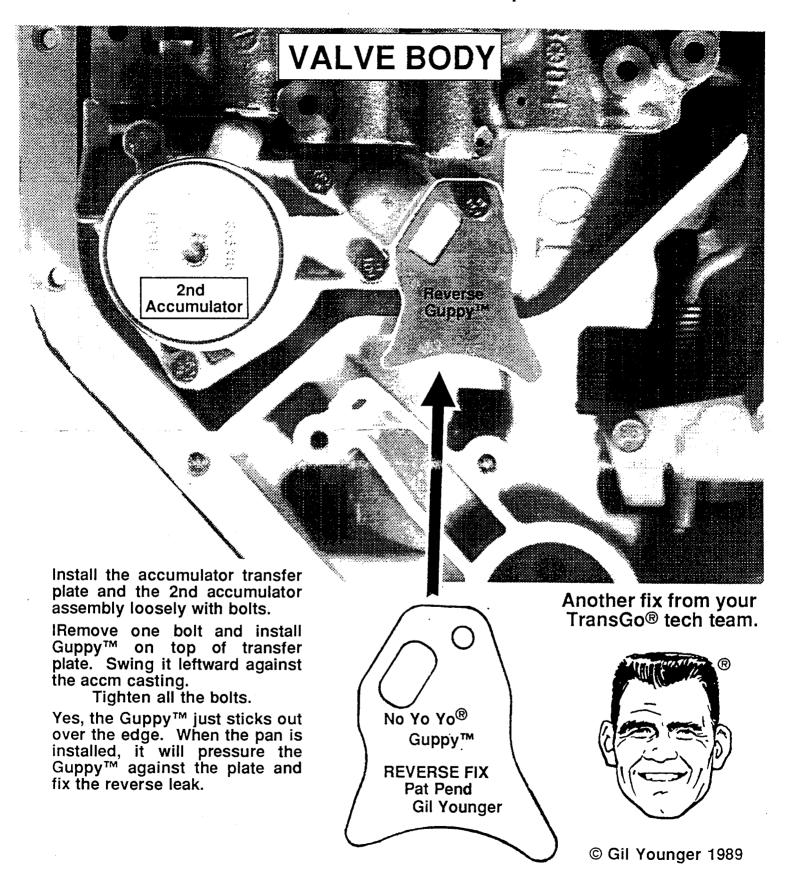
2004R Reverse Fix

Prevents/corrects hot chatter or slip in Reverse
