# INSTRUCTION SHEET

**TORONADO & EL DORADO 425  
(Front Wheel Drive)**

## SHIFT KIT

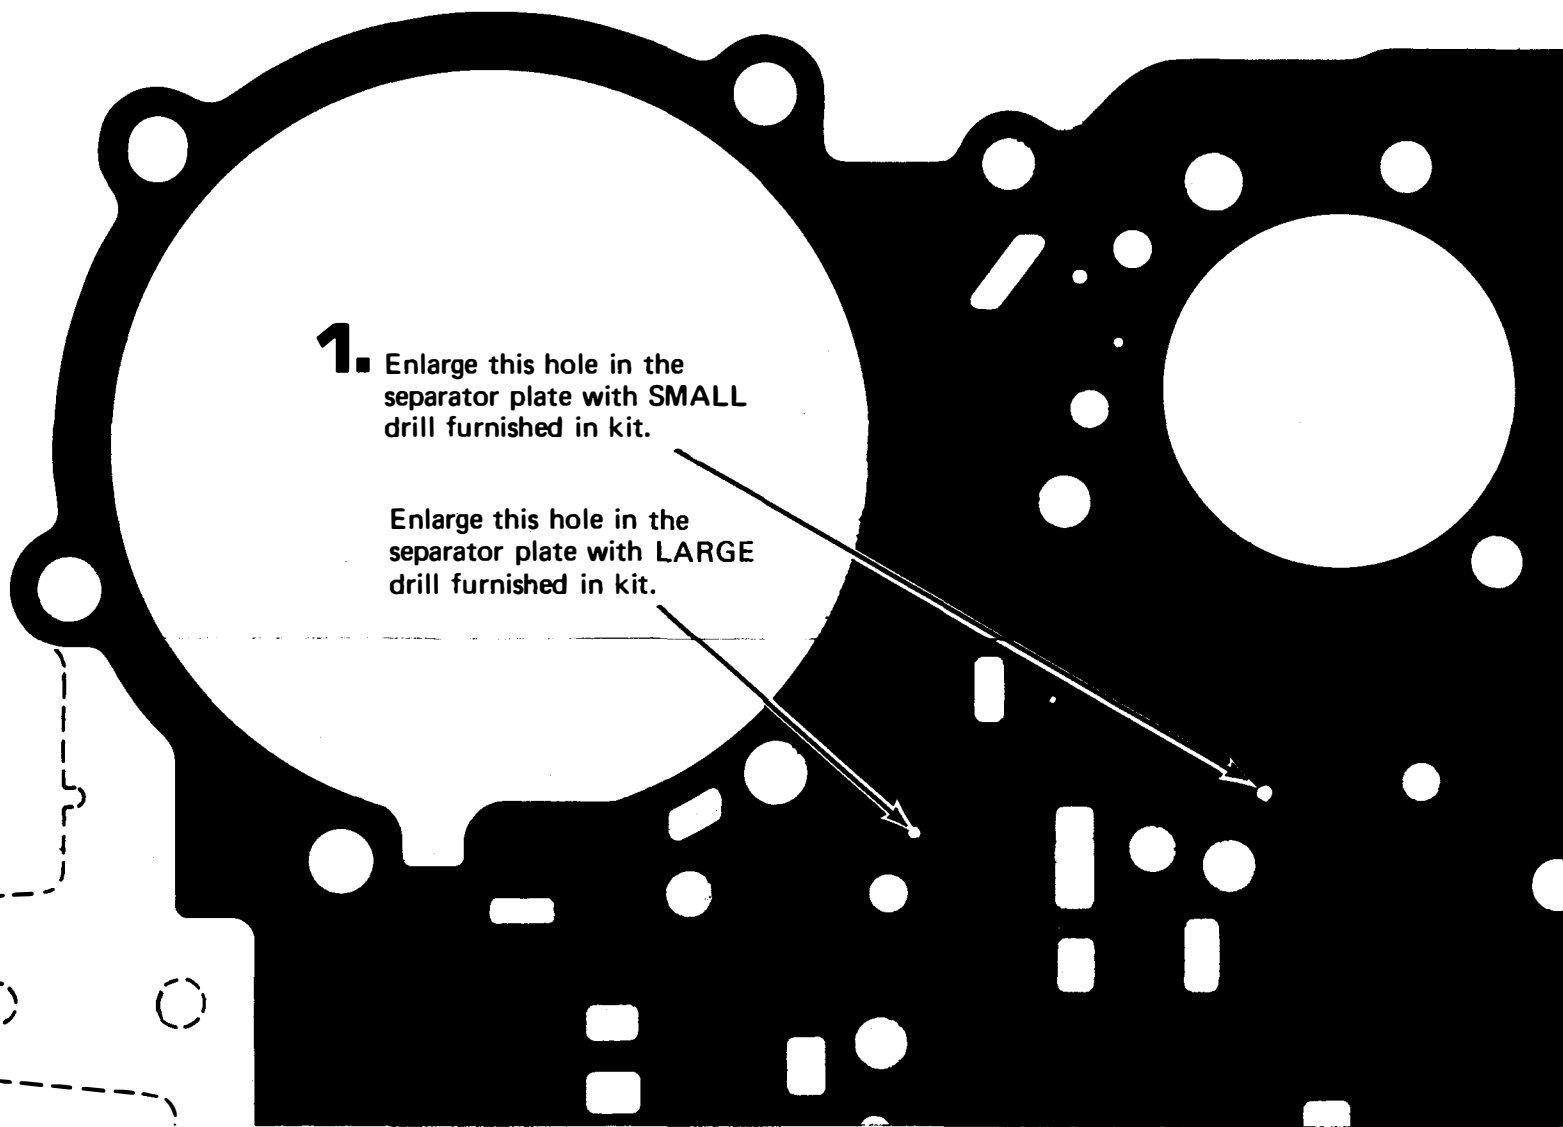
Figure 1.

- 1.** Enlarge this hole in the separator plate with **SMALL** drill furnished in kit.

Enlarge this hole in the separator plate with **LARGE** drill furnished in kit.

THIS SOLENOID MOUNTING TAB WAS OMITTED ON 68 MODELS AND LATER.

- 2.** When this Shift Kit is being installed with the transmission in the car, place check balls (7) at locations shown on separator plate.

CHECK BALLS (7)

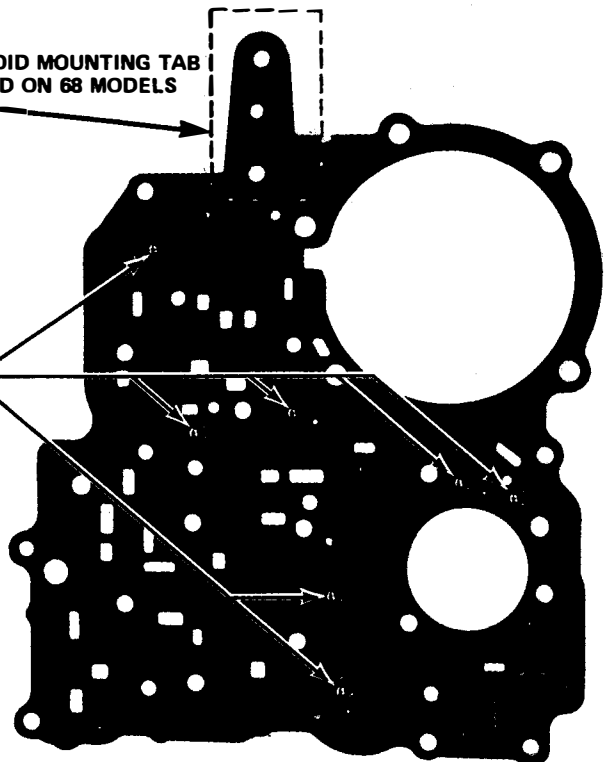
**ASSEMBLY TIPS:** Grease separator plate lightly and stick gasket to each side. Put a small amount of heavy grease at each check ball location, so that ball will not fall off plate during assembly.

**3.** If transmission is out of the car, install check balls (7) as shown in Figure 2.

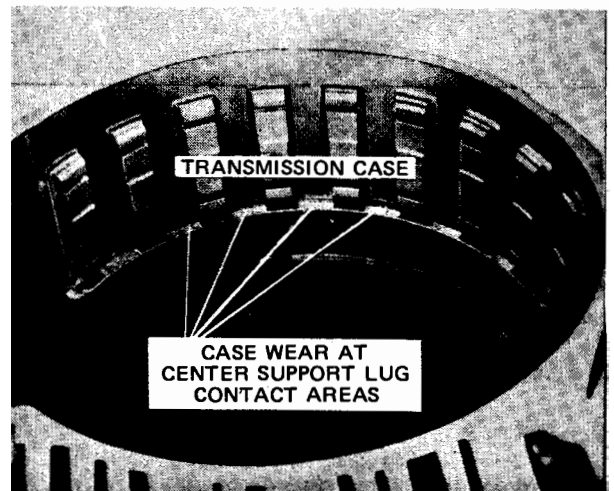
Figure 3.

**6.** CASE WEAR AT CENTER SUPPORT LUG CONTACT AREAS

This is the main wear problem that has driven many a good man right up the wall. Wear at this point (Figure 3) allows excessive center support movement and misalignment. This can cause — high clutch failure — late or no 2-3 shift when hot — failure of rear thrust washer — shudder or snapping during 1-2 shift — falls out of high when hot —

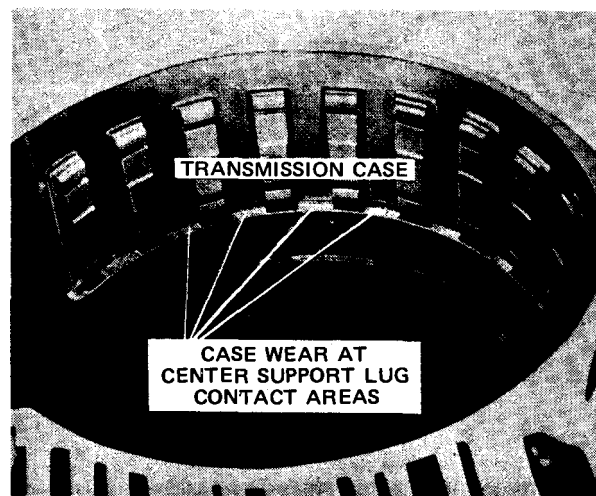
Figure 3.

## 6. CASE WEAR AT CENTER SUPPORT LUG CONTACT AREAS

This is the main wear problem that has driven many a good man right up the wall. Wear at this point (Figure 3) allows excessive center support movement and misalignment. This can cause — high clutch failure — late or no 2-3 shift when hot — failure of rear thrust washer — shudder or snapping during 1-2 shift — falls out of high when hot — center support bushing wear — front planetary noise and stator support failure.

IT IS NOT NECESSARY TO REPLACE THE CASE.

A replacement center support is available with a steel shim that installs under the support giving it a solid seating surface.
