# LJ4AEL Shift Kit®

1995-03 Mazda Millenia-S 2.3L  
JF403E 1990up Geo Storm  
Isuzu Impulse and Gemini

**This Kit is about: Prevents Clutch Drum Blowout and Planetary failures caused by Hi-line and Low-Lube .**

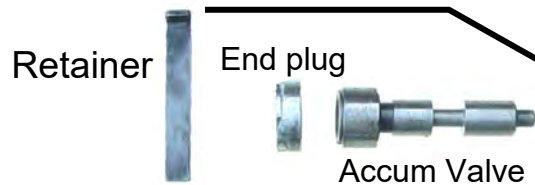
**Step 1.** Remove **Retainers**. With sand paper smooth the small burr where the retainer was against bore.

**Step 2.** Insert **Flat Bent Pry** between the end plug & accum piston. Push piston inward *away* from the end plug far enough to insert the stem end of eyelet pry.

**Step 3.** With **Eyelet Pry** *push* the end plug **GENTLY** in various spots to remove it. Then remove 2nd accum piston, spring & washer on **Page 2**. Then *push* accum valve and end plug from this side of VB with a thin punch.

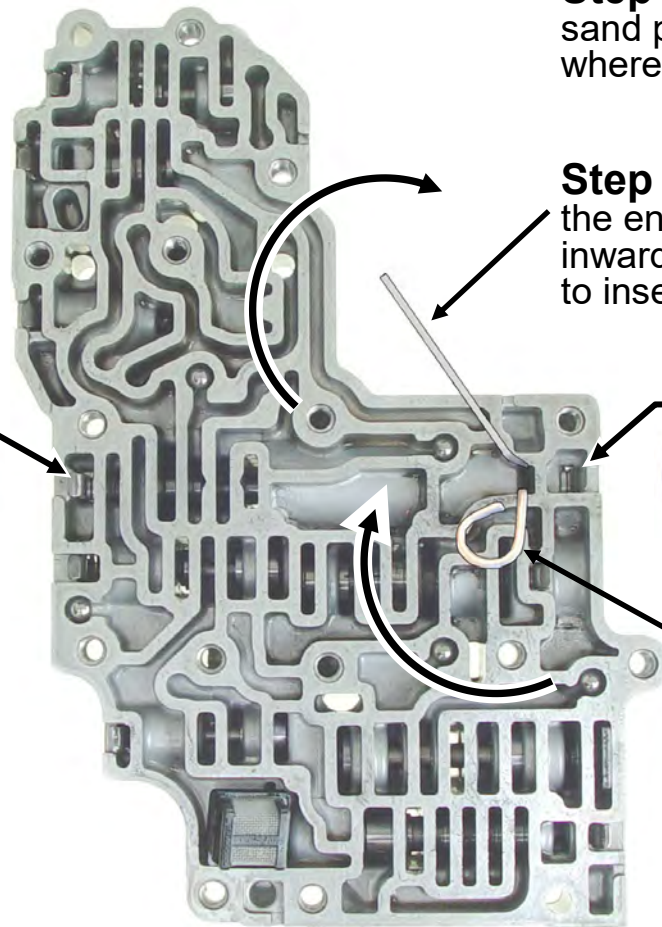
**Upper Valve Body**

Install accumulator valve first. Then install the flat washer on the **stem** of accum valve, then the remaining parts as shown.

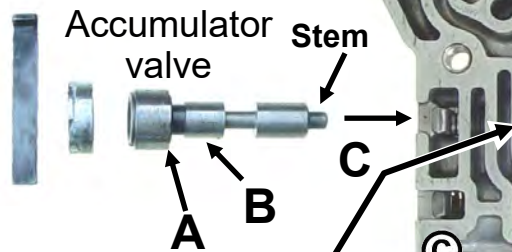
**Step 1:** Remove accum valve and chamfer partition as shown below. Clean bore and **reinstall** the valve.

**Here's Why:** Edge **A** on the valve hits partition at **C**. This deforms the bore which sticks the valve at land **B**.

By **HAND**, make a small chamfer in the valve bore at "**C**" with a **sharp** 7/16 or 15/32 drill.

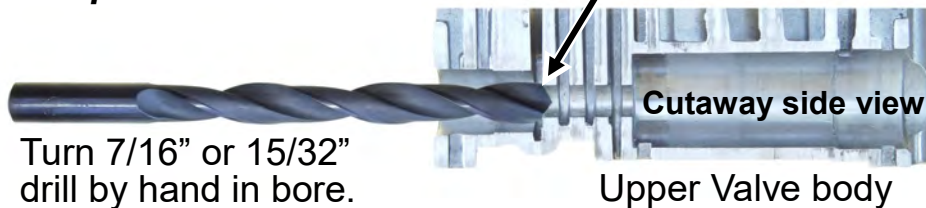
## Here's how to fix it:

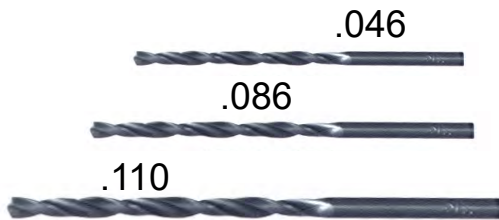
# Small Plate

Make this hole .086  
OK if already bigger.

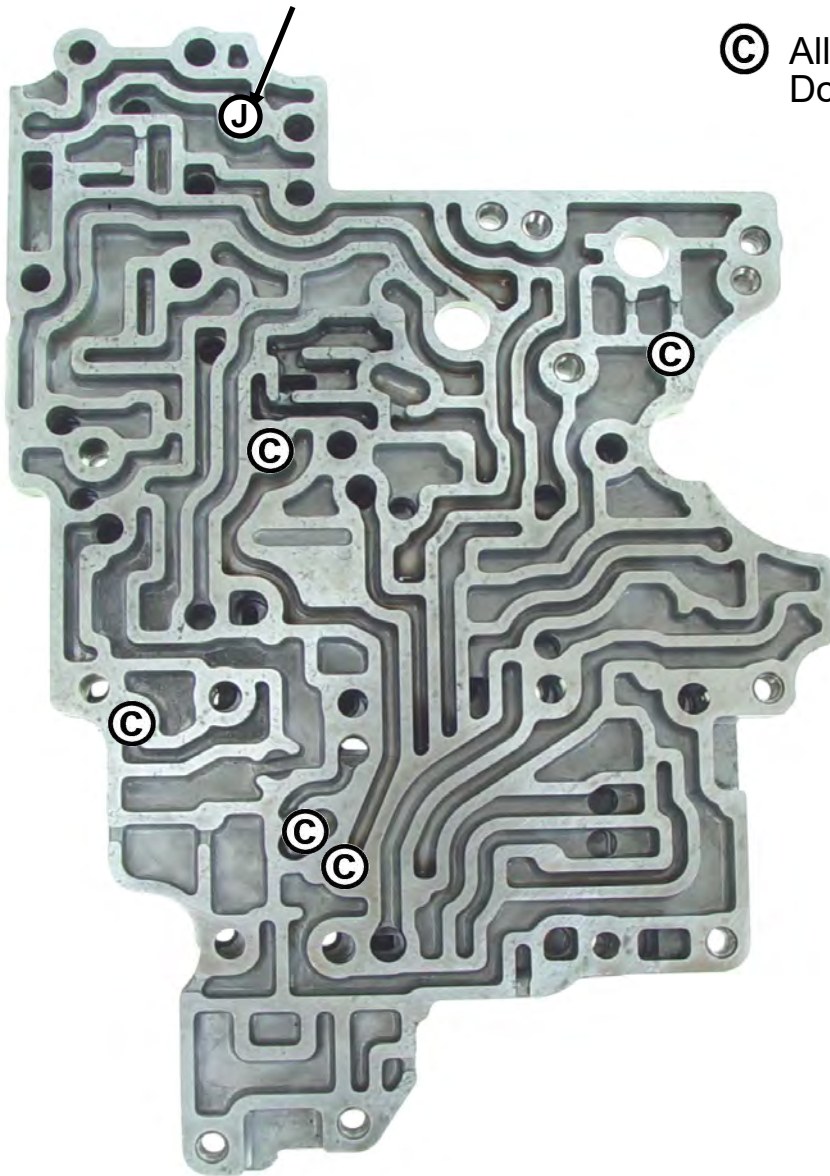
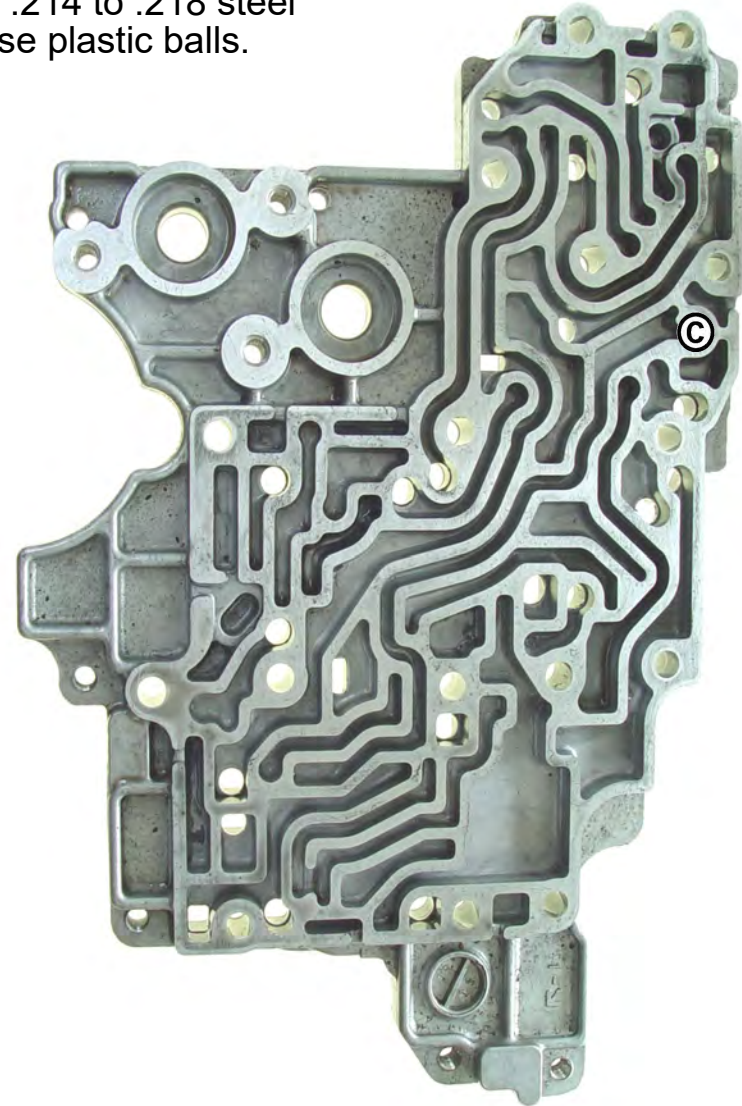
## Intermediate Valve Body

If main plate has slotted "JF"  
hole install ball "J" here.

© All Balls: .214 to .218 steel  
Do not use plastic balls.

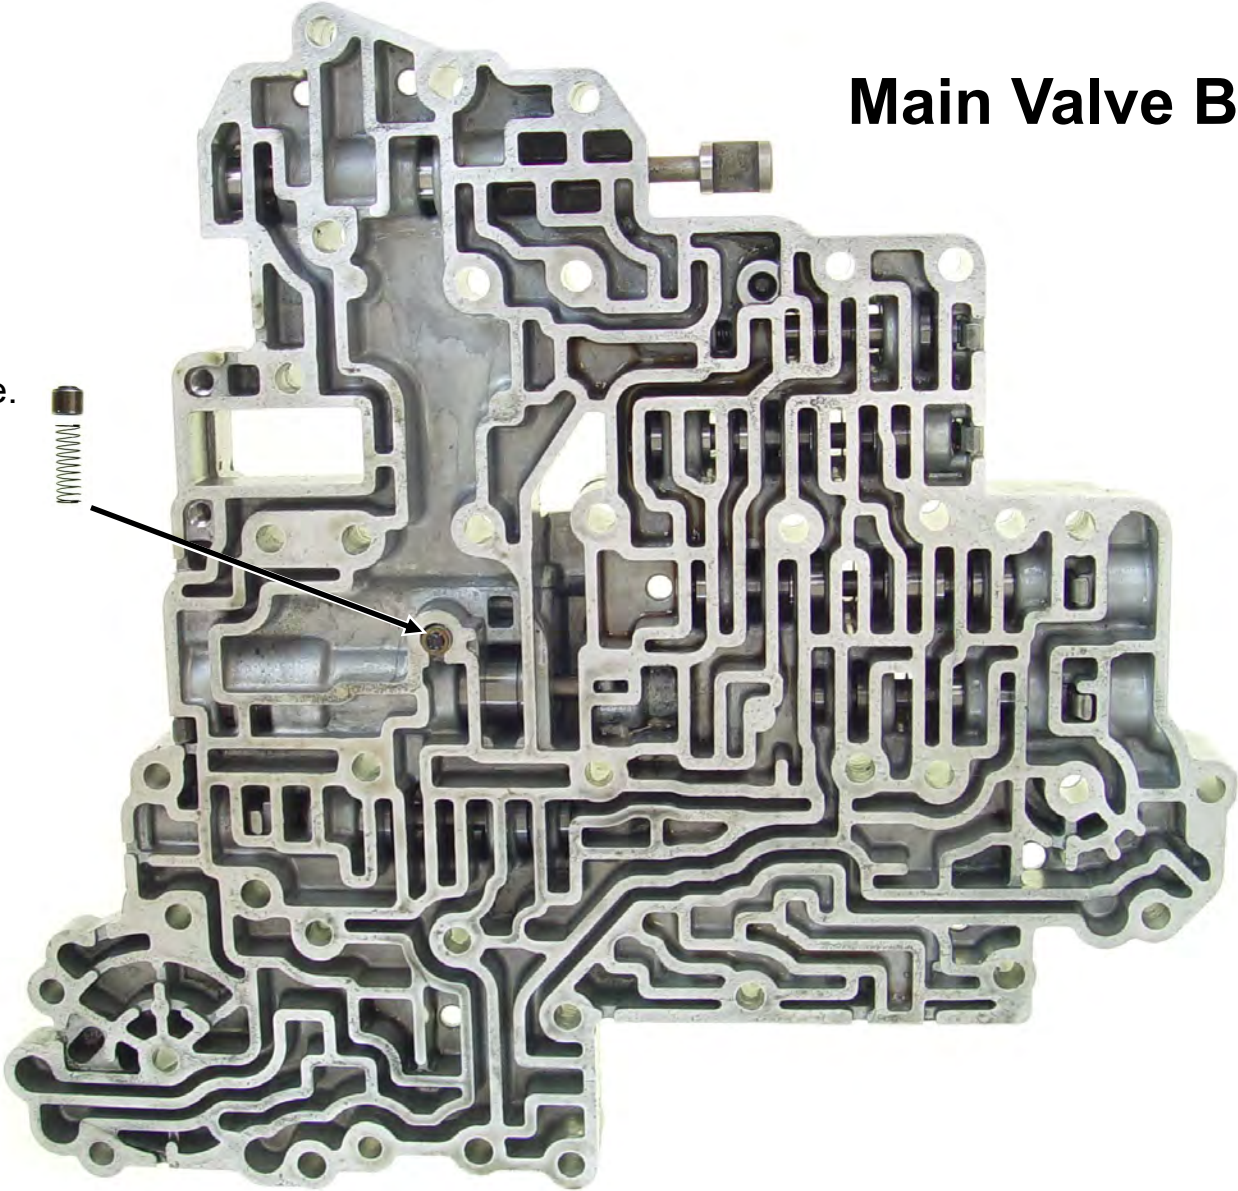
# Main Valve Body

One way Lube Valve.  
[Very weak Spring]

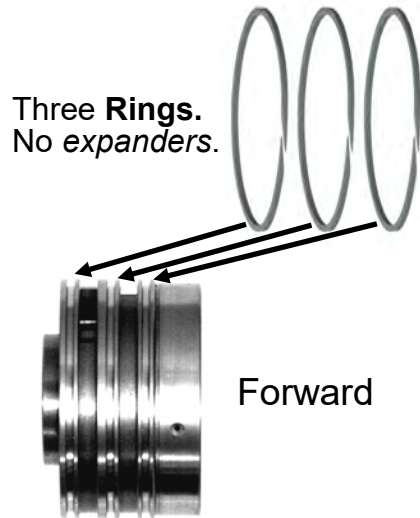
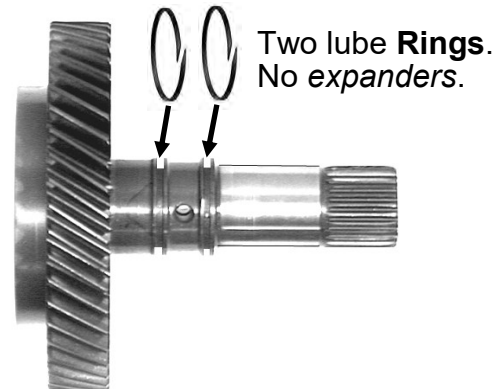
## 1. Forward & Lube Rings

Use Trans Jel and **GENTLY** push rings down into grooves. Ends of rings should just touch or have small gap. If pushed together **FIRMLY** they **BIND** in groove & **WON'T SEAL**.

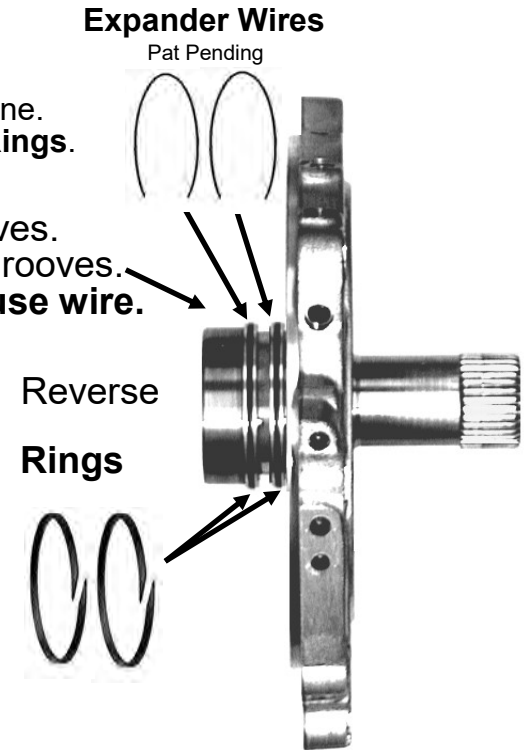
## 2. Reverse Rings

Fill grooves with Trans Jel or Vaseline. Install **Expander Wires**, then two **Rings**.

Some models have shallow grooves. Rings **MUST** push **flush** into the grooves. **If rings wont push flush don't use wire.**

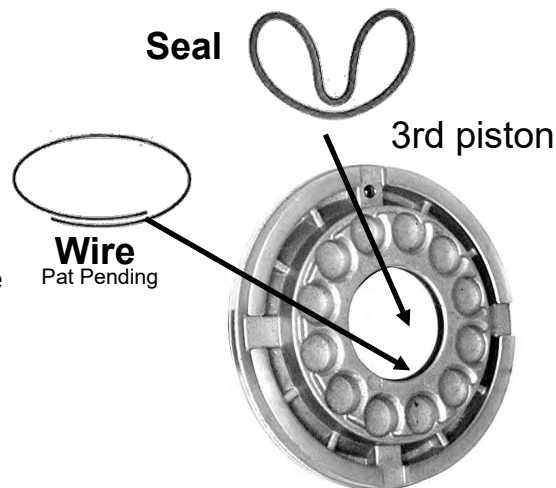
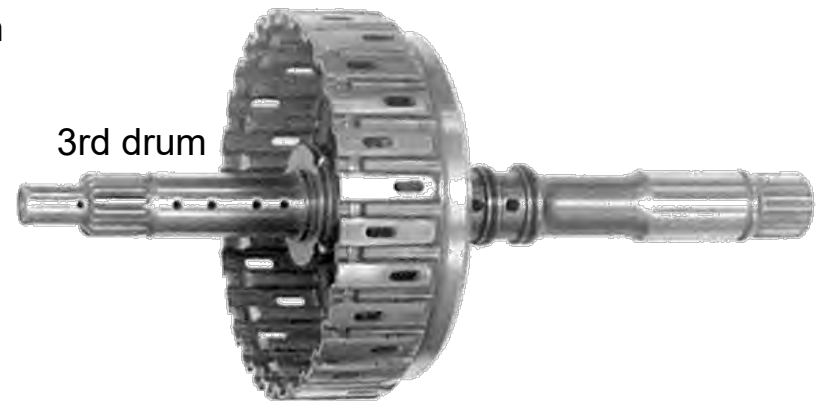
## 3. Third Clutch (Direct) Inner Piston Seal

Insert overlap part of **Wire** into groove at 6 O'clock. Then shape the **Seal** as shown and install into the piston groove.

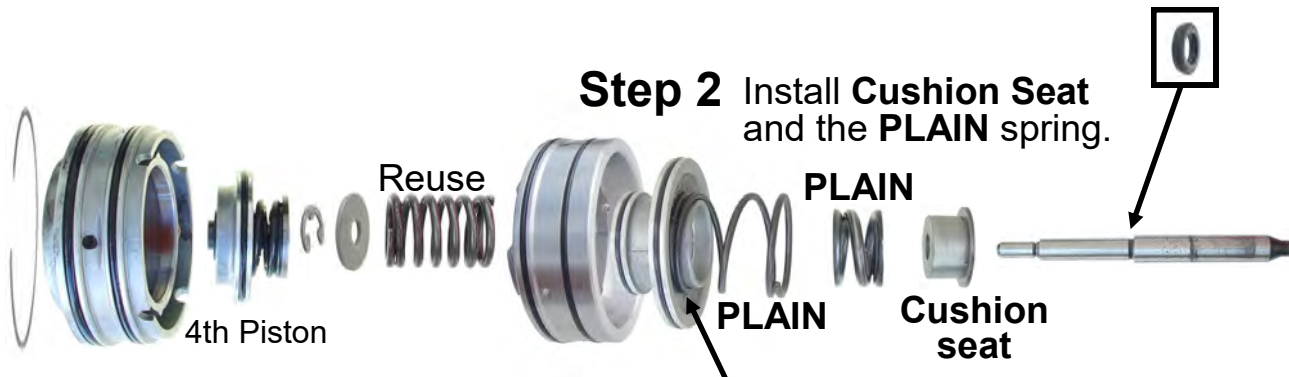
**Step 1** Remove and discard original hard washer.

**Step 2** Install **Cushion Seat** and the **PLAIN** spring.

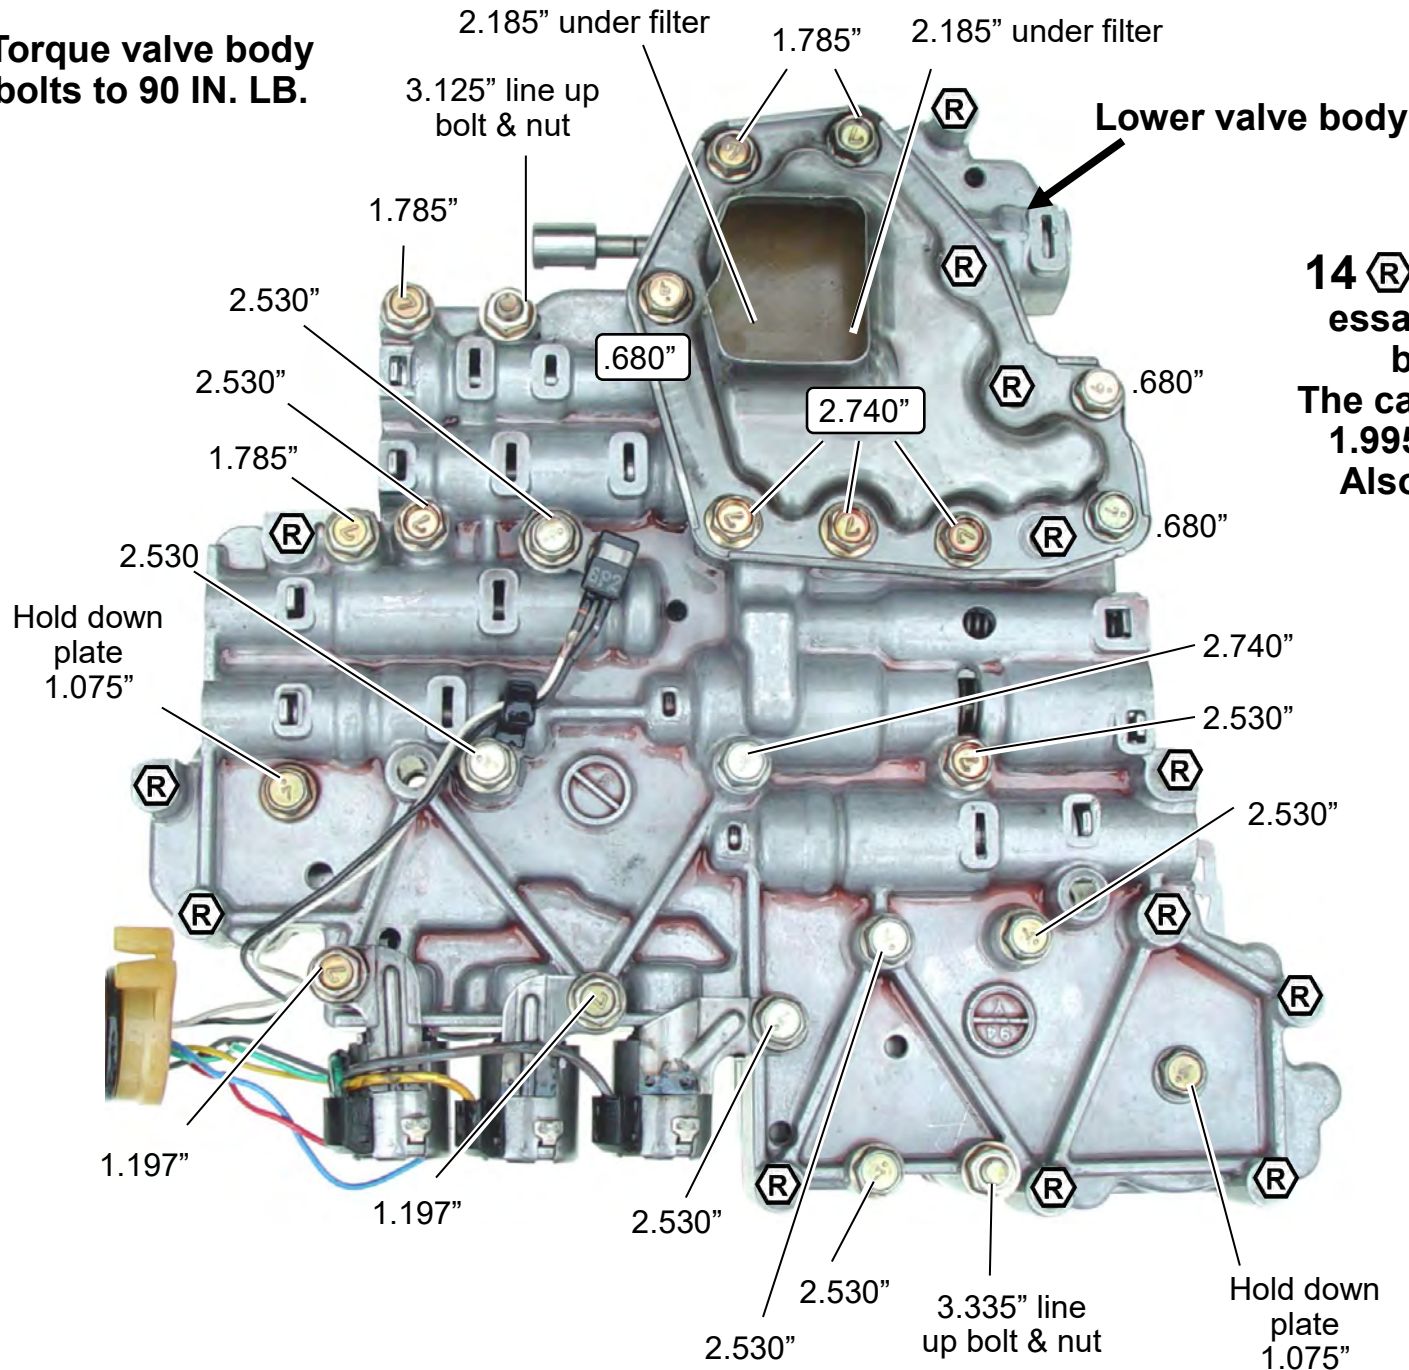
**Torque valve body bolts to 90 IN. LB.**

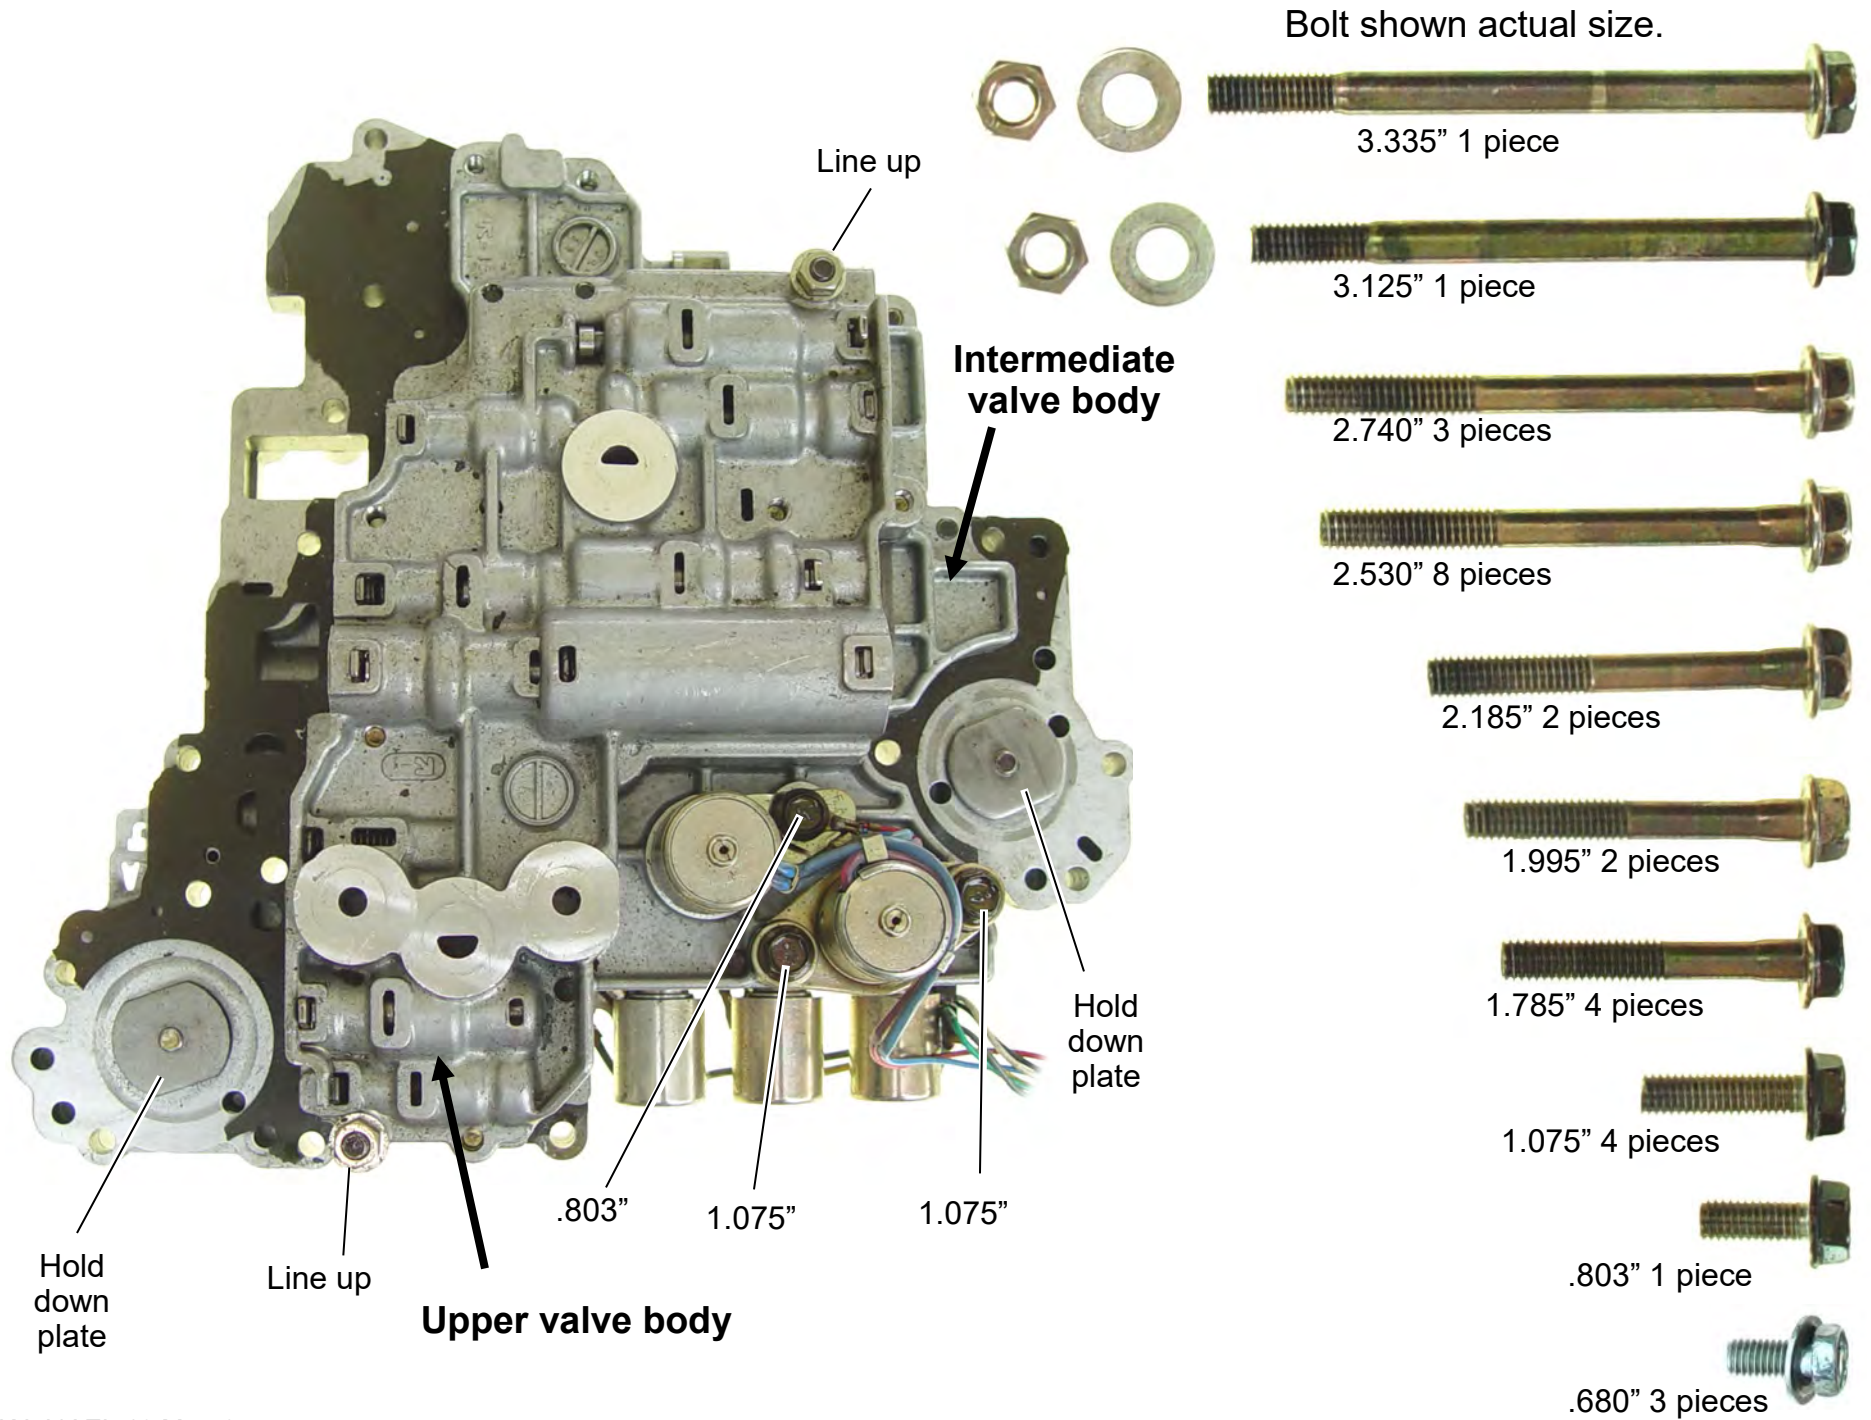
**14 (R) bolts are the ones necessary to remove the valve body from the case. The case bolts on the filter are 1.995\"**
