**Installation Instructions for 603301
Input Drum Reinforcement
For GM 4L60, 4L60-E, 4L65-E & 4-70-E Transmissions**

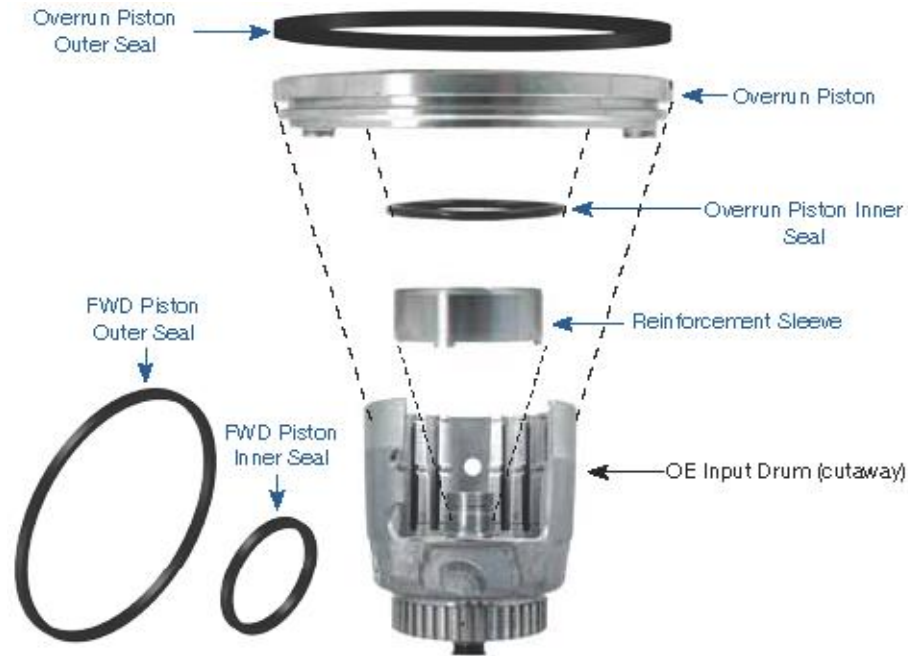
- b. Refer to photo shown above. Clean the reinforcement sleeve area and take note of the overrun clutch feed hole location.
- c. Thoroughly clean the reinforcement sleeve.
- d. Coat the inside of the sleeve with green Loctite® 609. With the tabs located toward the inside of the drum, line up the overrun clutch oil feed hole between the sleeve tabs. Then set the sleeve into position on the input drum.
- e. Using the press, install the sleeve until just barely seated. Do not seat the sleeve with the full force of the press since excessive force will ruin the housing. Do NOT hammer or pound the sleeve into place.

- a. Inspect the drum for cracks or damage. This sleeve will not repair a cracked drum. Set the input drum into a hydraulic press (or arbor press). Use an appropriate sized tube or a spare (not to be reused) 4L60 stator shaft with the selective spacer (with bearing left out) to support the aluminum housing directly under the area being pressed on. A 4L60-E rear sun gear works well to drive the sleeve on.

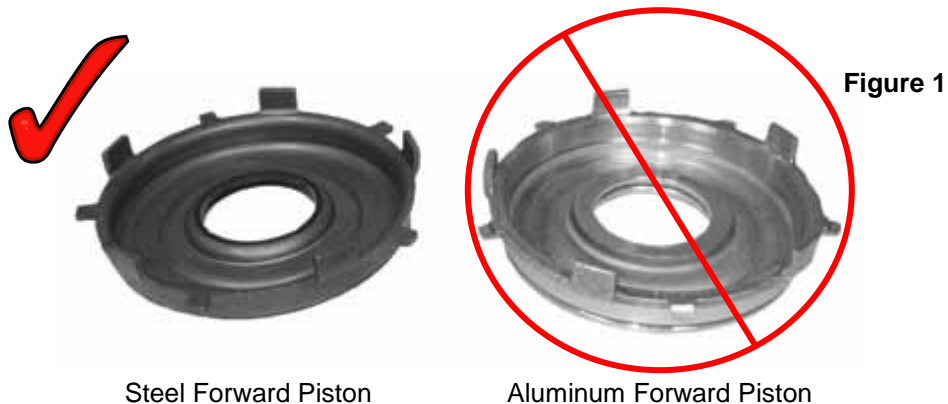
Steel Forward Piston

Aluminum Forward Piston

- a. Can be installed in early & late model transmissions, but requires a 1997-up stamped steel forward piston – see Figure 1.

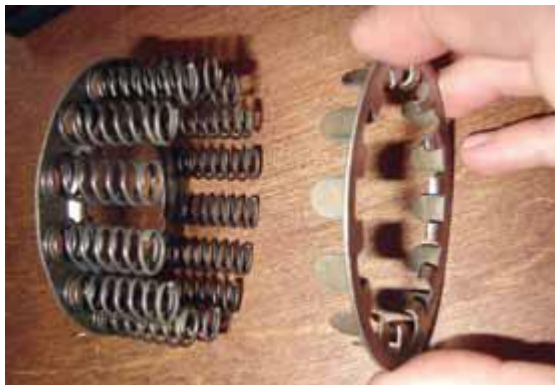
Figure 2

- b. If using a late-model return spring assembly (identified by two spring retainers on both ends of the springs), remove and discard the lower spring retainer (Figure 2). Although not required, the early-style return spring used with OE aluminum pistons is about 10% stronger and is preferred for high RPM applications.
- c. Assemble input drum as usual.
