INSTRUCTION SHEET FOR SET #8.3120 TOYOTA MATRIX/COROLLA

BILL OF MATERIAL

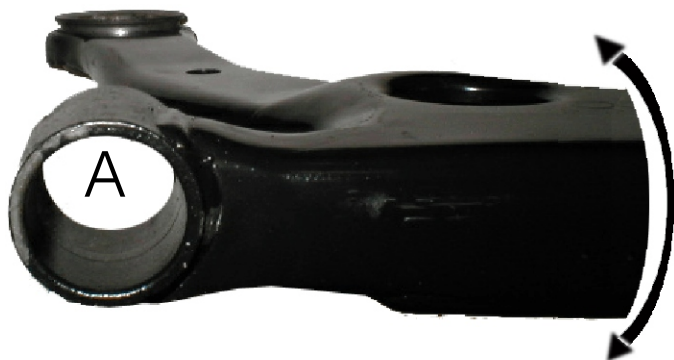
- The center bushing #3304 must be installed with the engraved arrow pointing towards front of car, or the horizontal position **Point A**. If you looked thru the horizontal eye, **Point A**, the cross-section of the vertical bushing assembly would look like **Diagram V**.
