Shift Improver Kit

555-60931

1965-1987 GM TH400

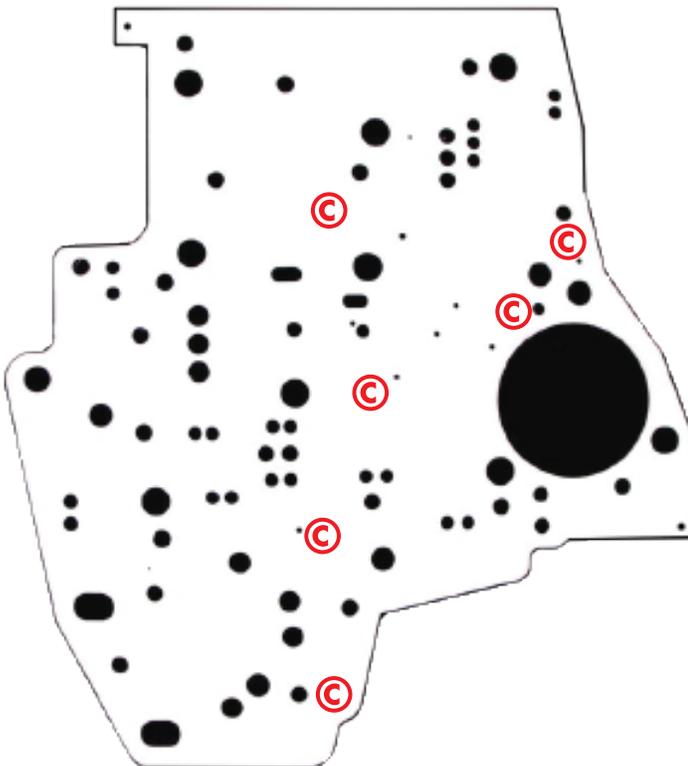
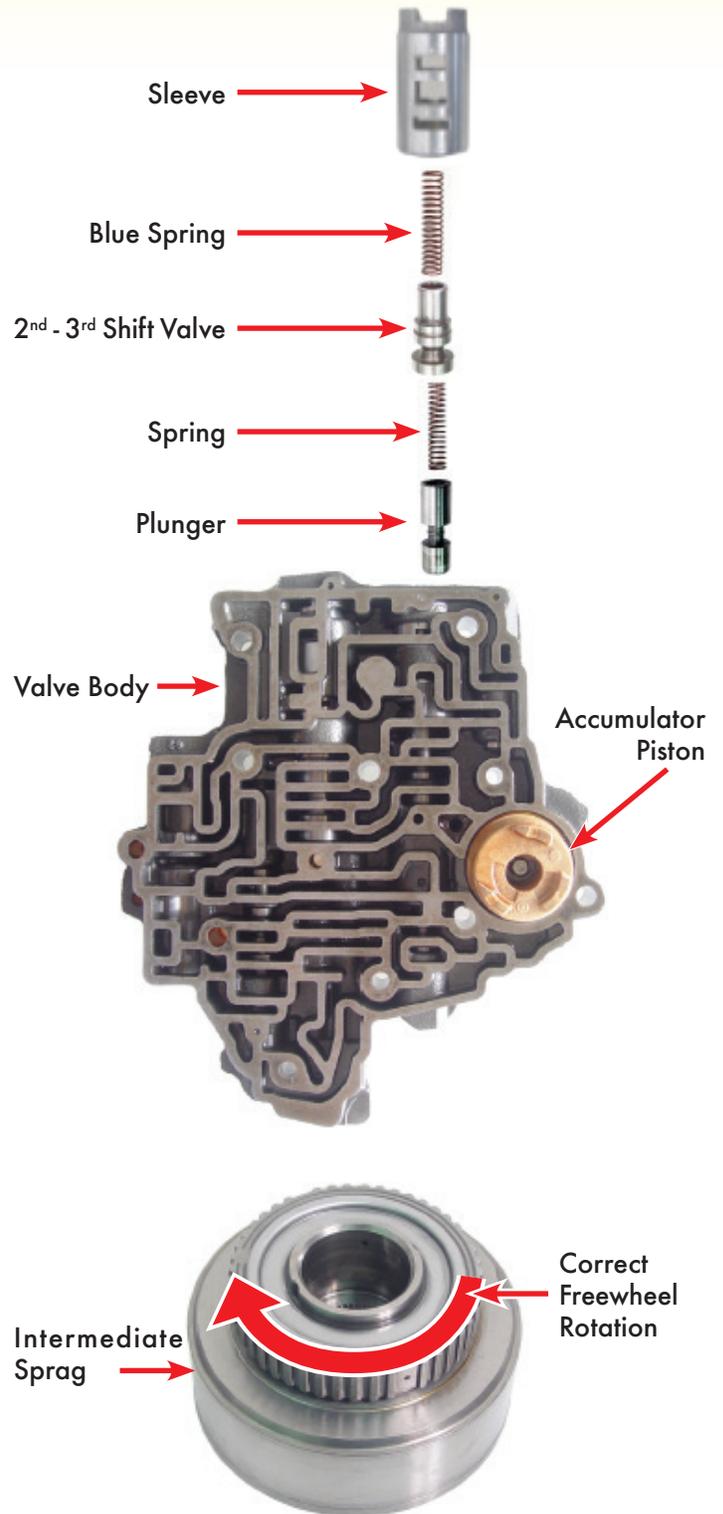
CHECK BALL LOCATIONS ON PLATE TRANSMISSION INSTALLED

1. Install the Blue spring between 2nd - 3rd shift valve and bushing.
2. The plastic accumulator pistons are prone to breaking. It is ideal to replace them with aluminum pistons.
3. The Direct Drum or Piston must have a check ball.
4. The Intermediate Sprag Outer Race must freewheel clockwise.
5. Install (6) 0.250" check balls on all models
 - Even 1987 and newer

1. Install (6) 0.250" check balls as shown in illustration.
2. Remove & discard any Horseshoe shims. Install Yellow spring included.
 - If transmission is in the vehicle, install the Yellow spring through the case window.
3. Modulator Valve Spring: Install Pink spring. After road test, if later/shorter $\frac{3}{8}$ throttle shafts are needed, remove Pink spring.
4. For earlier shifts install new Green governor springs.
 - Don't disassemble the governor.
5. Start "Z" bolts first to align Valve Body, Plate, Gaskets, and Case.

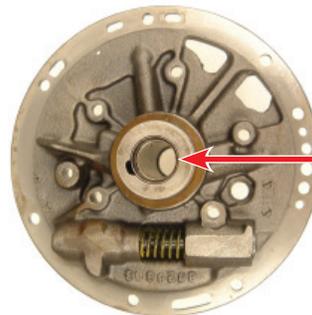
Don't install a thicker washer here to reduce front end play.

- The correct filter O-ring is the one that doesn't need stretched to go over tube.
- Don't reduce front end play by installing thicker washer. Forward rings can mis-locate the stator, causing forward clutch failure. Shim drums forward to reduce front end play. Rear unit end play (behind support) must remain less than front end play so that rear unit thrust does not reach the pump washer. (See Image Below)

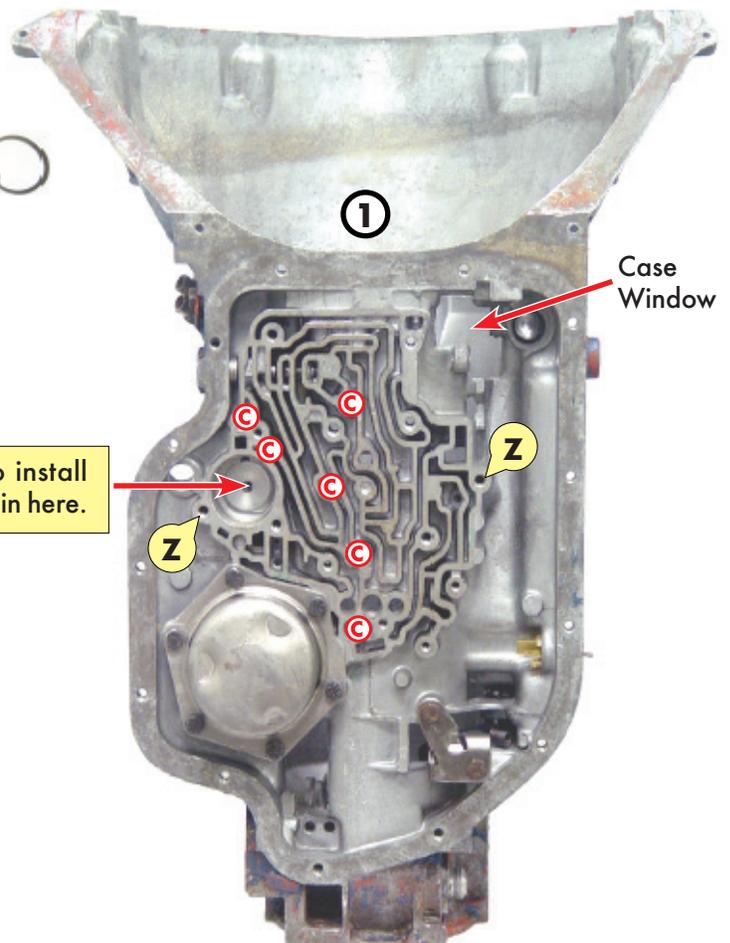
Remove and discard Horseshoe Shims. Install Yellow Spring

Modulator Valve Pink Spring Modulator

Don't forget to install the piston and pin here.

Governor Green Springs

Case Window

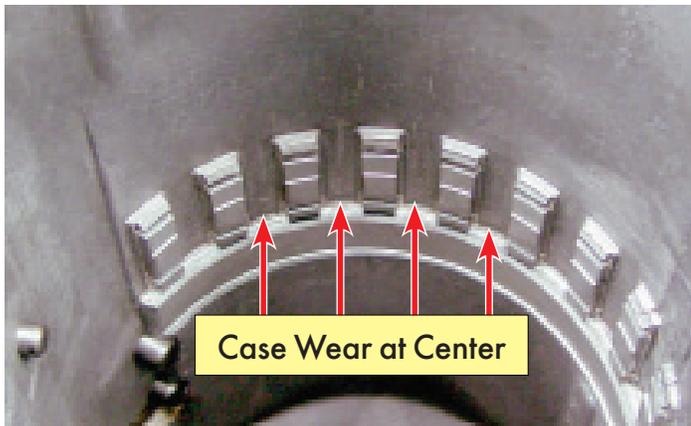
This case wear problem that has driven many a good man right up the wall. Wear at this point allows excessive center support movement and misalignment. This can cause high clutch failure, late or no 2nd- 3rd shift, falls out of high when hot; center support bushing wear, front planet wear and stator support failure. Only use center support that uses a steel shim in the case under the support.
