700 Parts and Info Update #2

PARTS AND INFO– FOR PREVENTION/CORRECTION OF THE FOLLOWING COMPLAINTS AND FAILURES:

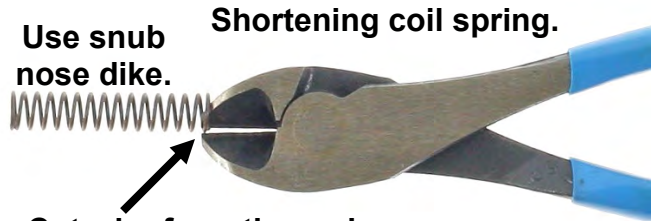
With 1st design 3-4 Shift Valve: Use smaller diameter of the two unpainted springs furnished in small plastic bag.

With 2nd design 3-4 Shift Valve: Use the larger diameter of the two unpainted springs furnished in the small plastic bag.

Use snub nose dike. Shortening coil spring.
Cut wire from the end.
Don't cut between the coils.

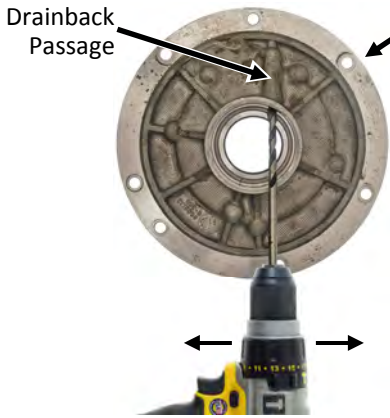
IF THE TRANS IS OUT—Enlarge the seal drainback passage to reduce LEAKS and keep the seal from blowing out. Use a 1/4"-9/32" drill (.250-.281)

"Bell Mouth" the drainback hole:
To increase flow, after enlarging the passage, insert the drill again into the hole about 3/4". Move the drill motor — Leftward and Rightward to widen the top of the hole.

Use the same drill to check or enlarge the holes shown in the pump and pump cover.

THE PROBLEM: Clearances and wear allow more oil to enter seal area than the drainback hole can handle. Pressure builds under seal causing the seal to blow out of the pump or leak.

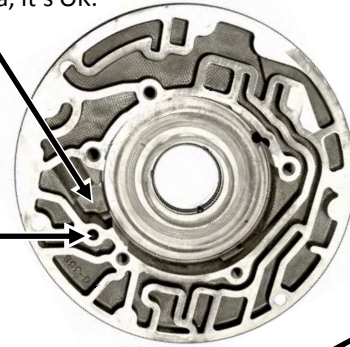
Look at the left end of this passage. If it has an open hole that the orifice plug furnished will fit, drive it in it. Otherwise: Tap it two or three threads deep and insert a piece of 1/4" bolt.
