TCI[®] 374400

Throttle Valve Sleeve Assembly for 700-R4/4L60

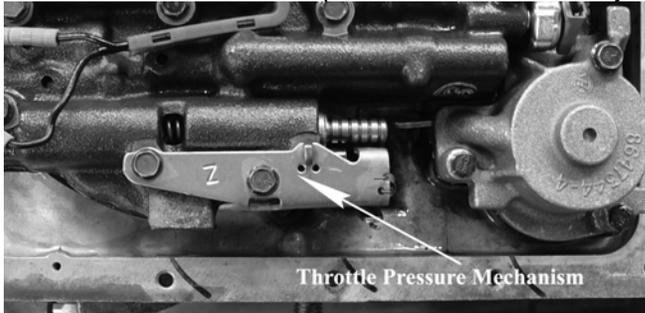
STEP 2 Locate the throttle pressure mechanism on your transmission. See **Photo 1**.

STEP 3 Remove the bolts retaining the throttle pressure mechanism to the valve body. Using a pair of side cutters, grasp and remove the roll pin holding the sleeve in the valve body. Pull the existing plunger and sleeve out together. *Be sure not to lose the spring behind the plunger.* Remove the existing plunger from the sleeve. Clean and lubricate the plunger with ATF and install in the new sleeve.

STEP 4 If the spring came out of the valve body, place it back in the bore. Orient the new sleeve so that the roll pin groove will line up with the roll pin hole in the valve body. Slide the new and new sleeve assembly into the valve body bore and replace the roll pin. Bolt the throttle pressure mechanism back into place making sure it is properly oriented. Torque the bolt to 8 ft.-lbs.
