## **2003-07 Ford 6.0L Boost Builder**

**P/N# 1516000**

### **- Installation Manual -**

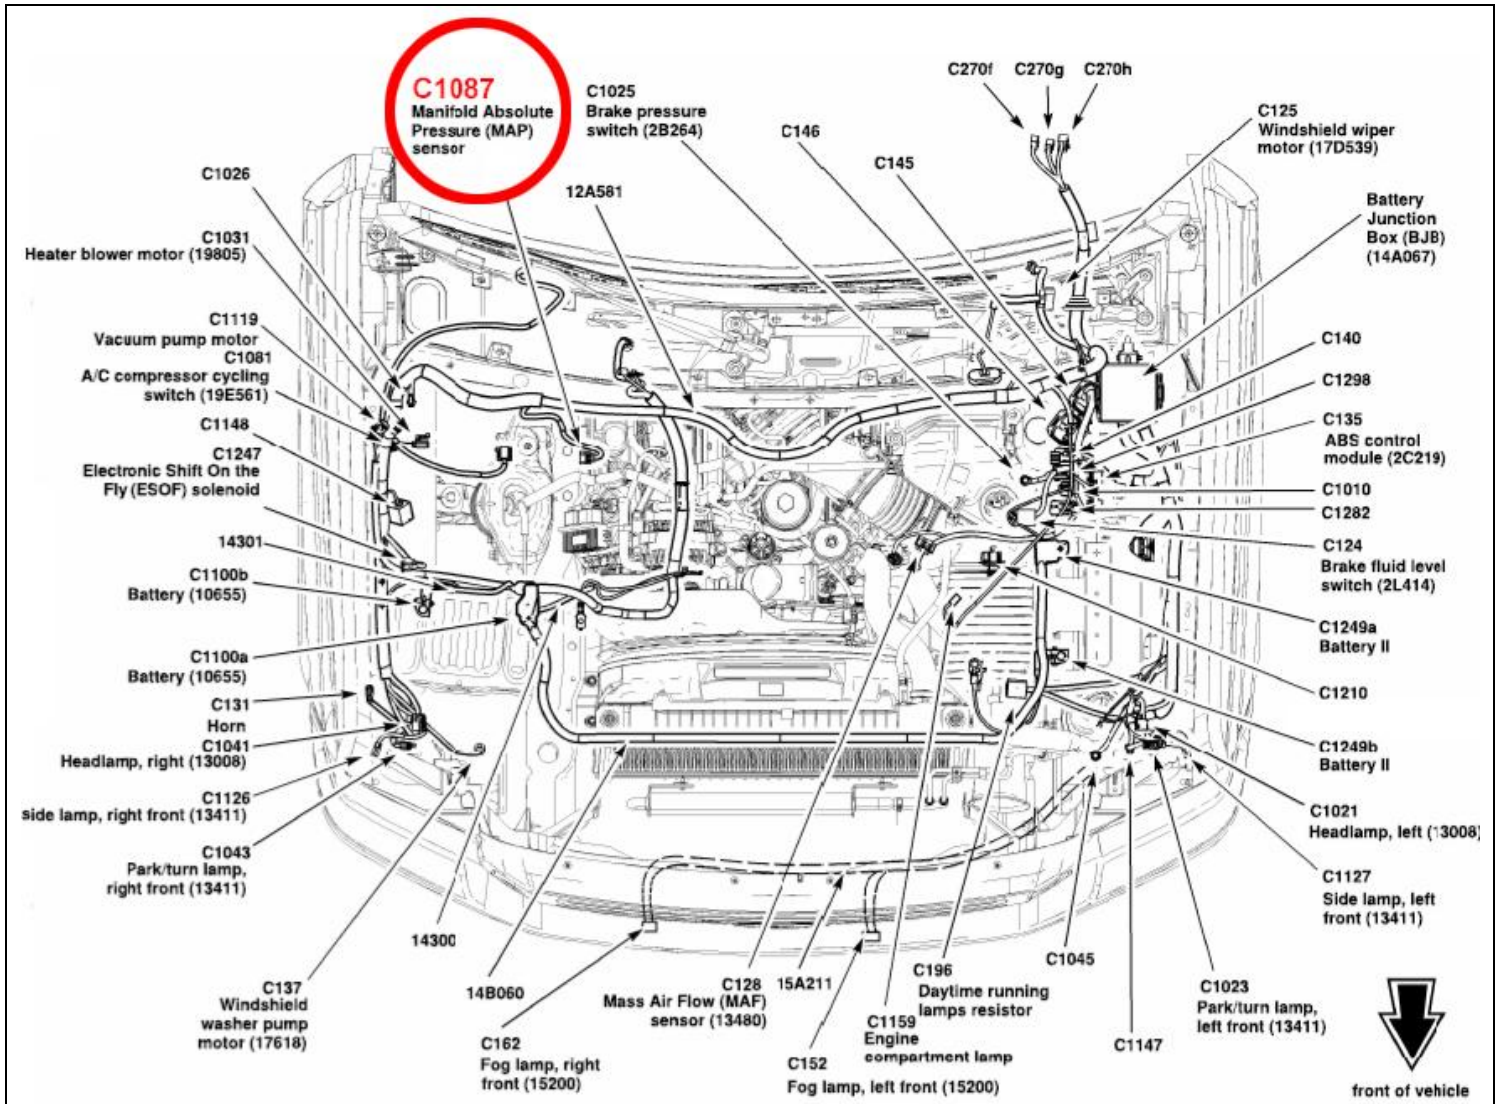
Locate the factory MAP sensor on the passenger side of the vehicle. It should be mounted near the firewall on a pedestal.

Remove the connector from the sensor and plug in the mating connector on the BD boost builder to the sensor. Also plug the other side of the connector to the factory connector.

Note that this factory connection is sometimes very difficult to separate. There is a red locking pin on the top that needs to be removed first.

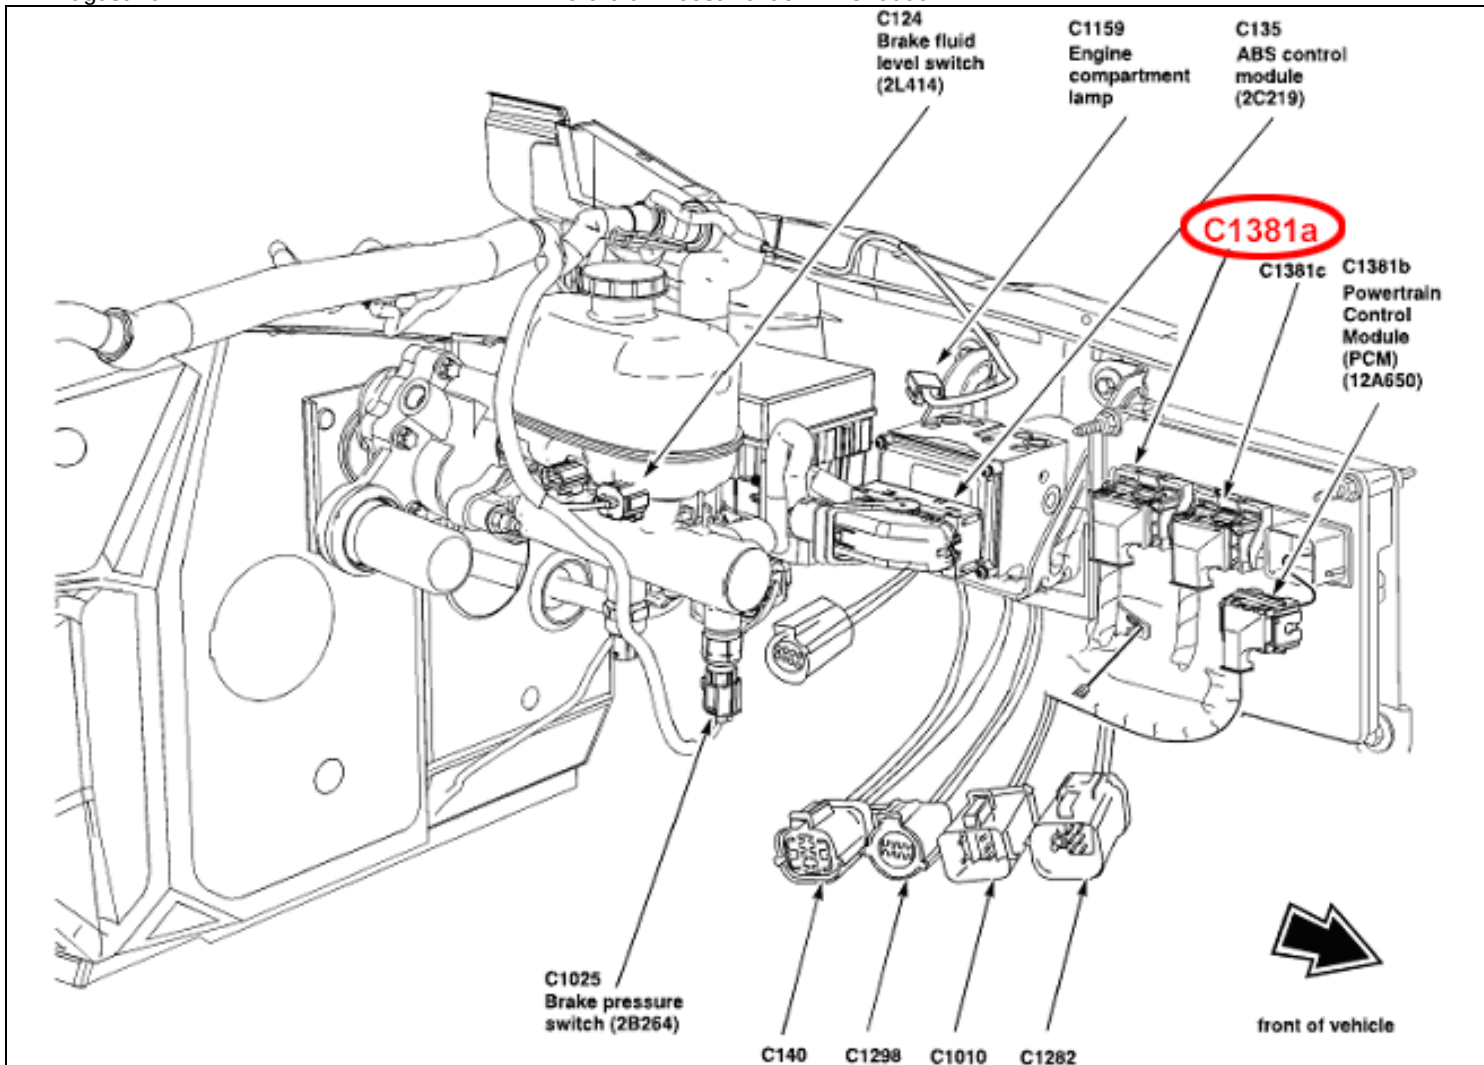
Once the connectors are connected, route the yellow wire along the top of the cowl, over to the driver side. The yellow wire will then connect to the ECM.

Locate the (46-pin) C1381a connector farthest to the rear on the ECM. We are looking to connect to the **APPS Sensor 2 signal wire**.

Use the provided POSI-TAP to TAP the connection to the PIN # 37 wire.

You may want to use a voltmeter to ensure this connection is made. The voltage at idle should be around 1.54V.
