Instruction Sheet #3.3187

Front Control Arm Set

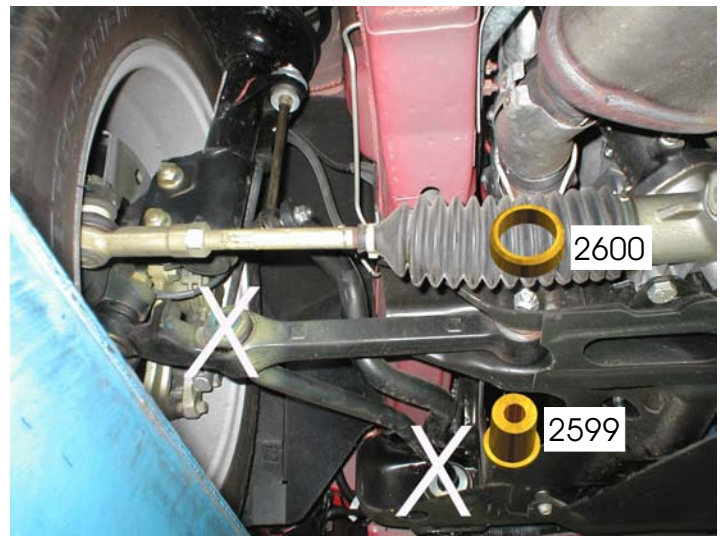
Once the OEM shell and bushing have been removed, clean out the eye of the arm. Also remove any sharp burrs in the metal. Now grease the ID of the arm and the OD/ID of bushing #2599. Install #2599 in from the front (see pic). Install the #2600 thrust washer bushing over #2599. Now install supplied sleeve. Reinstall arm and now tighten all bolts back to factory specifications.

Due to design constraints and safety concerns, no bushings were made for the strut arm positions. These positions are seen by an X. (see pic)
