Attention Jeep Owners!

Diagnosing possible causes of clutch noise: Squeaky clutch fork, bad bearing retainer collar and/or damaged throw out bearing clips

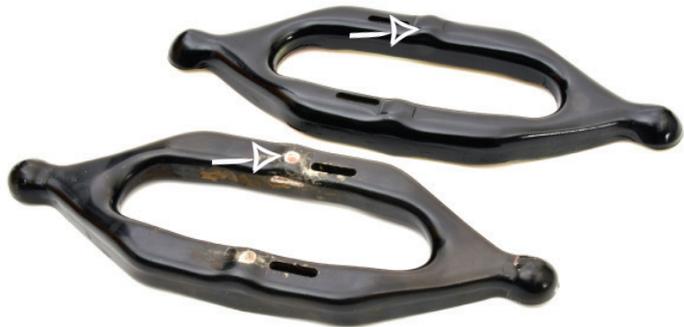
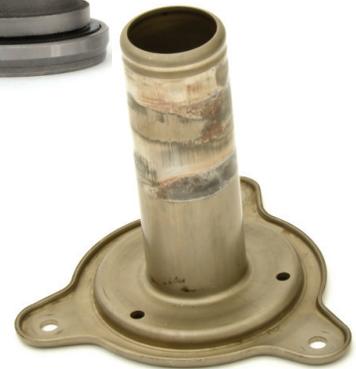
Inspect your transmission bearing retainer collar prior to installing your new clutch assembly. A worn bearing retainer collar will cause excessive wear to the diaphragm fingers of your pressure plate, heavy clutch pedal effort, squeaky clutch pedal and premature throw out bearing failure. To help prevent this from occurring ensure you have sufficient grease applied to the bearing retainer collar and fill the grease groove in your new throw out bearing.

Inspect your clutch fork for wear. A worn clutch fork will allow the throw out bearing to move side to side within the clutch fork causing noise. Your clutch fork should hold the throw out bearing securely in place.

Inspect the throw out bearing retainer clips when attaching to the clutch fork. Make sure the clips are not bent upward away from the throw out bearing ears/tabs. If the clips are bent, the clips will not secure the throw out bearing properly to the clutch fork allowing the throw out bearing to move freely causing noise.

Inspect your pivot ball for any signs of wear. A worn pivot ball will allow the clutch fork to move freely on the pivot ball which could result in noise.

Replace all worn parts as needed.

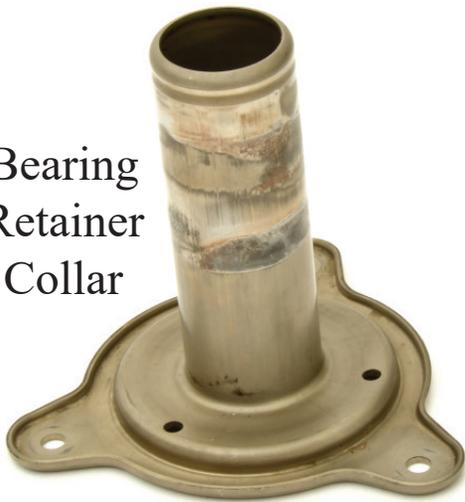
Bearing Retainer Collar

Worn

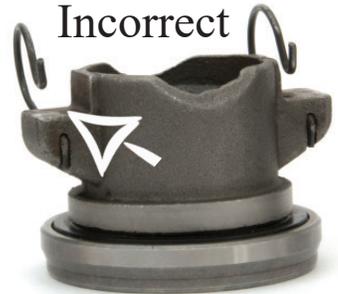
Pivot Ball

New

Worn
