RP20595

1939 Cadillac

1934 Oldsmobile

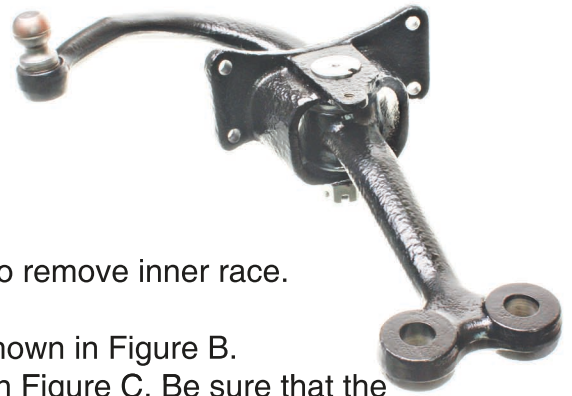
- Remove bell crank assembly, remove old bearings. Be sure to remove inner race.
- Press in bearings until bearing bottoms out.
- Roll O rings on flange side of bearings to keep out debris as shown in Figure B.
- Installation of grease fitting is highly recommended as shown in Figure C. Be sure that the grease fitting has enough clearance from bracket.
- Reassemble using castle nut, cotter pin and roll pin.
- Torque to specifications.
- Align as needed.

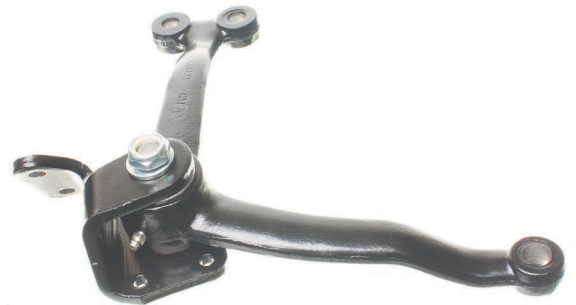
- Remove bell crank assembly, remove old bearings
- Machine 0.032" from each side of bell crank flange face
- Press in bearings until bearing shoulder sits flush on flange face.
- Roll O rings on flange side of bearings to keep out debris as shown in Figure B.
- Reassemble using washer and lock nut.
- Torque to specifications.
- Align as needed.
