## Installation instructions For set # 3.3188 2004 Pontiac GTO

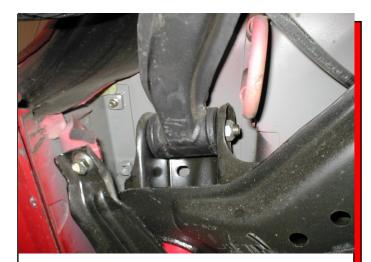
The outer position bushing has no outer metal shell that needs to be pressed out. The I.D. of control arm is Ø1.608, use something smaller when pressing out the old bushing. The O.E. rubber bushing is not bonded to the control arm. Trim off the flanges of the rubber bushing (both sides) and press out the bushing. Apply grease to all metal parts that contact the polyurethane bushings. Grease P/N's 2595 and sleeve P/N 15.10.180.39 and insert into the control arm.

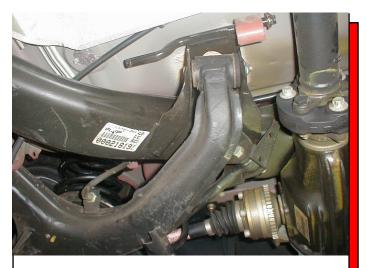
The inner position bushing has an outer plastic shell that needs to be pressed out. The I.D. of control arm is Ø1.608, use something smaller when pressing out the old bushing. Trim off the plastic flange of the shell and press out the bushing. Apply grease to all metal parts that contact the polyurethane bushings. Grease P/N's 2598 and sleeve P/N 15.10.180.39 and insert into the control arm.
