6L8 CS-TCC Fits: 6L45 thru 6L90 2007-20

Corrects/Prevents/Reduces

Shift Solenoid Performance Codes or false PO751 due to sticking or dragging Clutch Select Valves. Low Speed TCC "Chuggle" or Cycling during cylinder deactivation.

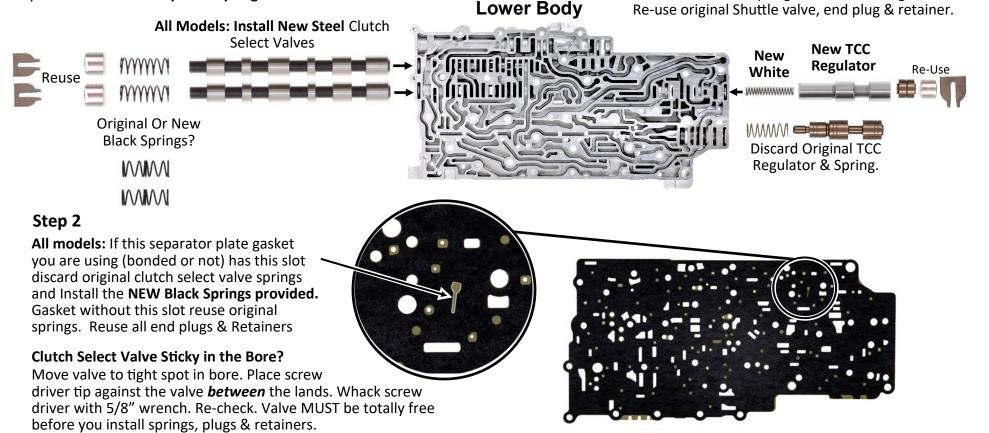
Step 1

Discard original clutch select valves. Save the springs. When installing the new select valves hold the valve body in the vertical position, let the valve drop into the bore. The valve should bounce off the bottom of the bore. The bounce tells you it's free. **Read step 2 for spring selection.**

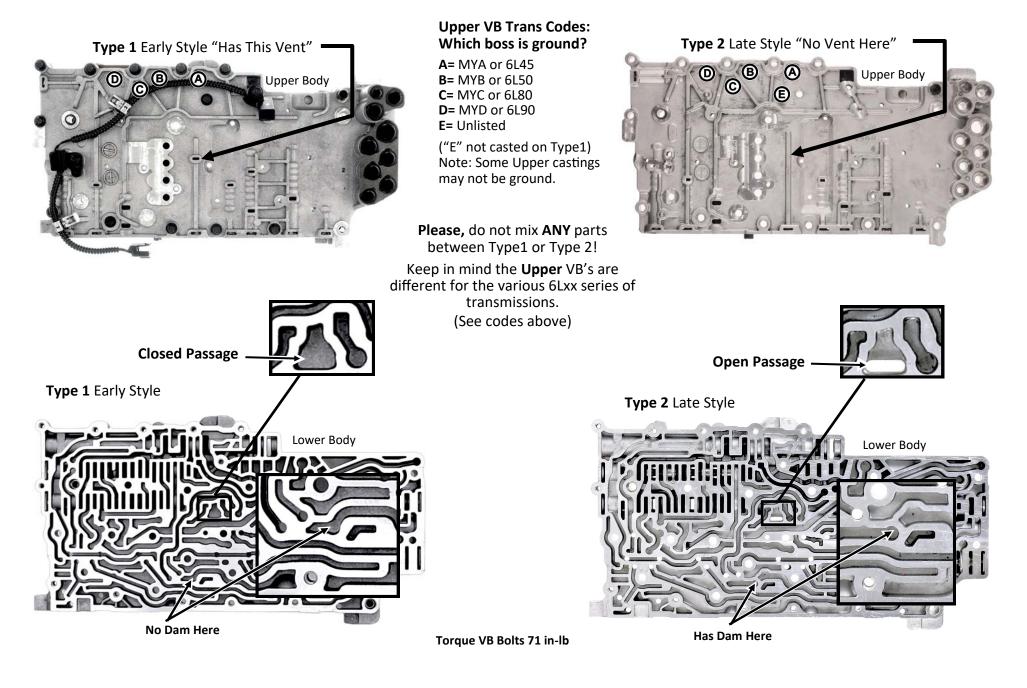
Valve Body Identification

Has Hole 2X Here

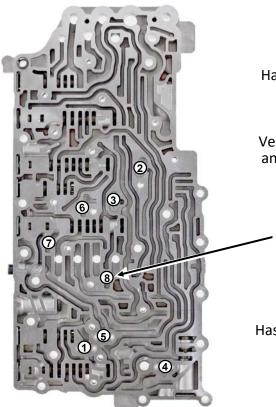
Type 2 Plate, Version 1 Used on Type 2 VB's thru 2013 Has the 3 circled holes & .180" feed hole A. No Hole 2X Install Check Balls 1-7 It is a good idea to update this Type 2 Version 1 plate to a Version 2 during repairs and add the #8 check ball. Plates are cheap and come with bonded gaskets.

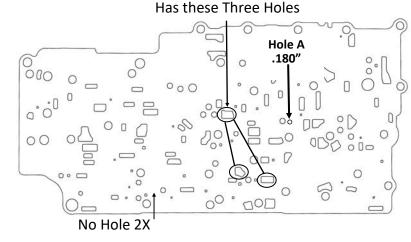
Type 2 Plate, Version 2. Used on Type 2 VB's 2014 up Has the 3 circled holes & .062" feed hole A. No Hole 2X Install Check Balls 1-8 GM # 24272467

Has these Three Holes Hole A .062" °C 0 000 0 000 a°0 00. 0 00 0 0 00 00 6 0 00 No Hole 2X

Always install #8 ball when using GM Type 2 Version 2 plate.

Pay attention to #1 & #5 check balls. They wear and will stick in the plate causing forward & Reverse engagement concerns.

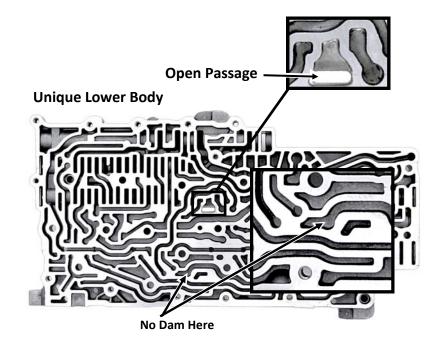
Unique Plate Has 2X hole & **Has wedge hole**, does not have lower holes, no replacement plate available.

Mid Production Unique Plate May or May not have wedge shaped hole here.

Install balls 1-7
