Part # 1512,15120- 1986-93 Ford Mustang V8 5.0L

Part # 1529,15290- 1994-95 Ford Mustang V8 5.0L GT/Cobra

## 1-5/8" Equal Length

## Shorty Headers

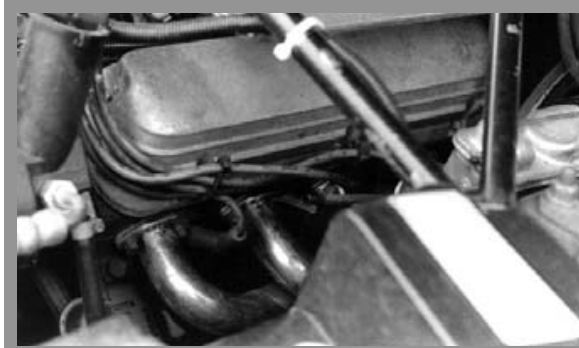
#### STEP 7

- Before re-installing, the dip stick will require clearance.

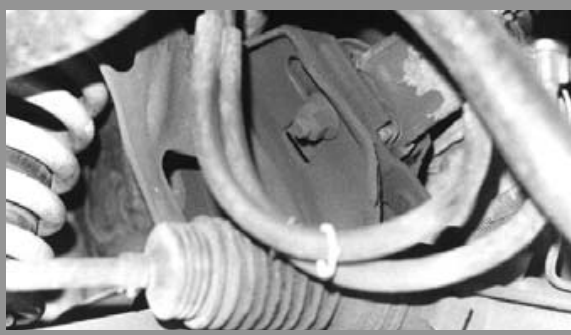
### STEP 8

- To avoid damage to the header coating or paint in the engine compartment it may be necessary to raise the right side of the engine while installing the passenger side BBK Header. The motor mount is connected to the vehicle with 1 nut, easily accessible from under the front of the vehicle.

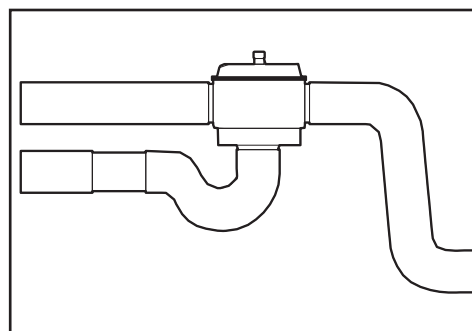
### STEP 12

- Before re-installation, the air injection tubes must be modified as shown above using the hose and clamps provided in the kit.
