# Spohn Performance, Inc.

## **Part #964 – Tubular Shock Tower Brace 1993-2002 GM F-Body (will not fit 1996-1997 Camaro SS or any V-6 cars)**

### **INSTRUCTIONS**

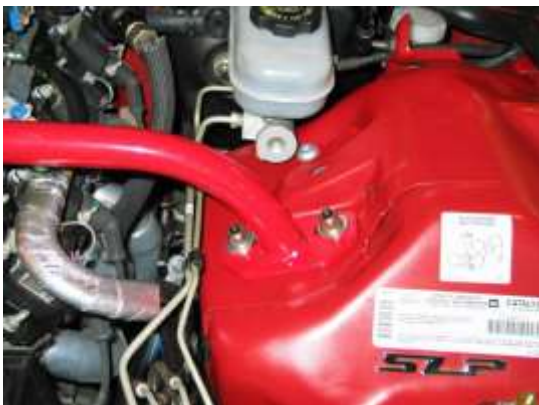
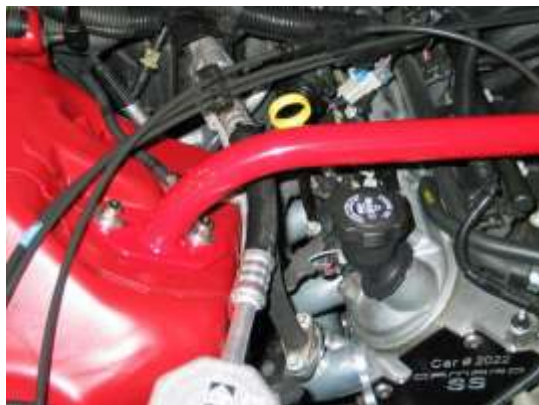
3. Position the shock tower brace over the passenger's side first. Then lower over the driver's side, there are two brake lines here running to the ABS unit that need to be gently pushed over in order to lower the brace all the way down.

4. Once in place, install the supplied flat washers, then the nuts can be re-installed. The outer nuts can be installed with the socket while the inners generally require a wrench. On newer models with the passenger side A/C line bracket, the bracket will either need to be deleted or slipped under the main mounting nut due to limited threads on the stud. On older vehicles, reinstall the A/C sensor and plug it back in.
