# EDELBROCK INTERCOOLER KITS

For 1992-1995 & 1996-2000 Honda Civic,  
and 1994-2001 Acura Integra  
Catalog #15009, 15036, 15037  
**INSTALLATION INSTRUCTIONS**

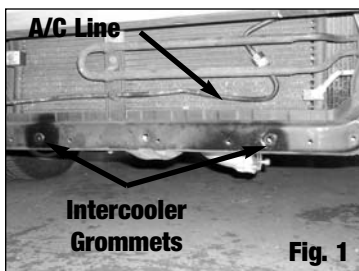
4. On 1994-2001 Acura Integras, there is an A/C line in front of the power steering cooler line. This will need to be modified in order for the intercooler to fit properly. Remove the bolts holding the power steering cooler line to the radiator support. Carefully flex the power steering line out of the way, and carefully bend the A/C line by pushing it towards the radiator. It should sit between the power steering cooler line and the radiator when the power steering cooler line is flexed back to its original position (**See Fig. 1**). Reinstall power steering cooler line mounting bolts.

3. Install the intercooler grommets into the holes in the lower radiator support as shown (**See Fig. 1**). Using a small amount of silicone-

based spray lubricant on the grommets will ease installation. Mount the intercooler by pressing the pins on the lower edge of intercooler into the installed grommets (**See Fig. 2**). For 1996-2000 Civics, use the factory horn bolt removed earlier to attach the inter-cooler brace and horn to the center radiator support (**See Fig. 3**). For 1992-1995 Civic, and 1994-2001 Integra, attach the intercooler brace to the center radiator support using the supplied 6mm x 1.0 bolt and nut, and 1/4" washer.
