# Installation Instructions

## SPORTLINE # 4.9082

### Scion, xB – 2008

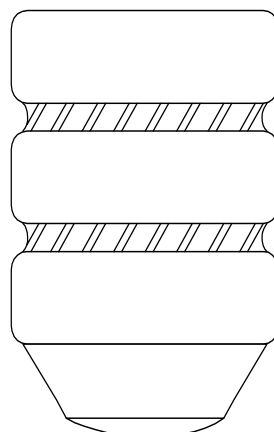
Typical Bump-Stop  
(Bump-Stop from your  
vehicle may have different shape)

Replace the O.E. Front Bump Stop  
With the Eibach Bump Stop  
Part Number BS 770015.

**Note:** Replace the OE front upper strut  
nut with the new provided Hex Nut
