Ford Technical Bulletin

PROCEDURE FOR 2008 F-250/F-550 6.4L DIESEL RADIATOR REPLACEMENT VENTURI TEE INSTALLATION KIT

2008 F-250/F-550 6.4L DIESEL RADIATOR
REPLACEMENT VENTURI TEE

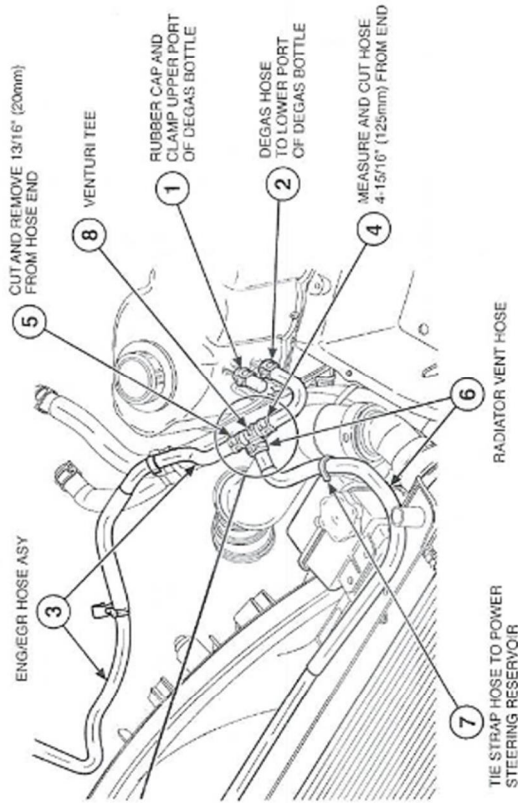
VIEW A

12. Tie-strap radiator vent hose to hole in edge of power steering reservoir (refer to Figure 1, item 7).
13. Install rubber cap and clamp assembly (view A) on upper Degas bottle port (refer to Figure 1, item 1).

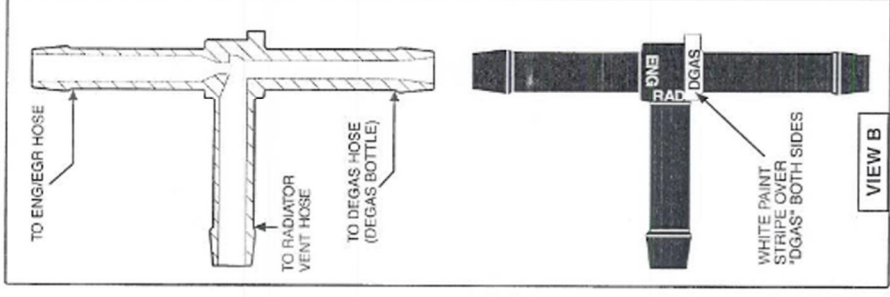
VIEW B

6. Insert end of Venturi Tee labeled "ENG" (view B) into Exhaust Gas Recirculation (EGR) vent hose (refer to Figure 1, item 3 and 8).
7. Insert end of Venturi Tee labeled "DGAS" (White Stripe) (view B) into end of Degas hose (refer to Figure 1, item 8).

8. Insert end of Venturi Tee labeled "RAD" (view B) into end of Radiator Vent Hose (refer to Figure 1, item 6 and 8).
9. Install Venturi Tee in a slight upward position to prevent contact with Upper Radiator hose (refer to Figure 1, item 6).
